SI M11 01 12
Engine

January 2013
Technical Service

Engine Oil Leak

R55 (Cooper Clubman and Cooper S Clubman) with N16 and N18 engine

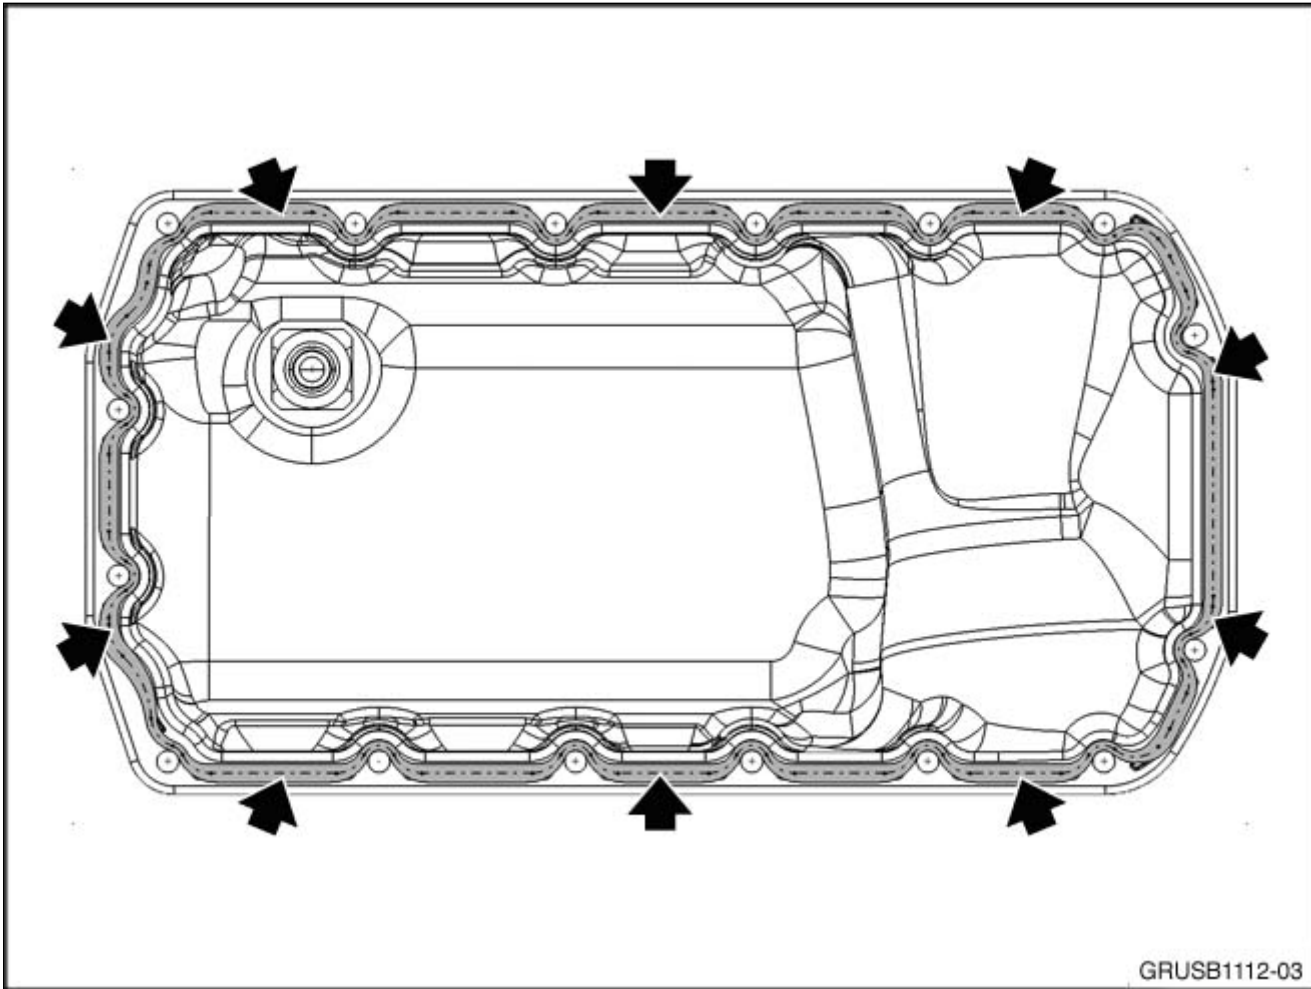
4. **NEW** The replacement engine oil pan gasket available via EPC (P/N 11 13 7 565 928) should no longer be used when resealing the engine oil pan. A substitute flexible liquid sealing material, P/N 83 19 0 404 517 Loctite 5970, should be used.

NEW Before reinstalling the engine oil pan, it must be cleaned of all adhesive residues. Apply Loctite 5970 (P/N 83 19 0 404 517) to the sealing surface of the engine oil pan. The bead of the flexible liquid sealer should be approximately 2mm-2.5mm in height when applied. The sealing material should be applied to the engine oil pan on the inboard side of the drilled fastener holes. Refer to the illustration below for proper flexible liquid sealer location. For proper tightening torque and vehicle reassembly procedures, refer to Repair Instruction 11 13 000, “Removing and installing engine oil pan.”
