# SERVICE BULLETIN

Classification: EC12-012	Reference: NTB12-051	Date: June 19, 2012
-----------------------------	-------------------------	------------------------

## 2011 - 2012 ALTIMA; MIL "ON" WITH DTC P0101

**APPLIED VEHICLES:** 2011 - 2012 Altima Sedan (L32) with QR25 only  
2011 - 2012 Altima Coupe (CL32) with QR25 only

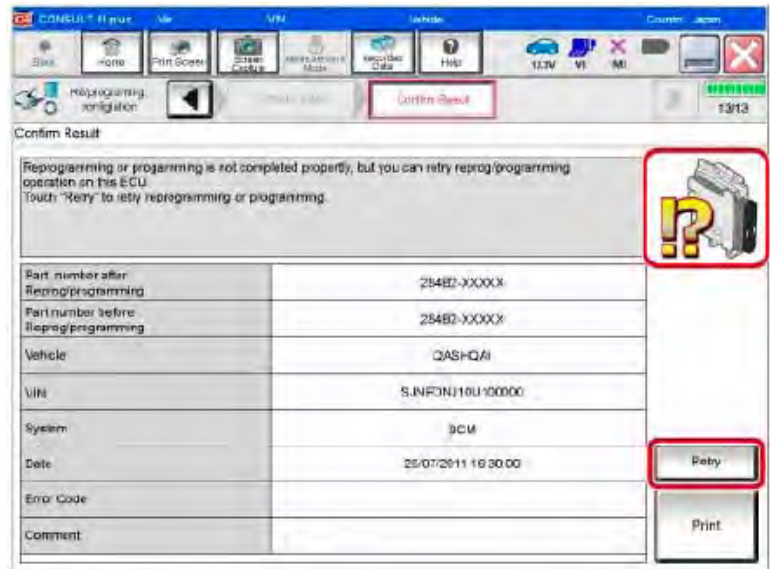
Figure 5

If reprogramming does not complete and the “!” icon displays as shown in Figure 5:

- Check battery voltage (12.0–15.5 V).
- Ignition is ON, engine OFF.
- External Bluetooth® devices are OFF.
- All electrical loads are OFF.
- **Select retry and follow the on screen instructions.**
- “Retry” may not go through on first attempt and can be selected more than once.

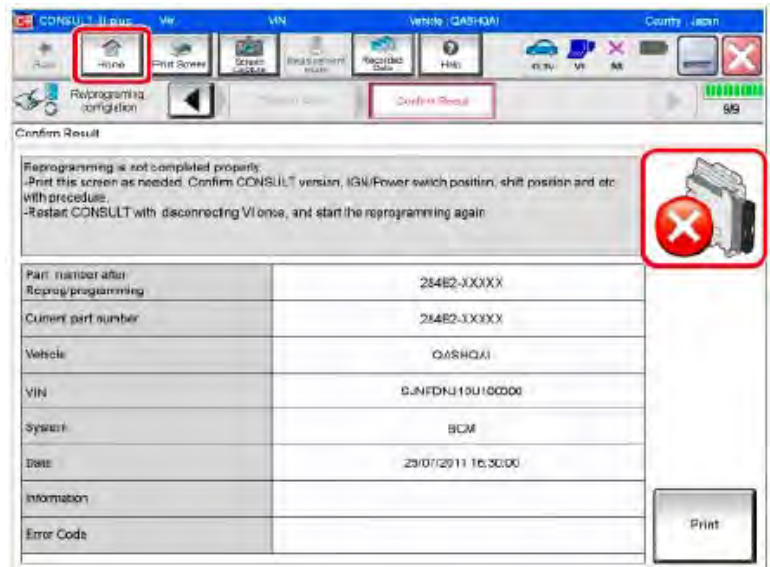
Figure 6

If reprogramming does not complete and the “X” icon displays as shown in Figure 6:

- Check battery voltage (12.0 – 15.5 V).
- CONSULT A/C adapter is plugged in.
- Ignition is ON, engine OFF.
- Transmission is in Park.
- All C-III plus / VI cables are securely connected.
- All C-III plus updates are installed.
- **Select Home, and restart the reprogram procedure from the beginning.**
