Service Bulletin

Bulletin No.: PI0746

Date: June, 2012

Subject: Malfunction Indicator Lamp (MIL) On, Poor Acceleration, Throttle Body Freezing, Multiple DTCs Set, Ice Deposits and/or Oil Deposits Present in Air Inlet Duct

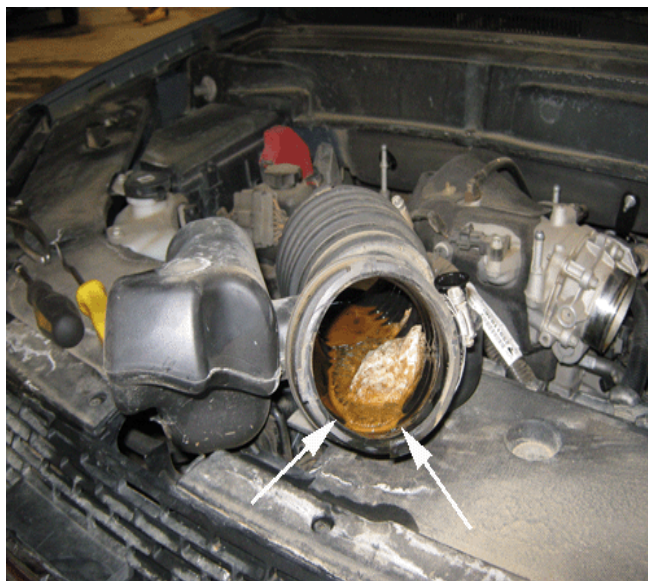
2837688

Technicians may find the presence of DTCs P0101, P0171, P0172, P0174, P0175, P1516, P2177, P2178, P2179, P2180, P2187, P2188, P2189, and/or P2190 along with either ice or oil deposits in the air inlet duct.

Ice formation is caused by condensation freezing at the base of the throttle body with additional collection of ice formation deposits in the air inlet duct. Freezing condensation forms after the vehicle has been driven and then parked in low ambient temperatures.

Oil deposits are the collection of the engine vapors, fuel dilution and oil mist at the base of the throttle body with additional formation collecting in the duct.
