SB-10045303-2761

Title: Air Horn Broken Off

Applies To: LoneStar model built with a single Air Horn Feature Code 0008WCL between May 11, 2011 through July 12, 2012

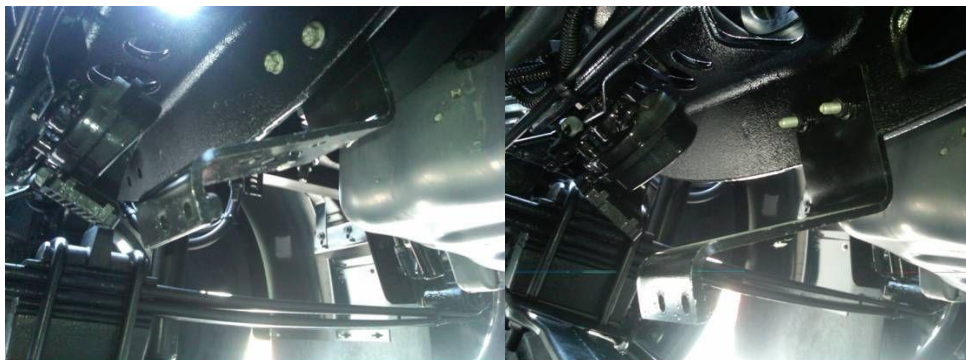
A limited number of LoneStar units have been identified to have been built with the mounting bracket mounted on the wrong side of the crossmember and air horn may be mounted on the lower side of the mounting bracket. This could allow the horn to contact the front axle during normal operation of the vehicle generally resulting in extensive damage to the air horn assembly

Wrong Bracket Installation

Correct Bracket Installation

Install bracket so that it is mounted to the inside of the crossmember and horn assembly is mounted on top of the bracket

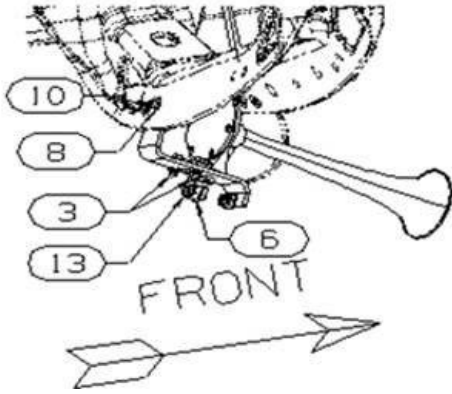
Correct Horn Installation

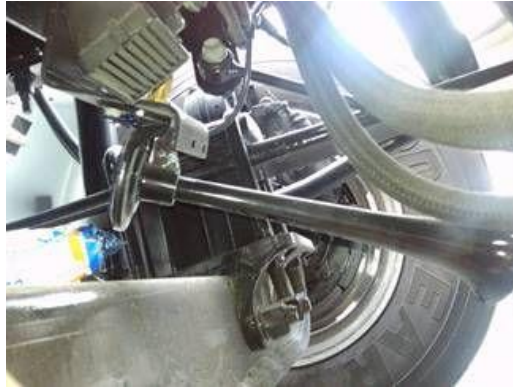
Wrong Installation
