SB-10045303-5547

Title: Air Horn Broken Off

Applies To: LoneStar model built with a single Air Horn Feature Code 0008WCL between May 11, 2011 through July 12, 2012

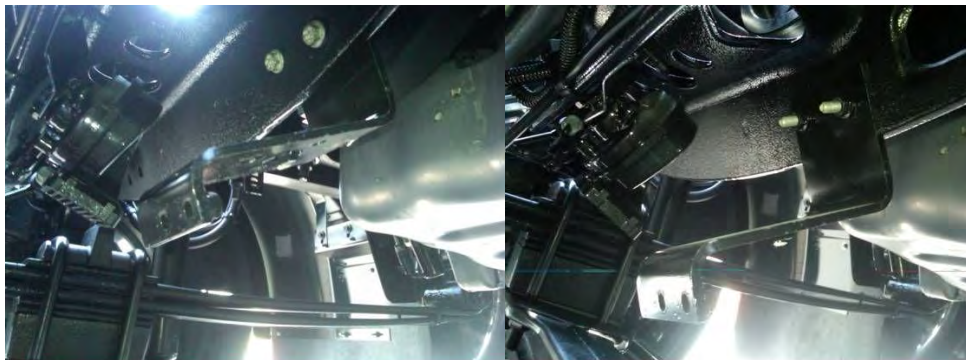
A limited number of LoneStar units have been identified to have been built with the mounting bracket mounted on the wrong side of the crossmember and air horn may be mounted on the lower side of the mounting bracket. This could allow the horn to contact the front axle during normal operation of the vehicle generally resulting in extensive damage to the air horn assembly

Wrong Bracket Installation

Correct Bracket Installation

Install bracket so that it is mounted to the inside of the crossmember and horn assembly is mounted on top of the bracket

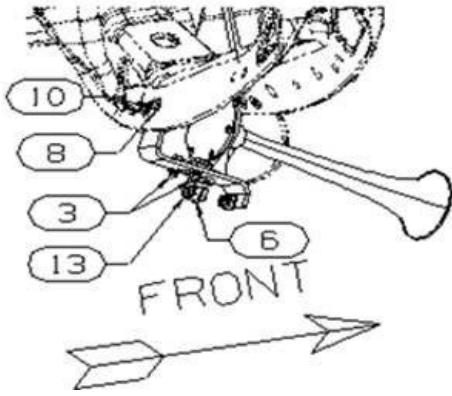
Correct Horn Installation

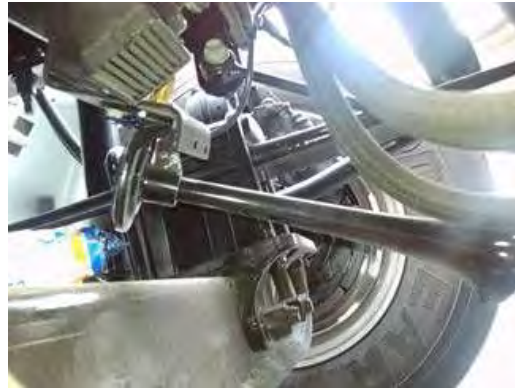
Wrong Installation
