**No or intermittent unlocking function from door handles
(S60 w/ Keyless drive)**

REF NO: TJ 26520	ISSUING DEPARTMENT: Technical Service	CAR MARKET: United States and Canada		
PARTNER: 3 US 7510 Volvo Cars North America		ISSUE DATE:		
FUNC GROUP: 8340	FUNC DESC: Lock, handle	YEAR 2013	MONTH 01	DAY 09
Page 1 of 4

Volvo Car Customer Service	
TJ Instruction	
TJ 26520	
January 2013	
No or intermittent unlocking function from door handles (S60 w/ Keyless drive)

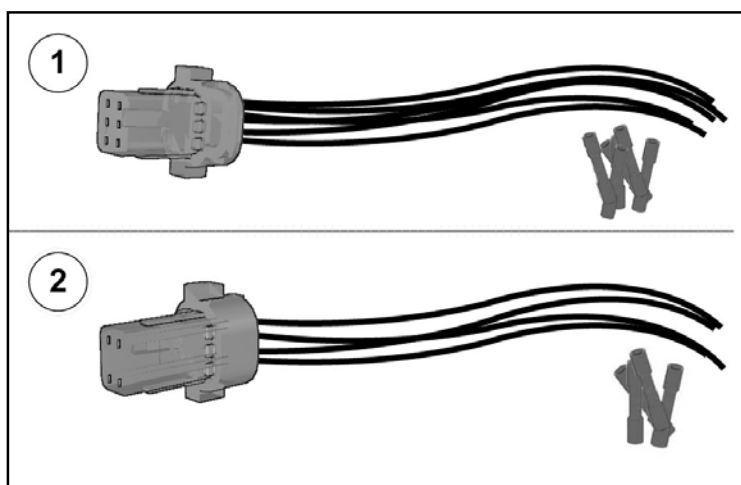
1: Front Door

2: Rear Door

Cut the wiring length of the extension cable to correctly match the vehicle.
