VOLVO CARS SERVICE AND PARTS BUSINESS

Technical Journal

TITLE:
**No or intermittent unlocking function from door handles
(S60 w/ Keyless drive)**

REF NO: TJ 26520	ISSUING DEPARTMENT: Technical Service	CAR MARKET: United States and Canada		
PARTNER: 3 US 7510 Volvo Cars North America		ISSUE DATE:		
FUNC GROUP: 8340	FUNC DESC: Lock, handle	YEAR 2014	MONTH 03	DAY 04
Page 1 of 5

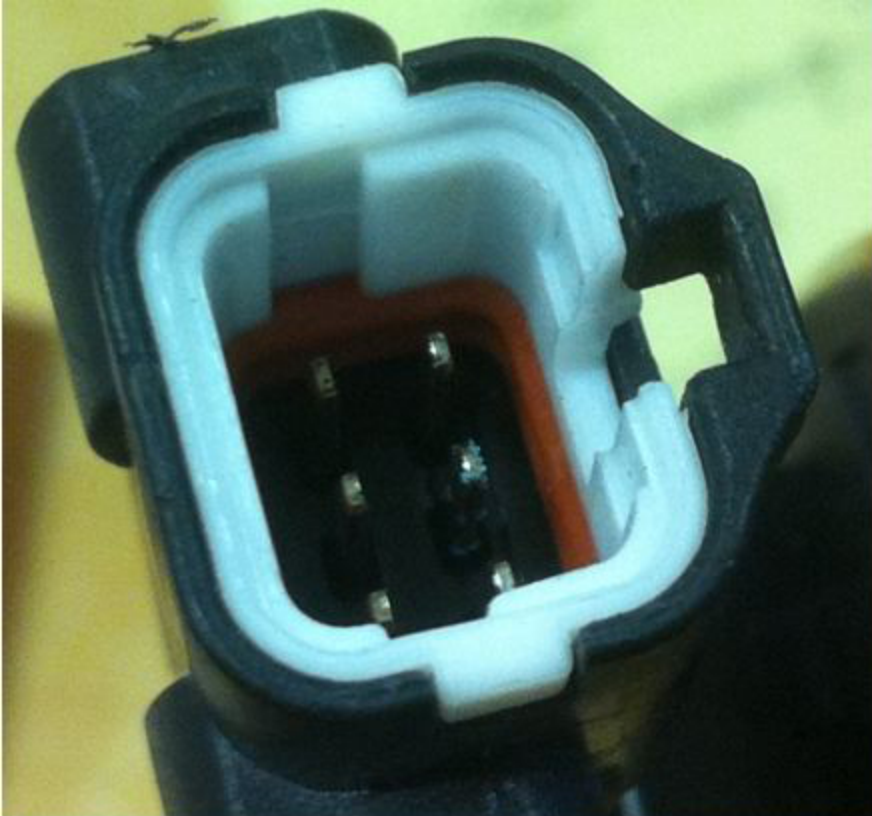
See Corrosion.JPG .

If corrosion is found, the door handle must also be replaced, as it is likely that the corrosion was caused by water leakage through the handle. See TJ 27787 for instructions on reusing painted outer door handle covers.

If the corrosion has extended deep enough into the harness that the copper is discolored at the location where the splices would be made, the harness cannot be properly repaired with the extension cables; the entire door harness must be replaced.

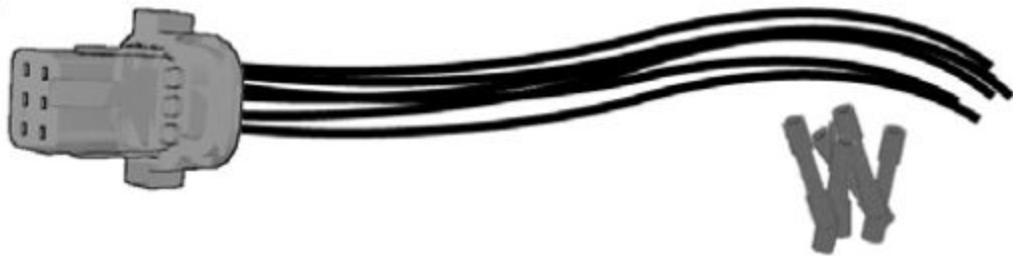
1

1: Front Door

230mm (9 inch) long extension cables are available for repairing the harness Extension_Cable.JPG.

- Front door: 31358682
- Rear door: 31382553

Cut the wiring length of the extension cable to correctly match the vehicle.

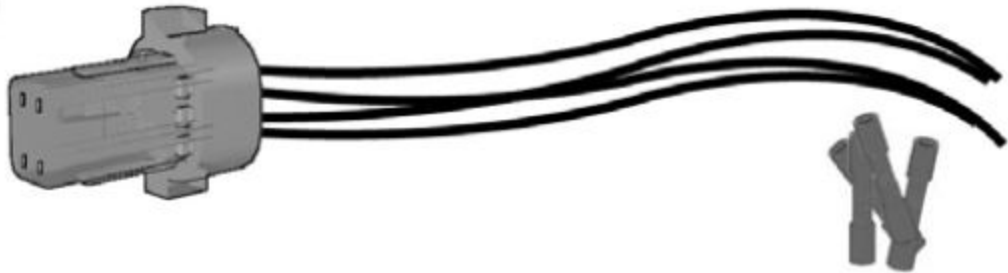
2

2: Rear Door
