# Cascadia Chassis Side Fairing Lower Air Deflector Retention

31-32

**Freightliner  
Service Bulletin**

**Description of Revisions:** *This bulletin replaces the version dated May 2013. The procedure has been revised to use production retaining clips.*

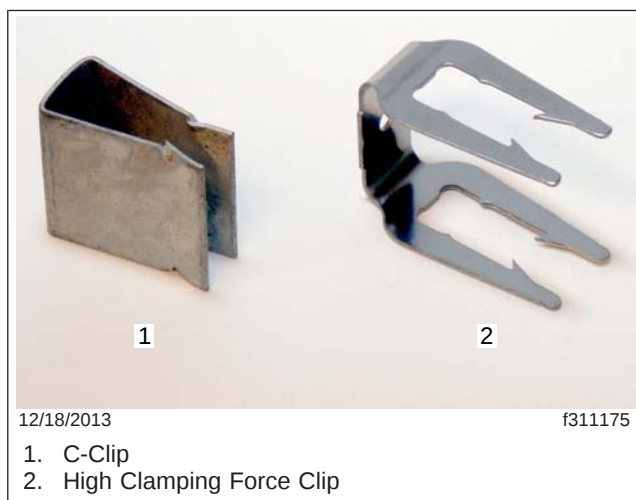
Cascadia vehicles with aerodynamic side fairings built before August 19th, 2013 have chassis side fairing lower air deflectors attached with C-clips that could become loose if dislodged or disturbed. In certain circumstances, a deflector may separate from the vehicle. To improve the retention of air deflectors, these C-clips can be replaced with current production clips that have more clamping force.

**IMPORTANT:** Vehicles built on and after August 19th, 2013 already have the newer retaining clips with higher clamping force installed. See [Fig. 1](#) for the difference between the older C-clips and the newer clips.

**Fig. 1, The older C-clip and more recent high clamping force clip.**

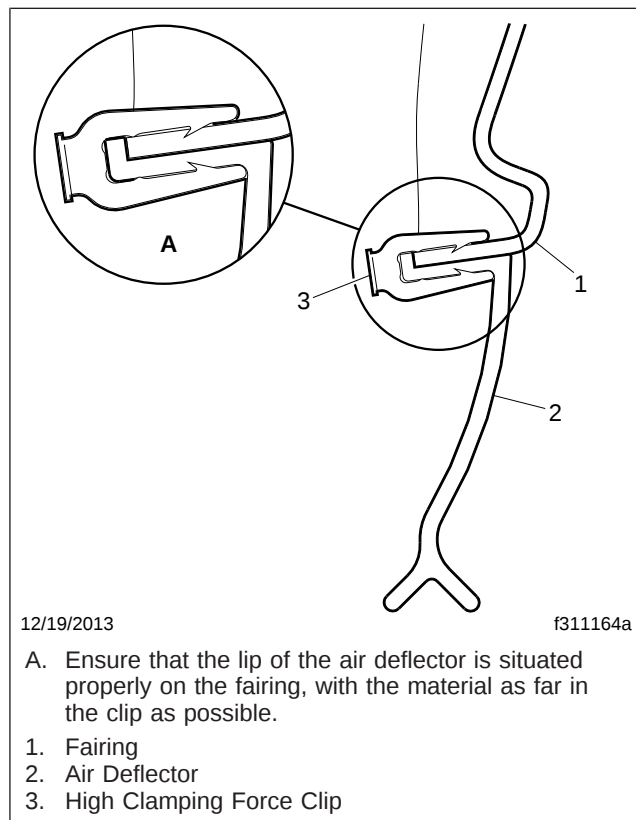
**Fig. 2, Air Deflector and Fairing Installation**

3. Ensure that the lip of the air deflector is situated properly on the fairing, with the material as far in the clip as possible. See [Fig. 2](#).
4. Working one clip location at a time, pry each existing C-clip off with a flathead screwdriver and replace it with a new retaining clip in the same location. Tap the new clip into place with a rubber mallet. Repeat this task for every clip.

**NOTE:** Make sure to use the same location and spacing as the existing clips. If clips are missing, the clip spacing for particular fairing configurations are shown in the installation drawing D22-69272 via EZWiring in PartsPro.
