# SERVICE BULLETIN

EC13-008

May 30, 2013

## 2013 SENTRA; INTERMITTENT LOW ENGINE RPM AT IDLE

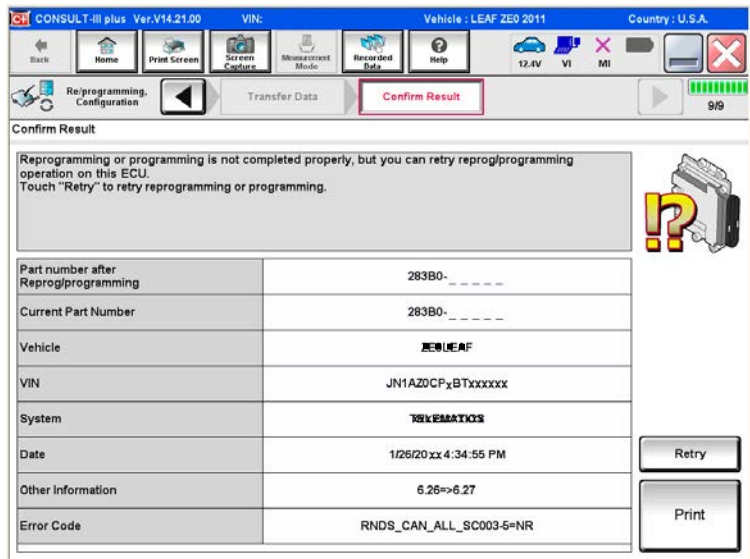
Figure 5

If reprogramming does not complete and the “!?” symbol displays as shown in Figure 5:

- Check battery voltage (12.0 – 15.5V).
- Ignition is ON, Ready Mode is OFF.
- External Bluetooth® devices are OFF.
- All electrical loads are OFF.
- **Select Retry and follow the on screen instructions.**

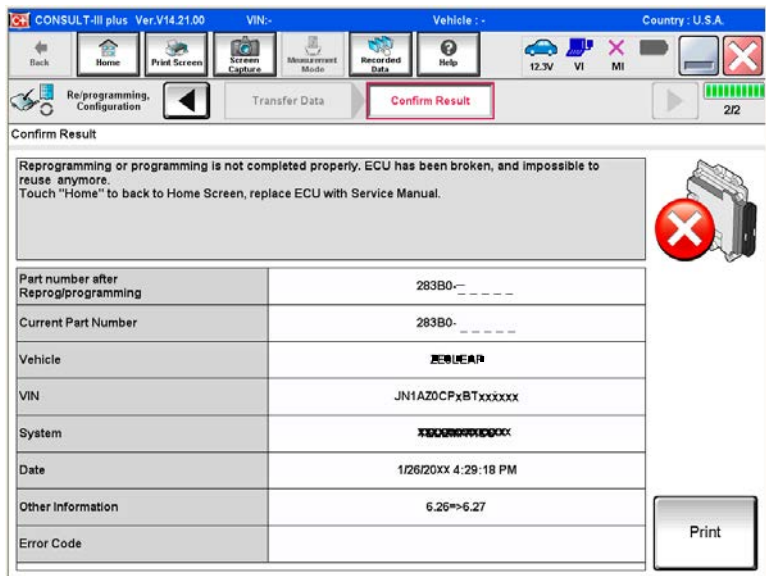
Figure 6

If reprogramming does not complete and the “X” symbol displays as shown in Figure 6:

- Check battery voltage (12.0 – 15.5V).
- CONSULT A/C adapter is plugged in.
- Ignition is ON, Ready Mode is OFF.
- Transmission in Park.
- All C-III plus / plus VI cables are securely connected.
- All C-III plus updates are installed.
- **Select Home, and then restart the reprogram procedure from the beginning.**
