SERVICE BULLETIN

EC13-008b

January 27, 2014

SENTRA; INTERMITTENT LOW ENGINE RPM AT IDLE OR STOPS RUNNING COMING TO A STOP

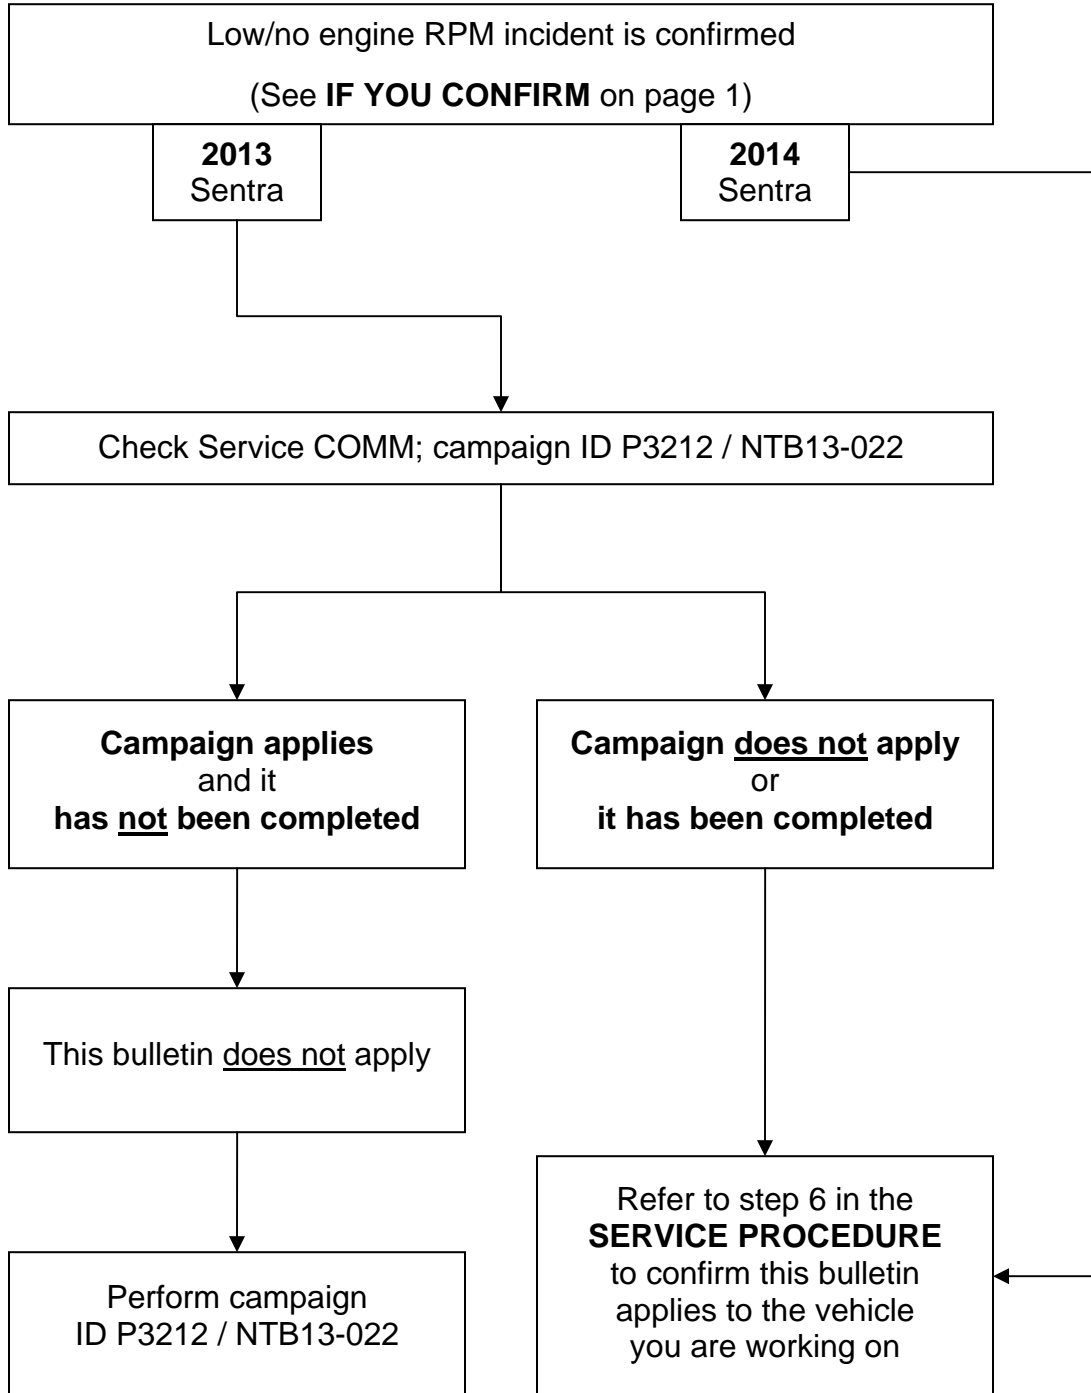
Repair Overview

The engine RPM intermittently drops very low while stopped (idling) or the engine stops running while coming to a stop.

1. Refer to the **Repair Overview** on page 2 to determine if this bulletin applies.

NOTE: On certain specific 2013 Sentra vehicles campaign ID P3212 / NTB13-022 may apply. Make sure to use the **Repair Overview** to determine if the campaign bulletin or this bulletin applies, or neither apply.

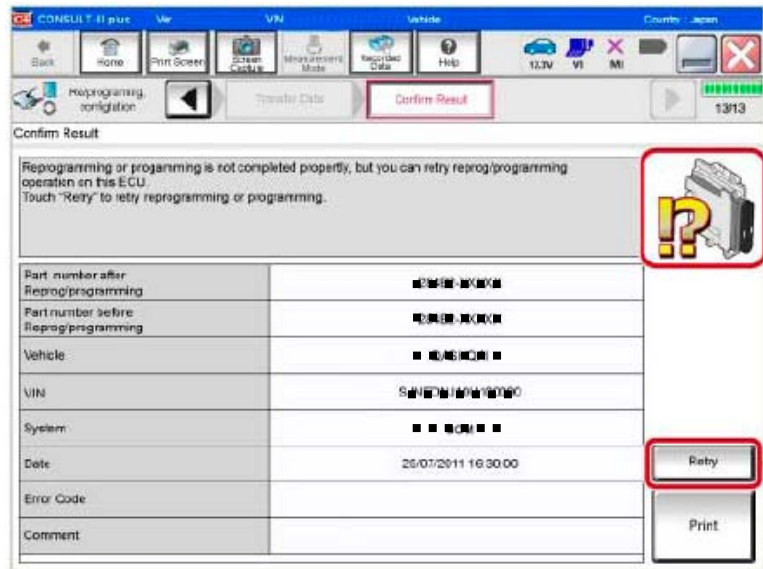
Figure 5

If reprogramming does not complete and the “!?” icon displays as shown in Figure 5:

- Check battery voltage (12.0–15.5 V).
- Ignition is ON, engine OFF.
- External Bluetooth® devices are OFF.
- All electrical loads are OFF.
- **Select retry and follow the on screen instructions.**
- “Retry” may not go through on first attempt and can be selected more than once.

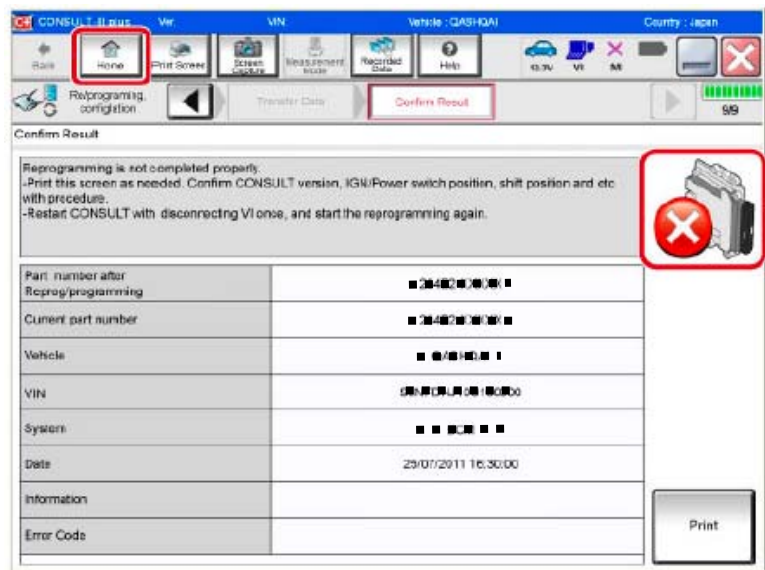
Figure 6

If reprogramming does not complete and the “X” icon displays as shown in Figure 6:

- Check battery voltage (12.0 – 15.5 V).
- CONSULT A/C adapter is plugged in.
- Ignition is ON, engine OFF.
- Transmission is in Park.
- All C-III plus / VI cables are securely connected.
- All C-III plus updates are installed.
- **Select Home, and restart the reprogram procedure from the beginning.**
