SERVICE BULLETIN

APPLICABILITY: 2013MY Legacy and Outback 2.5L Models
 2012-13MY Impreza 2.0L Models
 2013MY XV Crosstrek
 2011-2014MY Forester
 2013MY BRZ

NUMBER: 11-130-13R
DATE: 04/05/13
REVISED: 01/28/14

SUBJECT: Difficulty Starting, Rough Idle, Cam Position or Misfire DTCs
 P0340, P0341, P0345, P0346, P0365, P0366, P0390, P0391,
 P0301, P0302, P0303 or P0304

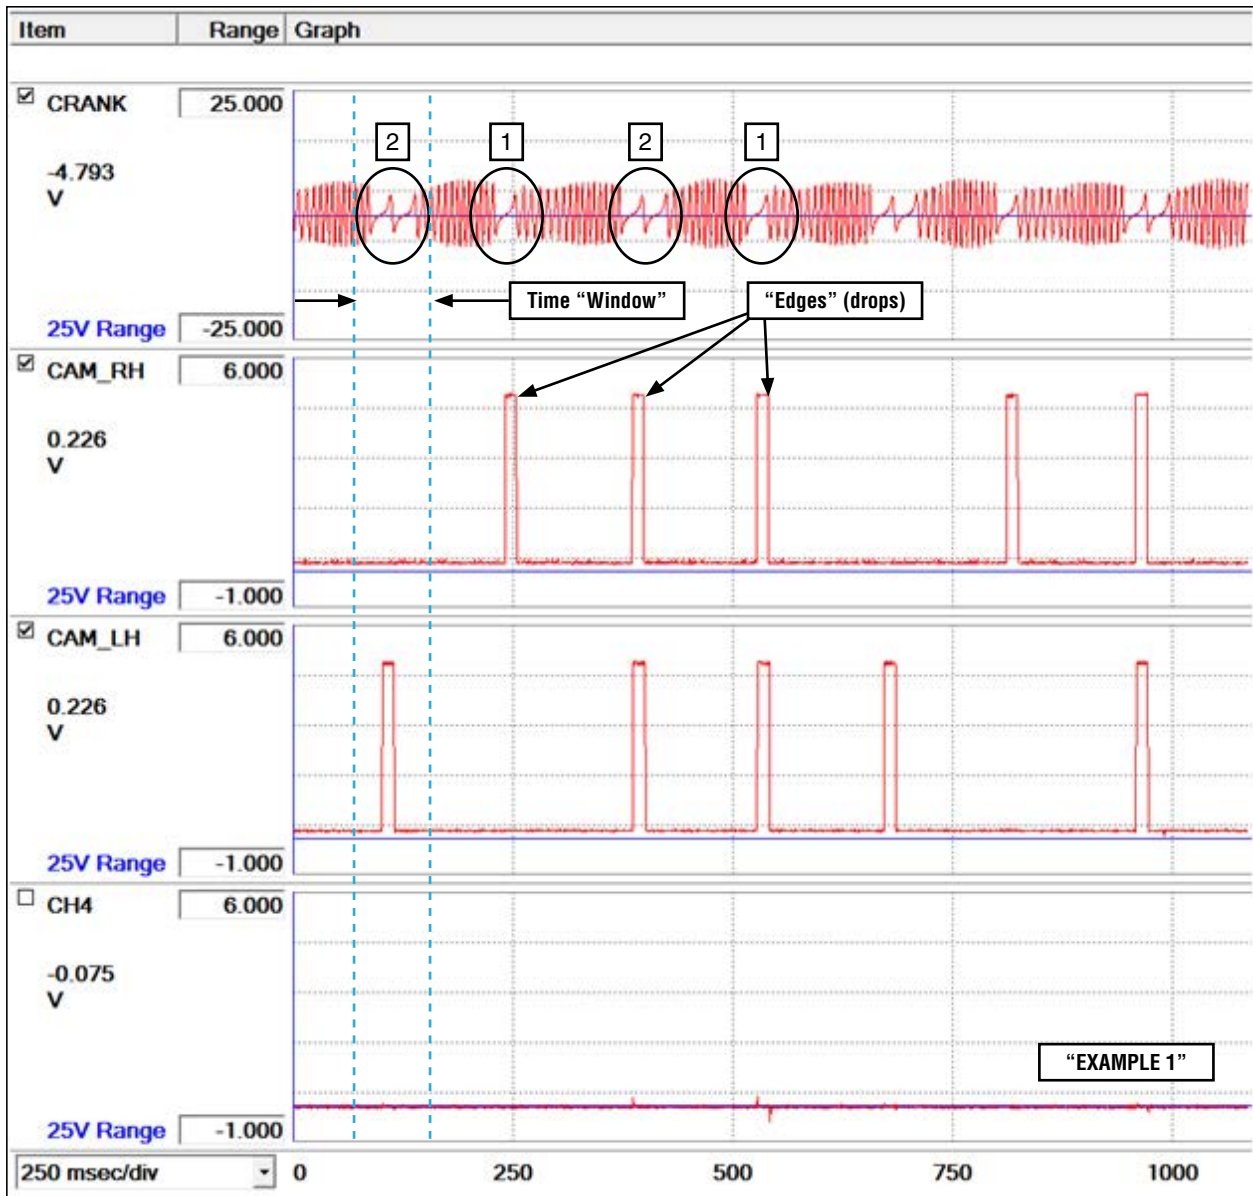
Engine Firing Order	#1	#3	#2	#4
Crank Signal ("1" or "2"?)	"1"	"2"	"1"	"2"
Is Cam Signal Edge Within Window RH?	Yes	No	Yes	Yes
Is Cam Signal Edge Within Window LH?	Yes	Yes	No	Yes

Using the chart above and comparing it to **Example 1**, it can be determined the first cylinder shown in the screen shot is #3 because the crank signal is a "2" and there is an edge signal within the window on the LH but not the RH cam sensor. Next cylinder in the firing order would be #2 as the crank position signal is a "1" and there is an edge signal in the window for the RH but not for the LH, and so on...

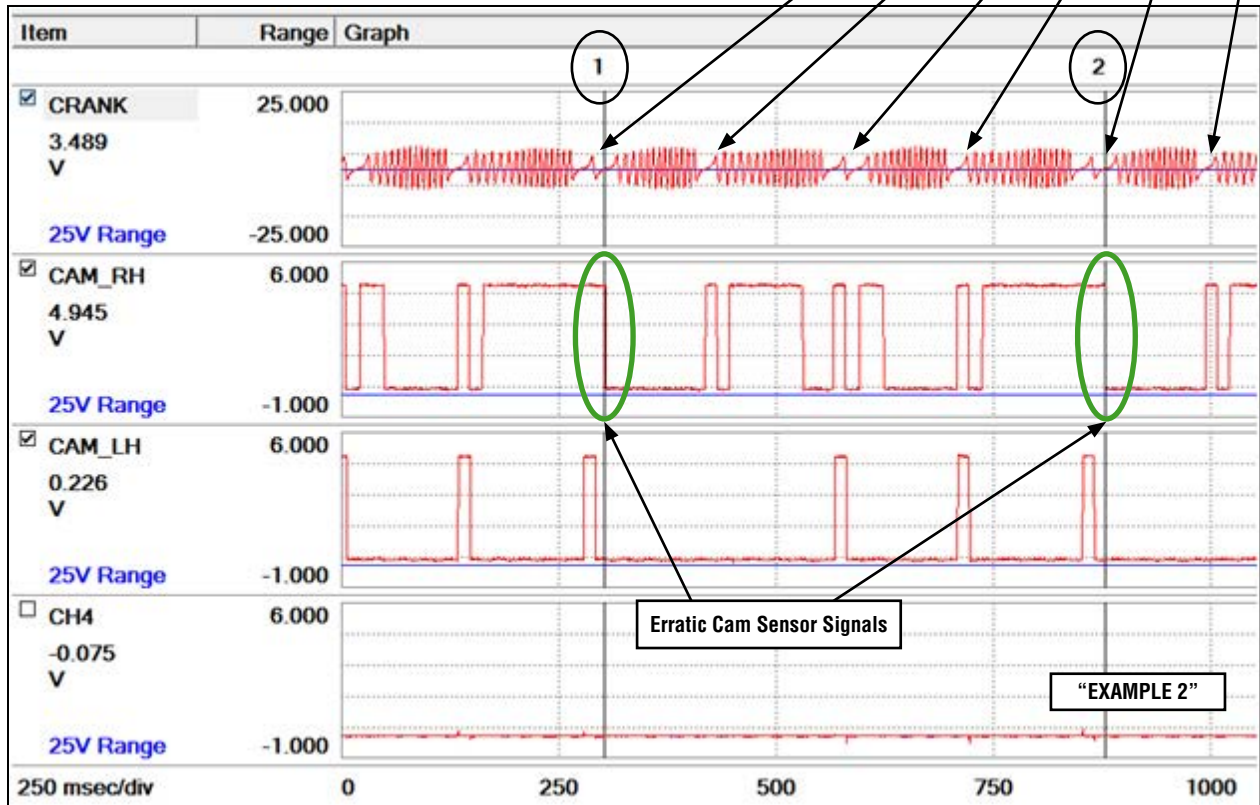
Example 2 below shows a “Bad” pattern for the RH cam sensor. Marks #1 and #2 show what appears to be #4 cylinder firing but, the next cylinder to fire according to the screen shot is #2 followed by #4 then #1. The pattern for the RH sensor never shows the proper sequence to fire #3 cylinder. In this case, recheck the data again after installing a .2mm shim under the RH cam sensor.

Proper Firing Order is: #3 #2 #4 #1 #3 #2

Firing Order shown in screen shot: #4 #2 #4 #1 #4 #2

IMPORTANT: If you confirm an irregular wave form pattern, BEFORE performing the measurement and shim selection procedures, install a .2mm shim under the suspect intake or exhaust camshaft position sensor. If there is no change, remove the .2mm shim and install a .4mm shim. **USE ONLY ONE SHIM PER SENSOR, NO STACKING.** If the wave pattern is lost, remove the .4mm shim and replace with a .3mm shim. Recheck the pattern and if it appears normal, complete the repair as shown below. If an abnormal pattern persists, proceed with the rest of the clearance measurement and shim selection procedures.

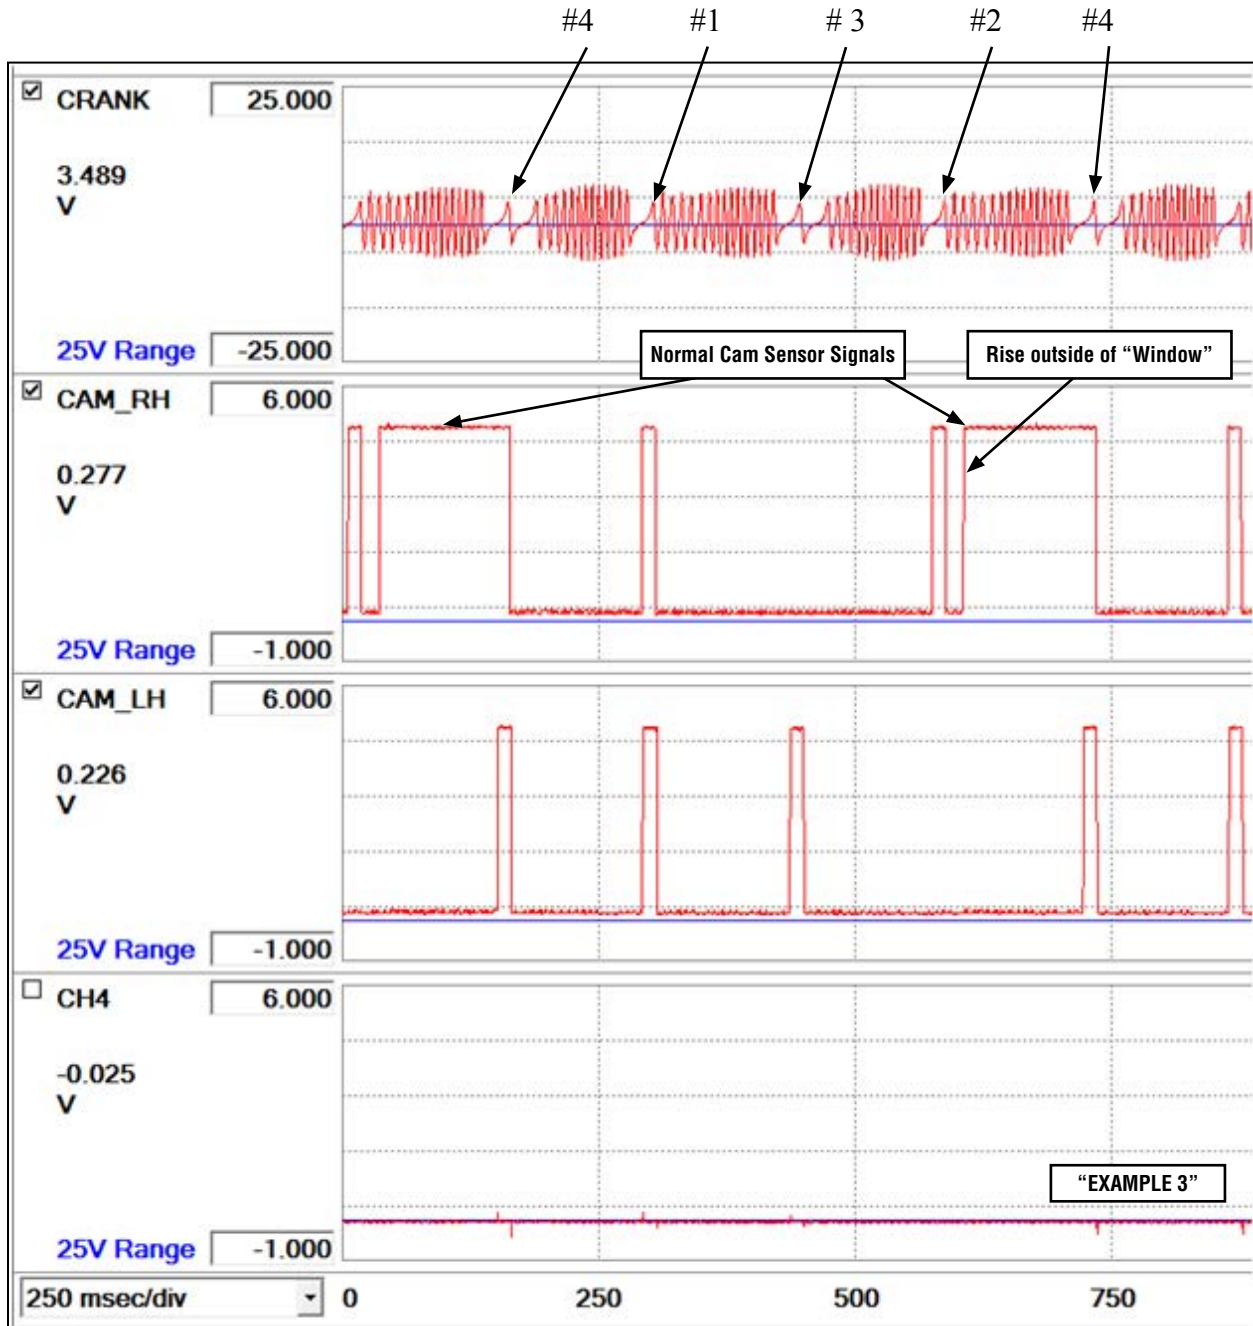
Example 3 shows what *appears* to be an erratic signal from the RH cam sensor but, you can see all the cam sensor data signal edges (drops) follow the chart and firing order as they are supposed to. Other signal edges (rises or drops) outside the “window” or a longer time line as shown here prior to the #4 signal edges seen on the RH cam sensor pattern are examples of signals which will be “ignored” by the ECM and are not a cause for concern.

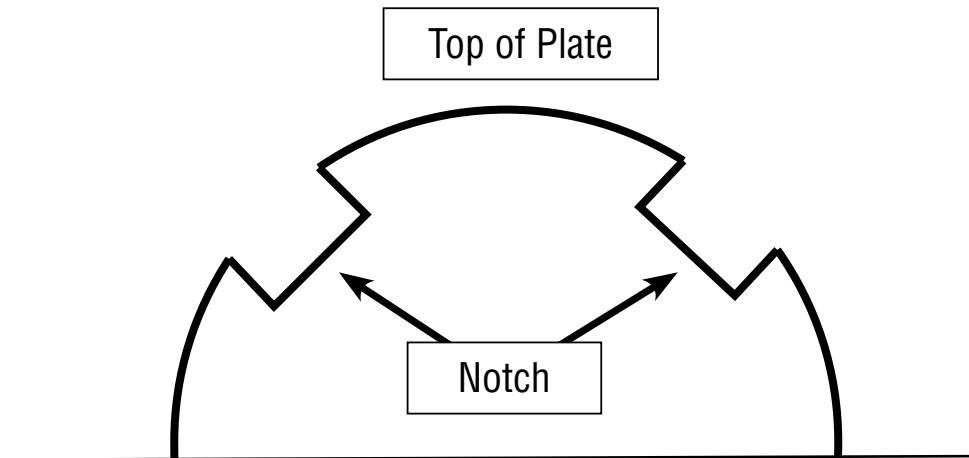
NOTE: When measuring “A”, make sure you are measuring to the outside diameter or “top” of the sensor plate and not to the bottom of a notch as shown below. Be sure to record all measurements.

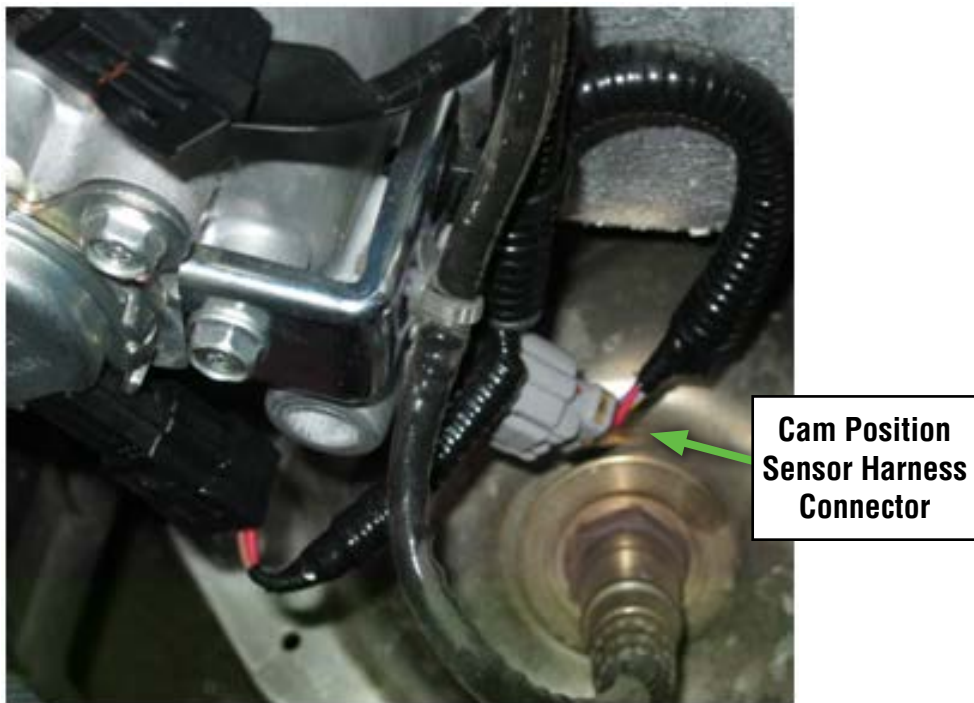
In the event you have a DTC stored for an exhaust camshaft position sensor, the repair procedure has been revised. Due to the position of the right-hand (Bank 1) sensor, measurement of the gap without removing the front catalyst is extremely difficult as shown in the photo below.

1. Confirm the irregular oscilloscope pattern for the corresponding DTC stored.
2. Remove the sensor from the timing cover and install a .2mm thick shim from the applicable kit.
3. Reinstall the sensor, torque the sensor retaining bolt to 6.4 Nm (4.7 ft. lbs. or 56.4 inch-pounds) then recheck the oscilloscope pattern.

If the pattern is normal, the repair is complete. If the irregular pattern persists, repeat Steps 2 and 3 after removing the .2mm shim and installing a .3 mm thick shim. **ONE SHIM ONLY, NO STACKING.** Repeat as necessary increasing the shim thickness .1 mm at a time until a normal scope pattern can be verified.
