# Technical Service Bulletin

## 28G6 UPDATE – Ignition Coils (NVLW)

Model(s)	Year	VIN Range	Vehicle-Specific Equipment
A4	2010-2013	See Campaign/Action screen in ElsaWeb	2.0L Engine
A5/A5 Cab	2010-2013		2.0L Engine
A6	2013		2.0L Engine
Q5	2011-2013		2.0L Engine

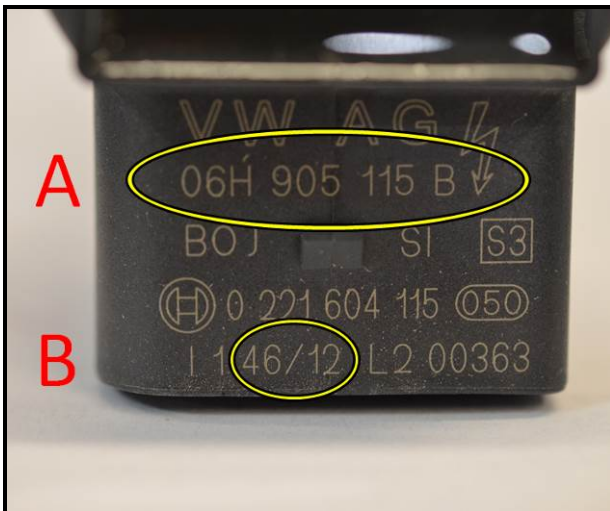
- Inspect the part number and build date of all 4 ignition coils.

⇐ If any one of the ignition coils is NOT part number 06H 905 115B or any of the build dates are 29/11 or earlier <circle B>

⇐ If any one of the ignition coils is NOT part number 07K 905 715F <circle A>

**Replace all 4 ignition coils if:**

- If all 4 ignition coils are P/N 06H 905 115B **AND** the build date is 30/11 or later or if all 4 ignition coils are P/N 07K 905 715F it is not necessary to replace the ignition coils.  
**Reassemble the vehicle.**
