INSTRUCTION TO SERVICE

ITS: 5481	
SECTION:	231 Coolant System
WRITTEN BY:	Mike Pearson
SUBJECT:	Rework OK6 Transmission Cooler Wire Harness UV Damage

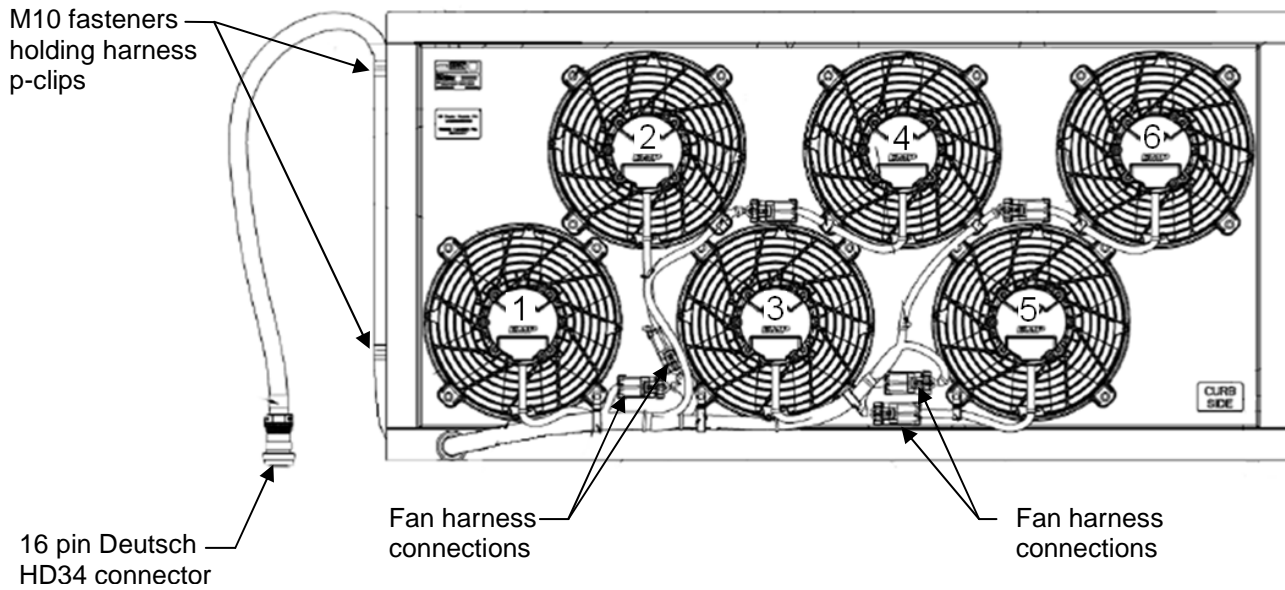
BEFORE:

Rooftop OK6 units are subjected to large amounts of UV radiation by the sun. Over time the red wires in the harness can become brittle and the wire insulation can crack, exposing the bare wire. Red wire UV damage is occurring on roof mounted OK6 Allison Hybrid Oil Cooler fan wire and harnesses installed in New Flyer buses prior to the spring of 2011. Continued UV exposure can cause copper wire to be exposed which if not repaired will lead to an inoperable fan. An inoperable fan will lead to possible fan fault dash light, hybrid propulsion overheat, initial system overheat dash light and in extreme cases propulsion system shut down due to overheat.
