Subject: Limited Service Campaign (LSC) D0N
Certain 2011 – 2012 Model Year Highlander Hybrid Vehicles
Rear Driveshaft Assembly Replacement

TECHNICAL INSTRUCTIONS
FOR
LIMITED SERVICE CAMPAIGN D0N
REAR DRIVESHAFT ASSEMBLY REPLACEMENT
CERTAIN 2011-2012 MODEL YEAR HIGHLANDER HV

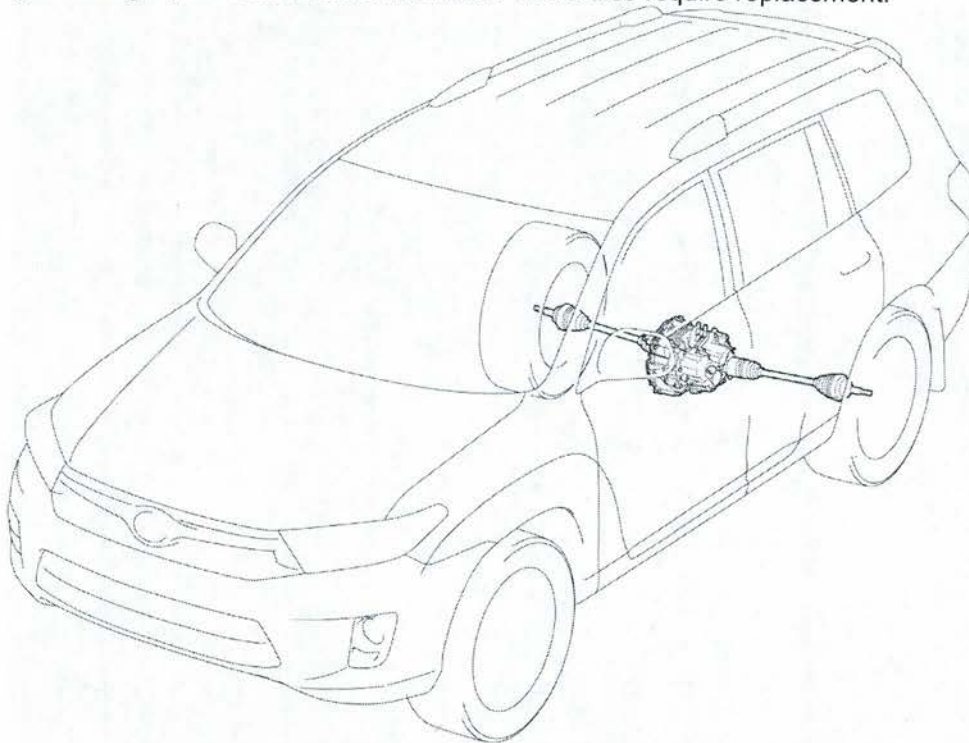
II. BACKGROUND

Due to an assembly error during manufacturing, the Rear Driveshaft in certain 2011-2012 Model Year Highlander Hybrid vehicles can disengage from its inboard joint assembly. If this occurs, the driveshaft could vibrate and rattle inside the inboard joint, causing a loud noise from the rear of the vehicle while driving. Continuing to drive the vehicle can damage the housing of the Rear Differential Motor. If the housing is damaged, the entire differential motor would also require replacement.

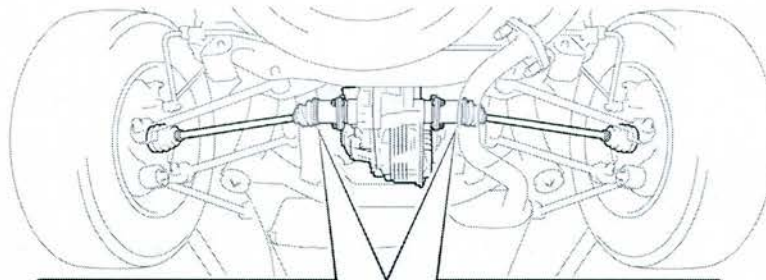
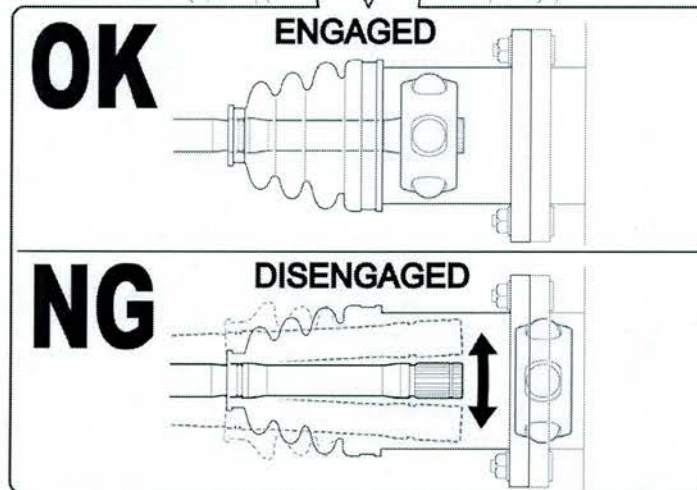
1. INSPECT THE REAR DRIVESHAFT ASSEMBLY FOR DISENGAGEMENT

NOTE: Disengagement of the driveshaft may cause damage to the inside of the rear differential motor. If either driveshaft is found to be disengaged, replacement of the rear differential motor is required.

Results	ACTION REQUIRED
BOTH Driveshafts Engaged OK	REPLACE THE REAR DRIVESHAFT ASSEMBLY Both drive shafts must be replaced. Proceed to section VII
One or both shafts disengaged NG	REPLACE THE REAR DIFFERENTIAL MOTOR ASSEMBLY AND REAR DRIVESHAFT ASSEMBLY. The rear differential motor assembly AND both driveshafts must be replaced. Proceed to Section VIII

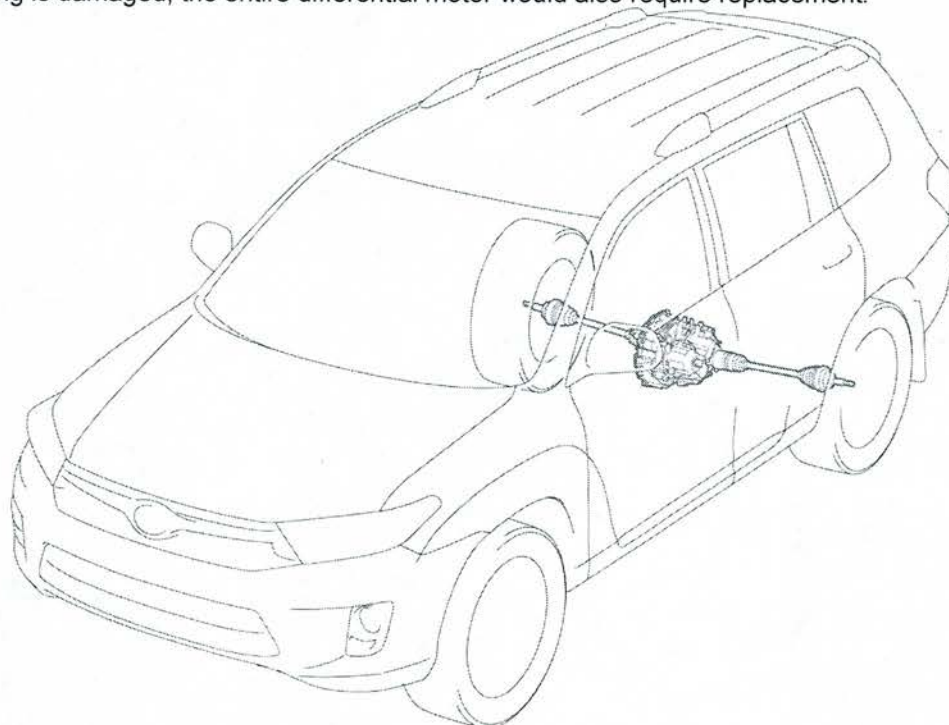
II. BACKGROUND

Due to an assembly error during manufacturing, the Rear Driveshaft in certain 2011-2012 Model Year Highlander Hybrid vehicles can disengage from its inboard joint assembly. If this occurs, the driveshaft could vibrate and rattle inside the inboard joint, causing a loud noise from the rear of the vehicle while driving. Continuing to drive the vehicle can damage the housing of the Rear Differential Motor. If the housing is damaged, the entire differential motor would also require replacement.

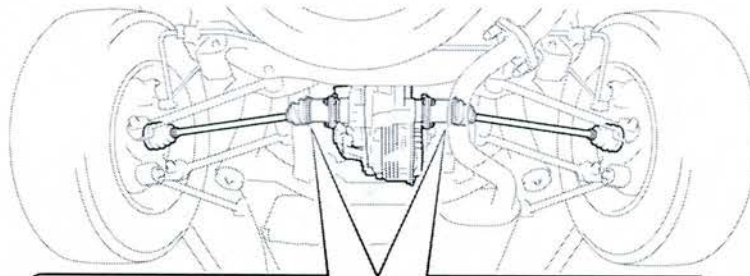
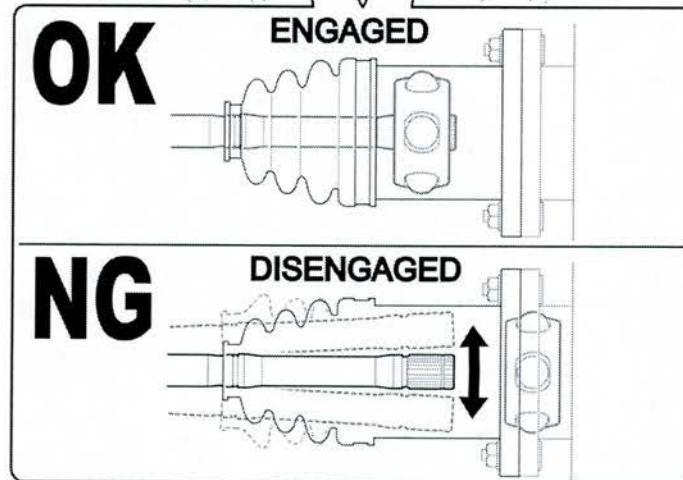
NOTE: Disengagement of the driveshaft may cause damage to the inside of the rear differential motor. If either driveshaft is found to be disengaged, replacement of the rear differential motor is required.

Results	ACTION REQUIRED
BOTH Driveshafts Engaged OK	REPLACE THE REAR DRIVESHAFT ASSEMBLY Both drive shafts must be replaced. Proceed to section VII
One or both shafts disengaged NG	REPLACE THE REAR DIFFERENTIAL MOTOR ASSEMBLY AND REAR DRIVESHAFT ASSEMBLY. The rear differential motor assembly AND both driveshafts must be replaced. Proceed to Section VIII
