SB-10054715-3876

Title: AFI Fuel Supply Line Rubbing SPN 3556 FMI 7 Codes After Dealer Service

Applies To: EPA 2010 IBB MF 11/13/15L

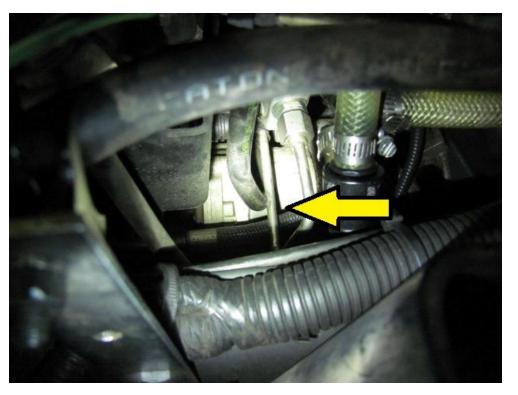
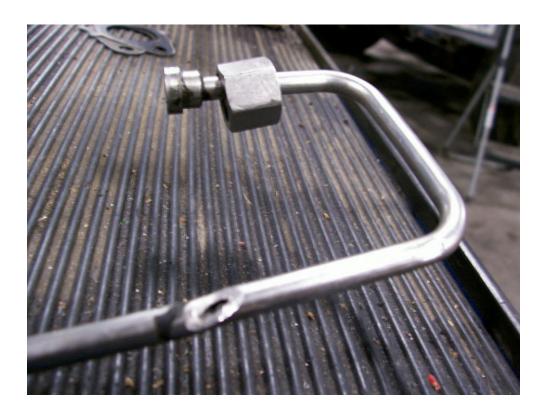
If the fuel lines are not routed correctly the AFI Fuel Supply line can rub through from the fuel system return line and cause regen issues or an inability to perform regens. Due to the ECM sensing a pressure issue in the line it will stop sending fuel to the AFI from the DSI so you will not see a fuel leak in the area. What you will see is a regen issue and aftertreatment temperatures not reaching the correct temp and eventually the ecm will abort the OBFCT.

See how the fuel system return line is rubbing into the afi supply line.

Need to inspect and verify that the afi supply line is secured to the AFI bracket with the P-Clip and that the line separator clip is installed on the return and afi line. Also, be sure the DSI supply line is not rubbing anything. See pic below.

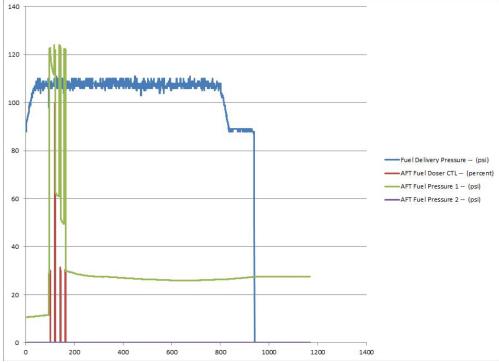
Example of a bad OBFCT with a hole in the AFI Fuel Supply Line

Notice AFT Fuel Doser CTL actuated 3 times to purge the air then went to 0 and AFT Fuel Pressure 2 never climbed off 0 PSI. This is why you won't see any leaks as there is no fuel actually getting sent to pressurize the line.

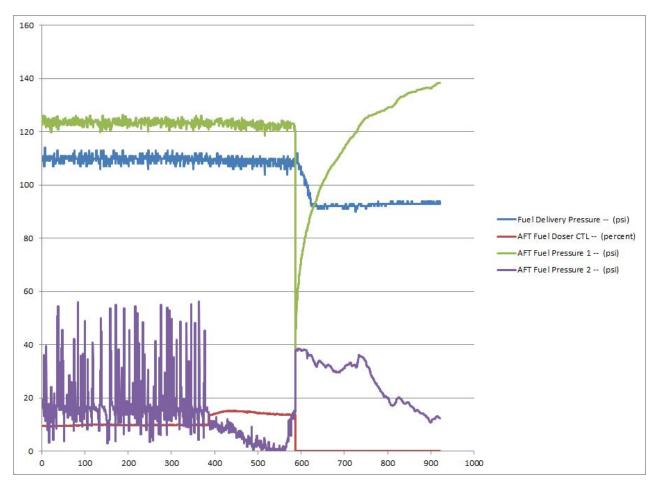
Example of a good OBFCT after the AFI Fuel Supply Line was repaired

Notice the AFT Fuel Doser CTL actuated and stayed active and AFT Fuel Pressure 2 is working properly now.
