**SB-10054723-3282**

**Title:** Horton VMaster Ultra (Stratis) Viscous Fan Hub Diagnostics and Troubleshooting Guide

**Applies To:** ProStars, LoneStars, WorkStar, TranStar, IBB

This article is a Troubleshooting Guide for the Horton VMaster Ultra (Stratis) Viscous Fan Drive.

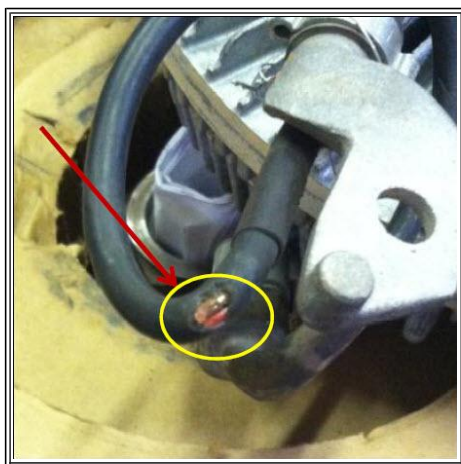
1. Check for rubbing on wire:

- If rubbing is present and inside wires are visible, but no copper is visible apply heat shrink over the harness.
- If copper can be seen, check to see if it is only one single wire, or multiple wires.
  - ▶ If it is one wire, place electrical tape over the wire.
  - ▶ Using 4:1 heat shrink will allow the heat shrink tubing to pass over the connector as shown. P/N: ZBJE849565 or equivalent

- ▶ If multiple wires are showing copper, remove and replace the fan hub assembly.
  - Reroute the wiring harness as outlined in the "Harness Re-Route Procedure" in this iKNow article.

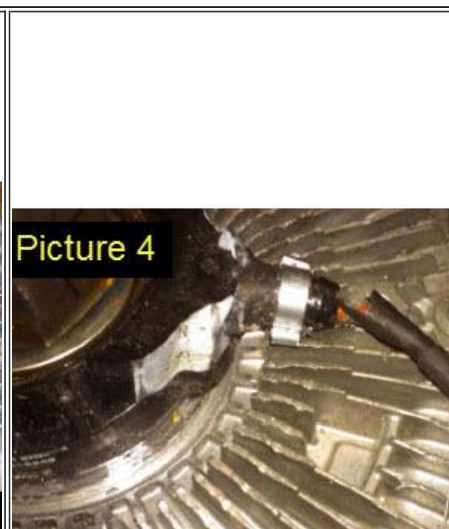
Figure 4

3. Check to see if the target wheel is loose, moves, or spins freely.
- If it is loose, moves, or spins freely replace the fan hub assembly.
  - An improperly positioned ARB or loose target wheel can cause the damage in *Figure 4*.

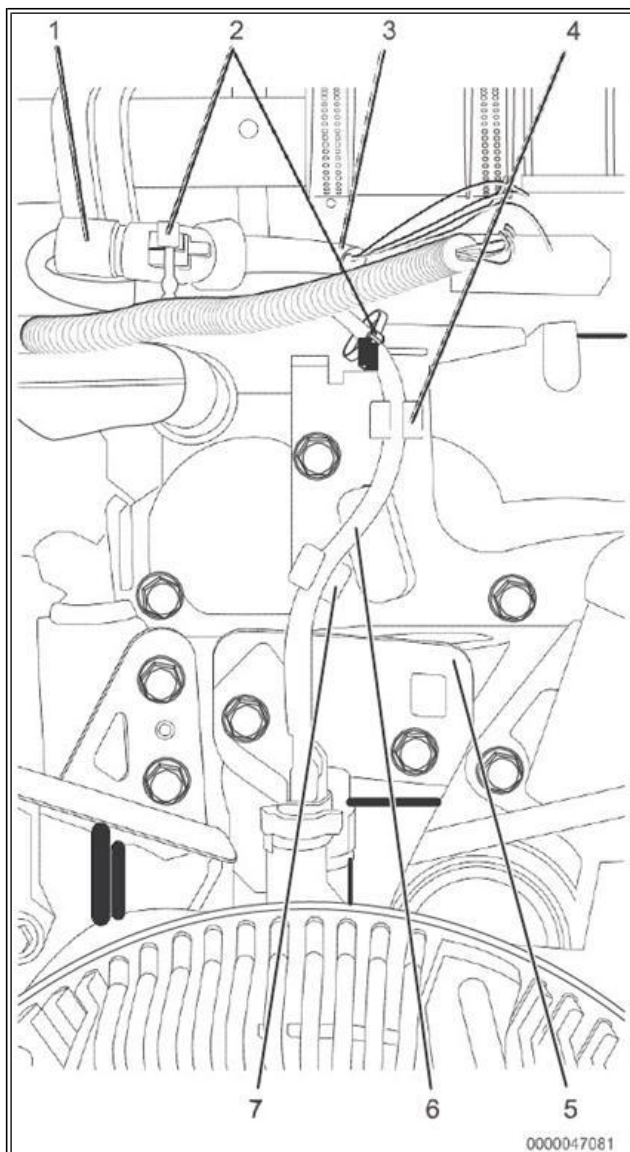
**Figure 14 - Fan Clutch Harness**

7. Inspect fan clutch harness (*Figure 14, Item 6a*) for signs of wear from contact with sharp or hard surfaces of harness bracket (*Figure 14, Item 5*).

b. If insulation chafing is observed or if copper is exposed or damaged, proceed to Step 8.

5. Remove two tie straps (*Figure 14, Item 2*) securing fan clutch harness (*Figure 14, Item 6*) to engine harness (*Figure 14, Item 3*) and fan clutch harness bracket (*Figure 14, Item 5*). Discard tie straps.

6. Remove harness from upper and lower push pins (*Figure 14, Items 4 and 7*).
