**SB-10054723-6187**

**Title: Horton VMaster Ultra (Stratis) Viscous Fan Hub Diagnostics and Troubleshooting Guide**
**Applies To: ProStars, LoneStars, WorkStar, TranStar, IBB**
**CHANGE LOG**

This article is a Troubleshooting Guide for the Horton VMaster Ultra (Stratis) Viscous Fan Drive.

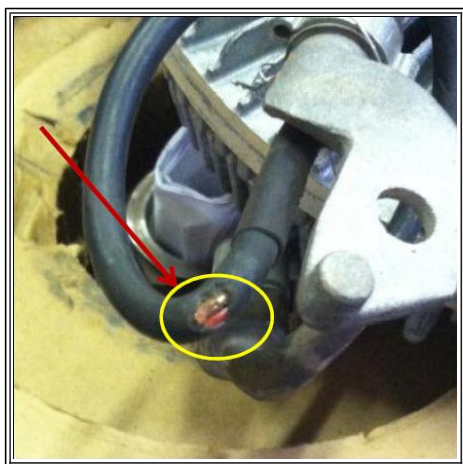
1. Check for rubbing on wire:

- If rubbing is present and inside wires are visible, but no copper is visible apply heat shrink over the harness.
- If copper can be seen, check to see if it is only one single wire, or multiple wires.
  - ▶ If it is one wire, place electrical tape over the wire.
  - ▶ Using 4:1 heat shrink will allow the heat shrink tubing to pass over the connector as shown. P/N: ZBJE849565 or equivalent

- ▶ If multiple wires are showing copper, remove and replace the fan hub assembly.
  - Reroute the wiring harness as outlined in the "Harness Re-Route Procedure" in this iKNow article.

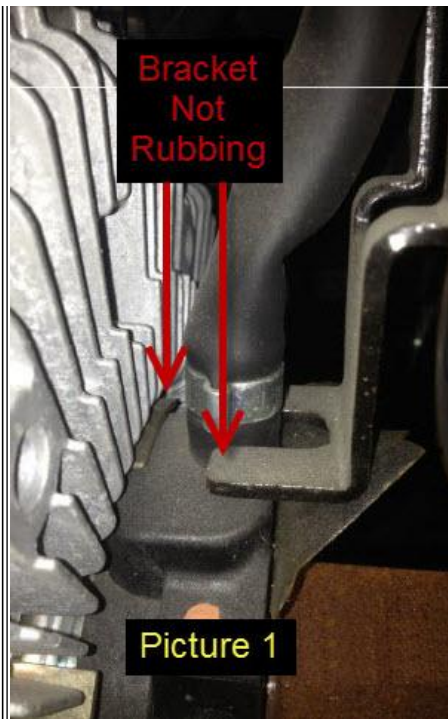
Figure 1

2. Check to see if ARB is touching the target wheel. Refer to *Figure 1* and *Figure 2*.
- If it is touching, reposition ARB to clear the target wheel as shown in *Figure 1*.

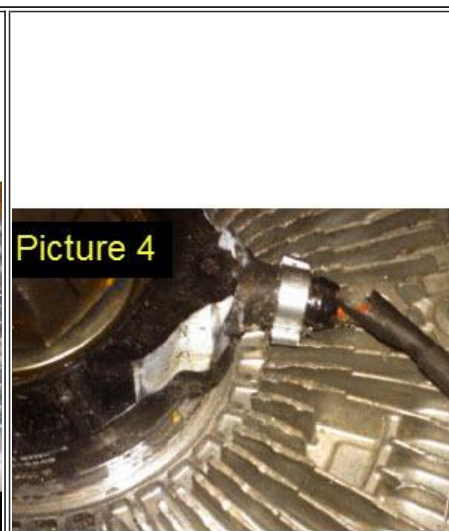
Figure 4

3. Check to see if the target wheel is loose, moves, or spins freely.
- If it is loose, moves, or spins freely replace the fan hub assembly.
  - An improperly positioned ARB or loose target wheel can cause the damage in *Figure 4*.

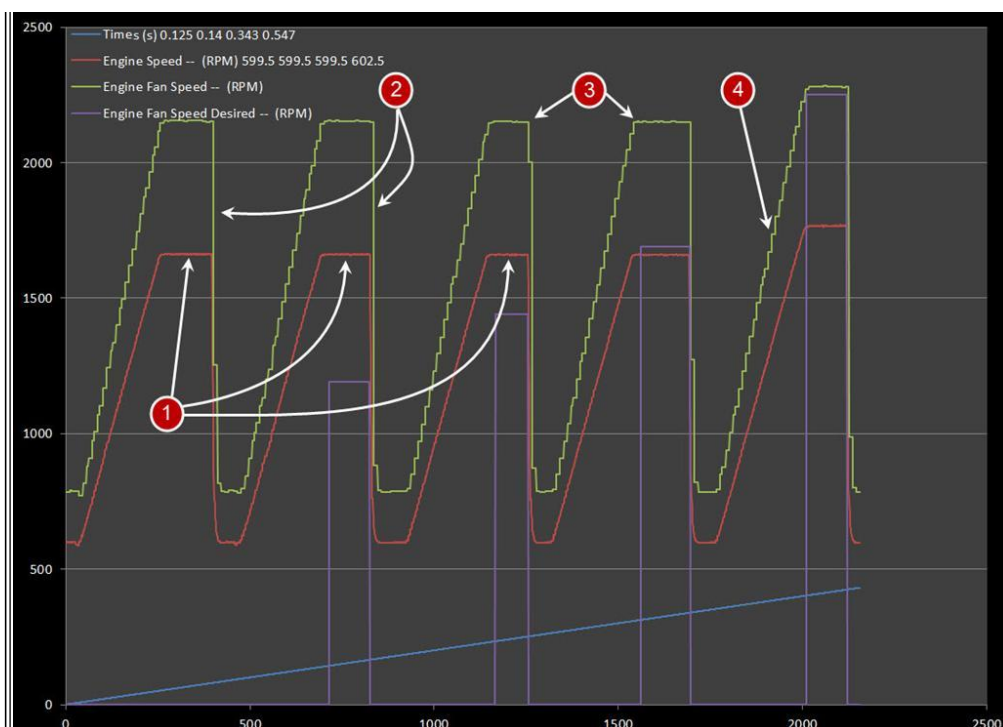
**Figure 10 - Failed Fan Hub Assembly**

1. Engine ramps to the same speed for each section of the test.
2. When the ECM is no longer requesting a set fan speed, the fan disengages. However, in this example, the viscous portion of the fan is not responding, allowing the fan speed to drop off rapidly.
3. Notice the fan speed is always engaging to over 2000 RPM. The fan is turning on fully. This is not normal operation for the fan test.
4. This is showing when the fan is commanded off, the fan hub speed increases with engine speed. Fan speed never drops back off, as shown in the working fan example above.
  - Note: This is one example of a failed fan. Not every fan hub will fail this way.
  - You can review your fan test in ServiceMaxx to see a chart view of the signals shown in this chart.

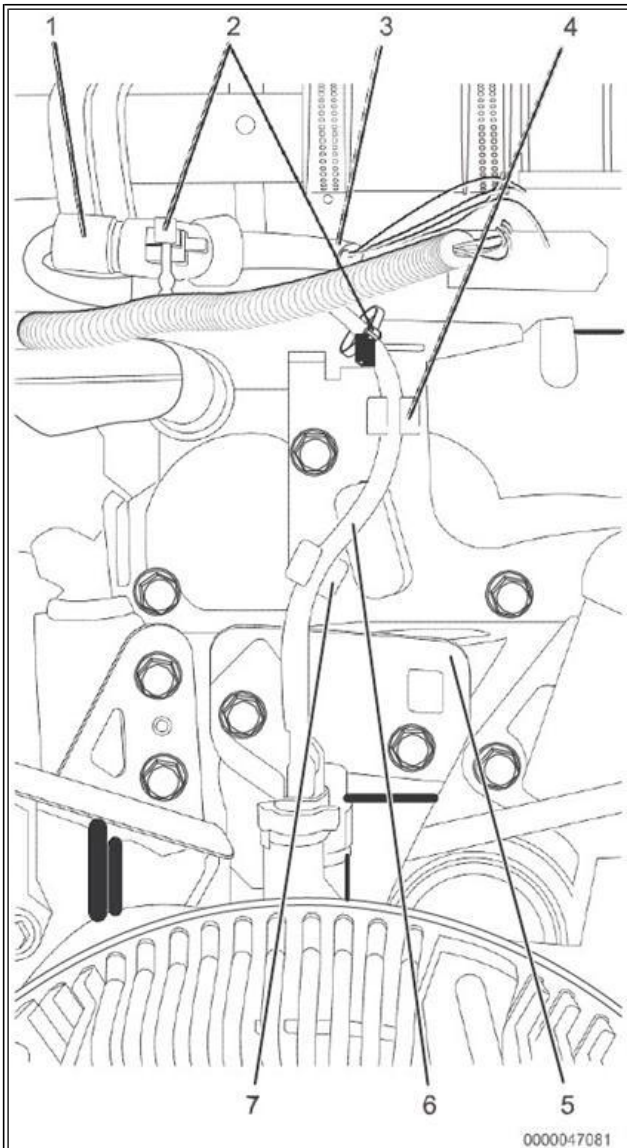
**Figure 14 - Fan Clutch Harness**

The fan clutch harness can rub on the fan wiring harness bracket and cause intermittent fault codes. Some of the symptoms can include:

7. Inspect fan clutch harness (*Figure 14, Item 6a*) for signs of wear from contact with sharp or hard surfaces of harness bracket (*Figure 14, Item 5*).

b. If insulation chafing is observed or if copper is exposed or damaged, proceed to Step 8.

5. Remove two tie straps (*Figure 14, Item 2*) securing fan clutch harness (*Figure 14, Item 6*) to engine harness (*Figure 14, Item 3*) and fan clutch harness bracket (*Figure 14, Item 5*). Discard tie straps.

6. Remove harness from upper and lower push pins (*Figure 14, Items 4 and 7*).

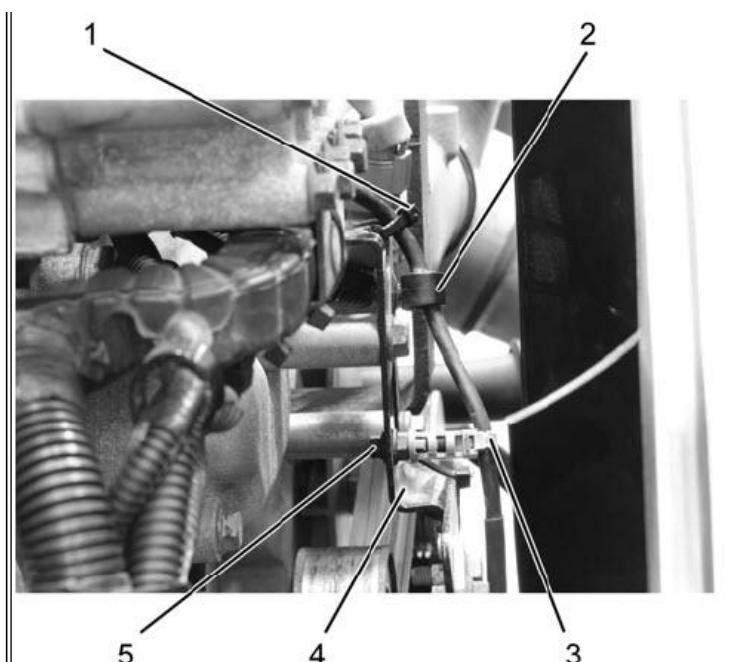
**Figure 19 - Fan Clutch Harness Re-route**

Wiring on the Horton Stratis Fan Hub has shown to be rubbing, causing DTC codes. Re-routing of the wiring harness before a failure will prevent future failures. Re-routing after a failure will prevent multiple failures.

16. Install M6 x 25 mm bolt (*Figure 19, Item 5*) into fan clutch harness bracket (*Figure 19, Item 4*), then install M6 prevailing torque nut to bolt and tighten nut to 80 lb-in (9 N•m).

17. Loosely secure fan clutch harness with stud cap tie strap (*Figure 19, Item 3*) before securing stud cap tie strap to bolt (*Figure 19, Item 5*). Tighten tie strap when cap is secured to bolt.

18. Remove slack from fan clutch harness, and install harness in upper push pin (*Figure 19, Item 2*). Verify proper clearance between fan clutch harness and fan clutch harness bracket.
