## SB-10054723-7072

**Title:** Horton VMaster Ultra (Stratis) Viscous Fan Hub Diagnostics and Troubleshooting Guide

**Applies To:** ProStars, LoneStars, WorkStar, TranStar, IBB

This article is a Troubleshooting Guide for the Horton VMaster Ultra (Stratis) Viscous Fan Drive.

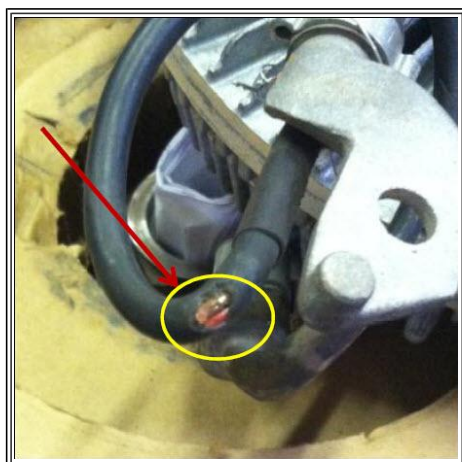
1. Check for rubbing on wire:

- If rubbing is present and inside wires are visible, but no copper is visible apply heat shrink over the harness.
- If copper can be seen, check to see if it is only one single wire, or multiple wires.
  - ▶ If it is one wire, place electrical tape over the wire.
  - ▶ Using 4:1 heat shrink will allow the heat shrink tubing to pass over the connector as shown. P/N: ZBJE849565 or equivalent

- ▶ If multiple wires are showing copper, remove and replace the fan hub assembly.
  - Reroute the wiring harness as outlined in the "Harness Re-Route Procedure" in this iKNow article.

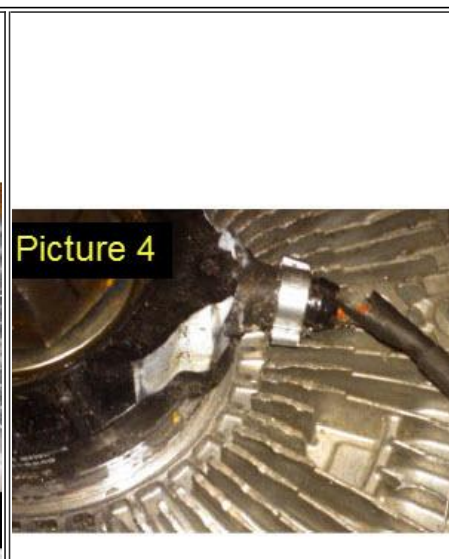
Figure 4

3. Check to see if the target wheel is loose, moves, or spins freely.
    - If it is loose, moves, or spins freely replace the fan hub assembly.
    - An improperly positioned ARB or loose target wheel can cause the damage in *Figure 4*.

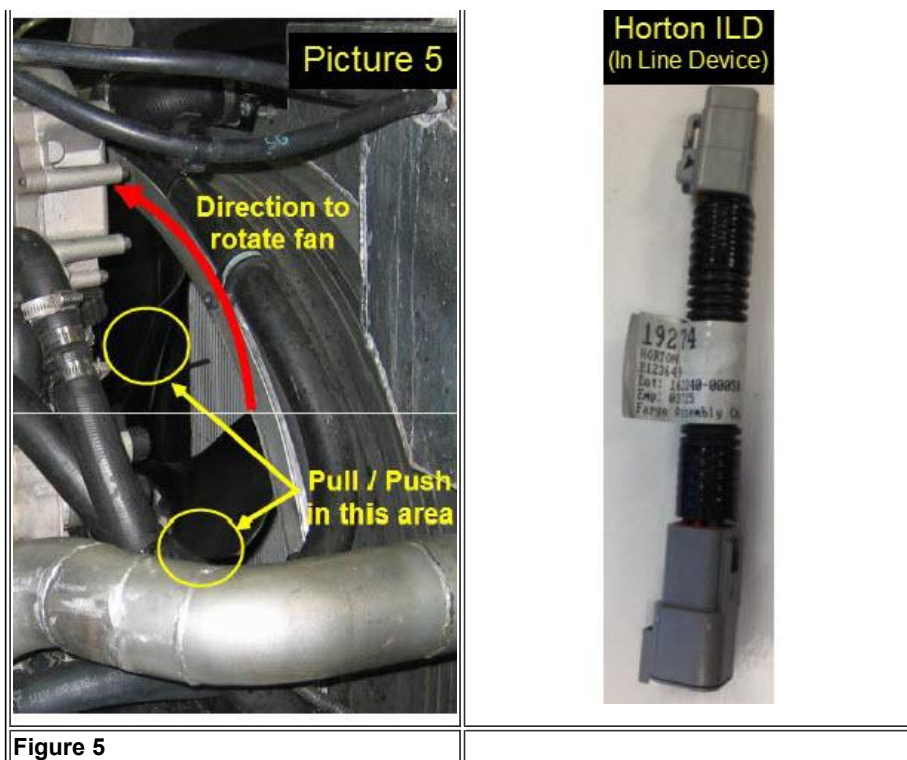
Figure 5

4. Pull / Push fan ON - refer to *Figure 5*.
    - Rotating the fan by hand, the hub should provide a smooth and consistent resistance.
    - If it rotates freely approximately 1" or more before resistance is felt, replace the fan hub assembly.

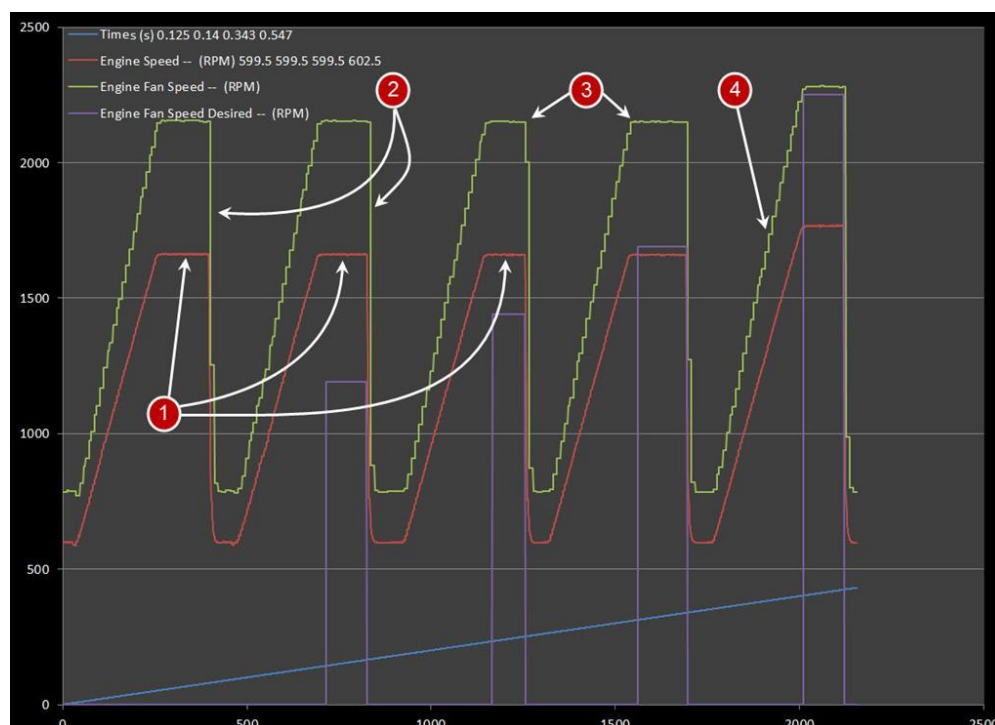
**Figure 10 - Failed Fan Hub Assembly**

- Engine ramps to the same speed for each section of the test.
- When the ECM is no longer requesting a set fan speed, the fan disengages. However, in this example, the viscous portion of the fan is not responding, allowing the fan speed to drop off rapidly.
- Notice the fan speed is always engaging to over 2000 RPM. The fan is turning on fully. This is not normal operation for the fan test.
- This is showing when the fan is commanded off, the fan hub speed increases with engine speed. Fan speed never drops back off, as shown in the working fan example above.
  - Note: This is one example of a failed fan. Not every fan hub will fail this way.
  - You can review your fan test in ServiceMaxx to see a chart view of the signals shown in this chart.

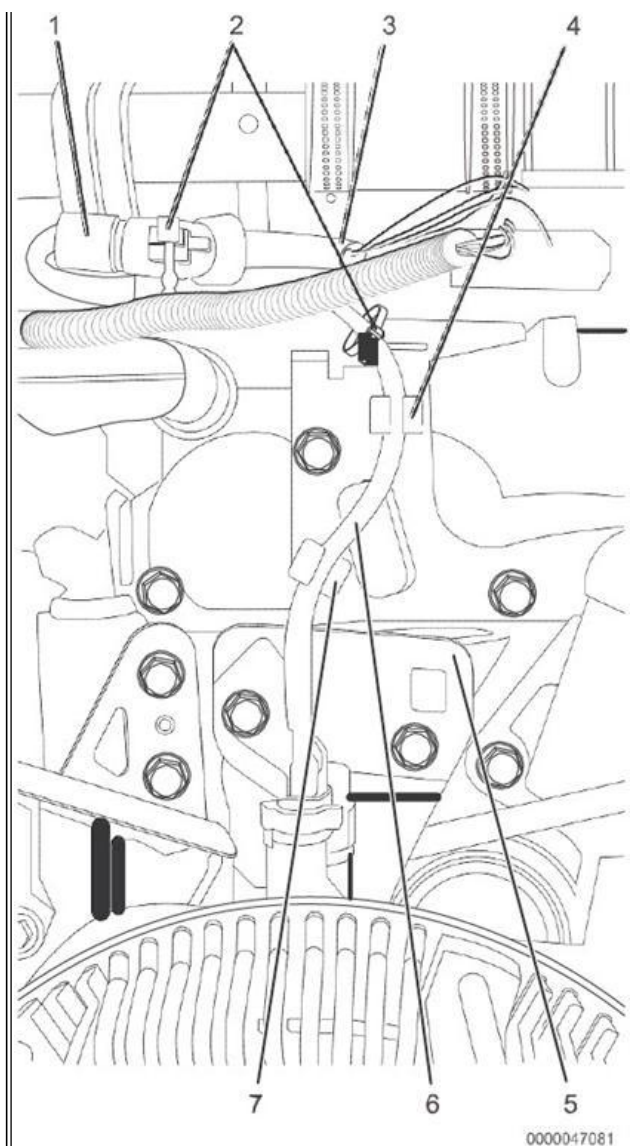
**Figure 14 - Fan Clutch Harness**

The fan clutch harness can rub on the fan wiring harness bracket and cause intermittent fault codes. Some of the symptoms can include:

5. Remove two tie straps (*Figure 14, Item 2*) securing fan clutch harness (*Figure 14, Item 6*) to engine harness (*Figure 14, Item 3*) and fan clutch harness bracket (*Figure 14, Item 5*). Discard tie straps.
6. Remove harness from upper and lower push pins (*Figure 14, Items 4 and 7*).
  - a. If secured with two push pins, discard lower push pin (*Figure 14, Item 7*)
7. Inspect fan clutch harness (*Figure 14, Item 6a*) for signs of wear from contact with sharp or hard surfaces of harness bracket (*Figure 14, Item 5*).
  - a. If no damage is observed, proceed to Step 16.
  - b. If insulation chafing is observed or if copper is exposed or damaged, proceed to Step 8.
8. Disconnect harness connector (*Figure 14, Item 1*).

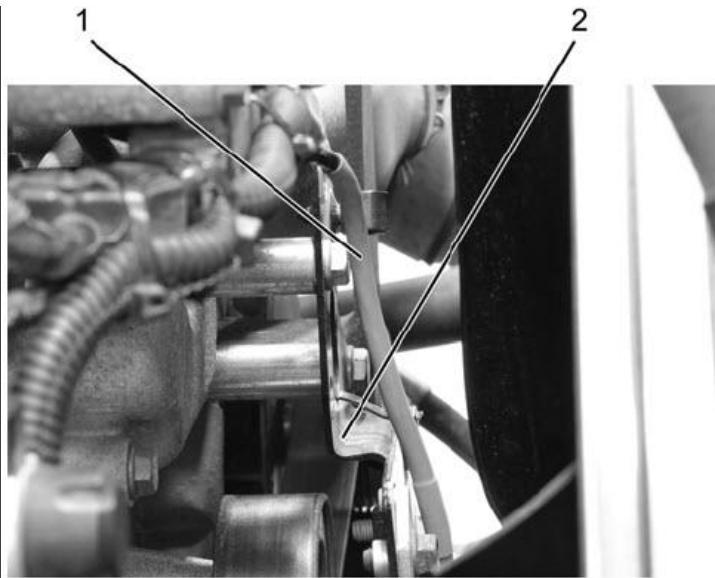
**Figure 17 - Fan Clutch Harness with Heat Shrink**

12. Install self-sealing dual wall heat shrink on damaged or repaired area of harness (*Figure 17, Item 1*).

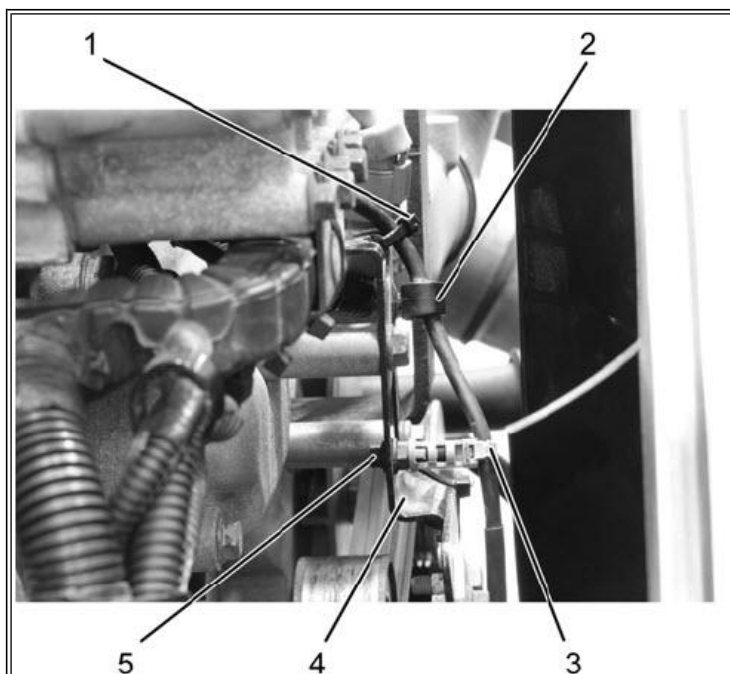
**Figure 19 - Fan Clutch Harness Re-route**

16. Install M6 x 25 mm bolt (*Figure 19, Item 5*) into fan clutch harness bracket (*Figure 19, Item 4*), then install M6 prevailing torque nut to bolt and tighten nut to 80 lb-in (9 N•m).

17. Loosely secure fan clutch harness with stud cap tie strap (*Figure 19, Item 3*) before securing stud cap tie strap to bolt (*Figure 19, Item 5*). Tighten tie strap when cap is secured to bolt.

18. Remove slack from fan clutch harness, and install harness in upper push pin (*Figure 19, Item 2*). Verify proper clearance between fan clutch harness and fan clutch harness bracket.
