ITB14-005a

SB-10054743-1917

VOLUNTARY SERVICE CAMPAIGN 2014 Q50 INFINITI InTouch SOFTWARE UPDATE

CAMPAIGN I.D. #: P4206**APPLIED VEHICLES:** 2014 Q50 (V37)
2014 Q50 Hybrid (V37)

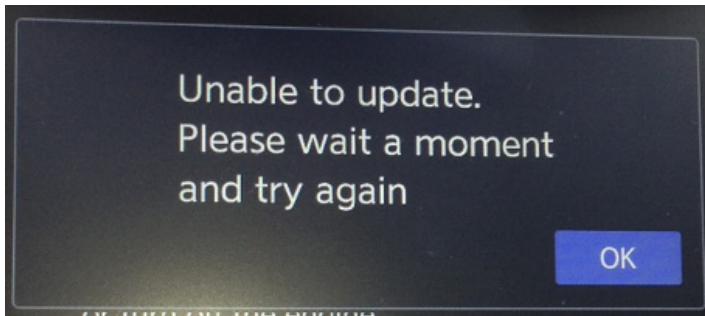
Q. What do I do if the below screen appears?

- A. This screen may appear while performing software update for other InTouch systems (steps 8-12). If it does:
1. Remove USB Flash Drive, turn the ignition OFF, and wait 30 seconds.
 2. Remove the map SD card and make sure the tab is in the unlocked position.

3. Insert Map SD card back into its slot.
4. Go to Step 8 and continue through the rest of the procedure from that point.
NOTE: Install may resume automatically, this is OK.

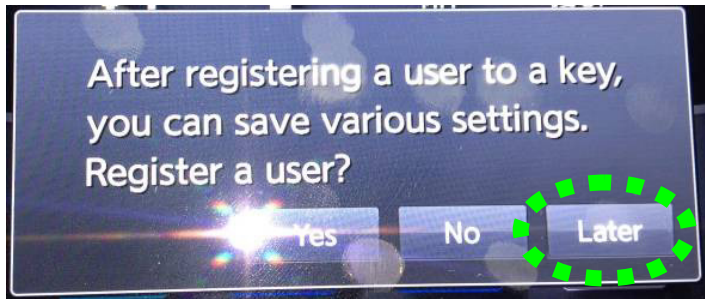
Q. What do I do if the below screen appears?

A. Select "Later" and then continue with the procedure. This is covered in step 2 of the procedure but this message can appear at other times in the update process.
