ITB14-005

VOLUNTARY SERVICE CAMPAIGN 2014 Q50 INFINITI InTouch SOFTWARE UPDATE

CAMPAIGN I.D. #: P4206
APPLIED VEHICLES: 2014 Q50 (V37)
2014 Q50 Hybrid (V37)

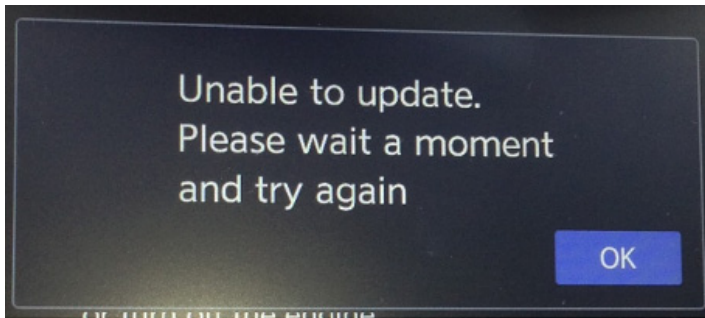
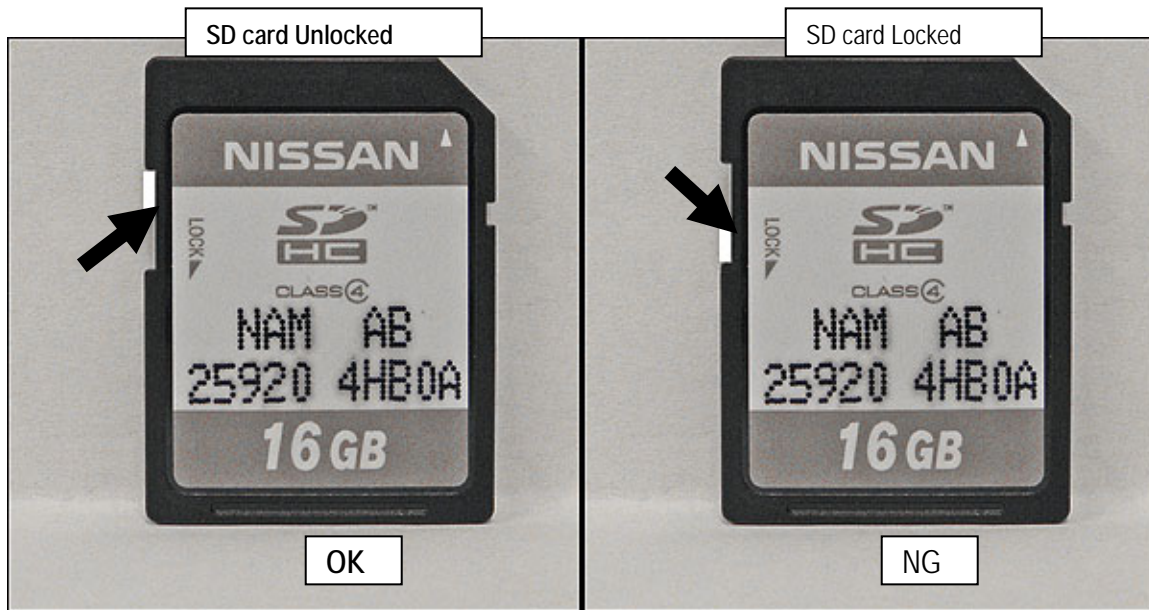
Q. What do I do if the below screen appears?

- A. This screen may appear while performing software update for other InTouch systems (steps 8-12). If it does:
1. Remove USB Flash Drive, turn the ignition OFF, and wait 30 seconds.
 2. Remove the map SD card and make sure the tab is in the unlocked position.

3. Insert Map SD card back into its slot.
4. Go to Step 8 and continue through the rest of the procedure from that point.
NOTE: Install may resume automatically, this is OK.

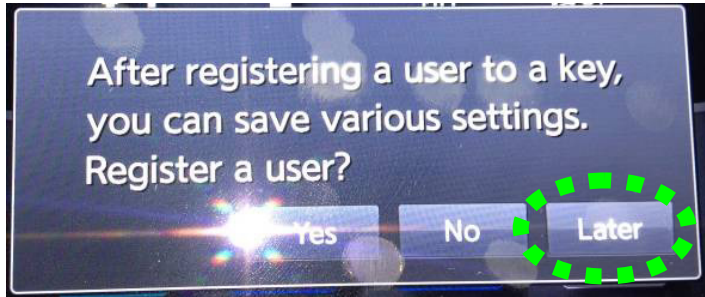
Q. What do I do if the below screen appears?

A. Select "Later" and then continue with the procedure. This is covered in step 2 of the procedure but this message can appear at other times in the update process.
