Technical Service Bulletin

45 ABS warning light on with additional warning lights on (EPB / TPMS / EPC / MIL) - wire harness damage

45 14 08 2033412/3 February 11, 2014. Supersedes Technical Service Bulletin Group 45 number 13-07 dated September 25, 2013 for reasons listed below.

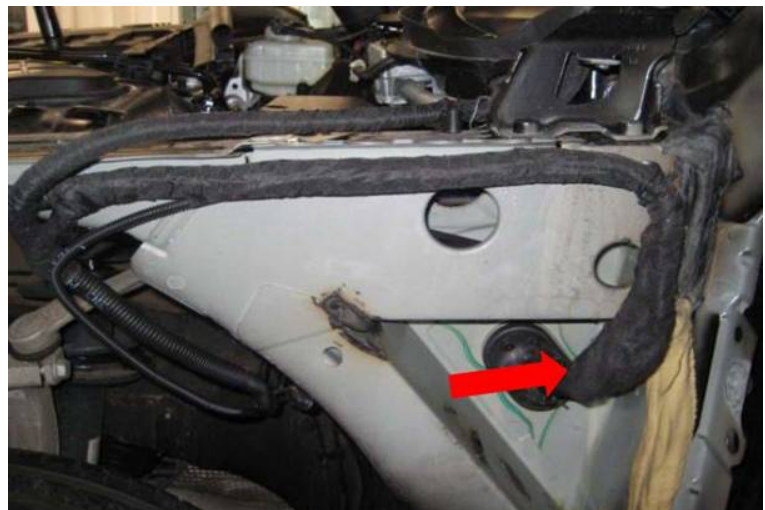
The insulation for the ABS wheel speed sensor is damaged in production. Over time, this can lead to corrosion on the wires and restricted functions with the ABS control module. Only the wires in the left bulkhead grommet (Figure 1) are affected.

Figure 1. Left front fender is removed to show the left bulkhead grommet

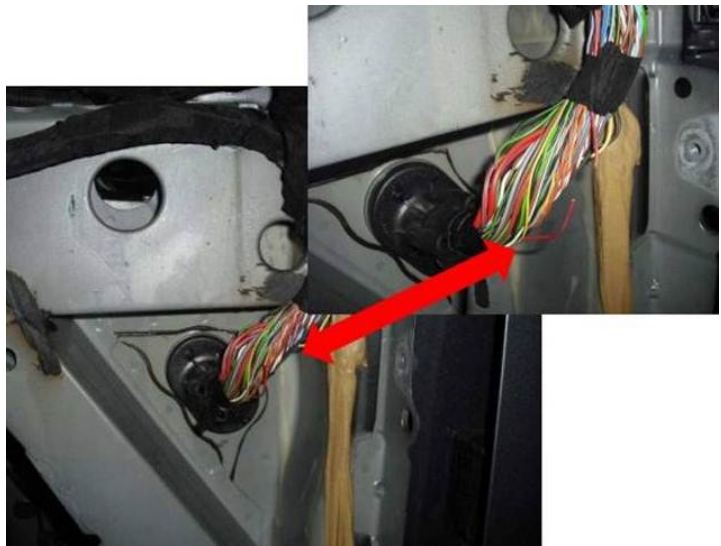
- Verify the fuse (SC6) is good.
- Disconnect T38a connector from ABS control unit.
- Apply a load with a 21W rating ($1.7\text{ A} = 21\text{ W}$) between pin 7 (T38a) and chassis ground. This will allow a precise voltage drop measurement across the completed circuit.
- Set the digital multi-meter to DC Volts (Direct Current Voltage)
- Connect the black multi-meter lead to pin 7 (T38a) and connect the red measuring lead to fuse SC6 while keeping the fuse in the socket. This will measure the voltage drop in the wiring between the fuse and pin 7 (T38a).
- If the voltage drop measures over 0.3 V, the wiring loom around the grommet must be checked (Figure 2).

Figure 2. Affected area of the left front wiring loom behind the fender

Tip: For better access to all sections of the wiring loom, the wheel arch liner and the windscreen washing reservoir must be removed.

3. Repair the damaged cable in the wiring loom using the VAS1978B wiring harness repair kit.
4. Remove the sections of the individual cable where the copper wires are black or corroded.
5. Pull back the insulation for the complete wiring loom, for a distance of about 40 cm from the grommet towards the front of the vehicle, and inspect for additional damage or corrosion.

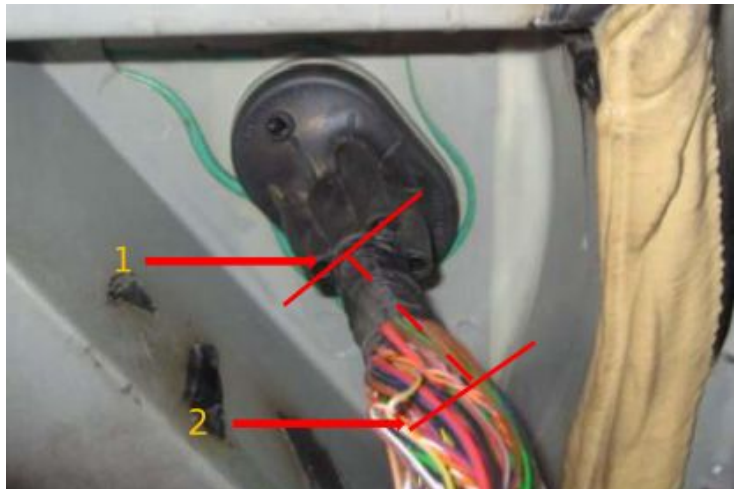
- Measure the distance from the **grommet front side** (Figure 3, point 1) to the **point of damage point** (Figure 3, point 2). Include this measured distance in the repair order comments.

Figure 3. Measuring point of damage in relation to the end of the grommet

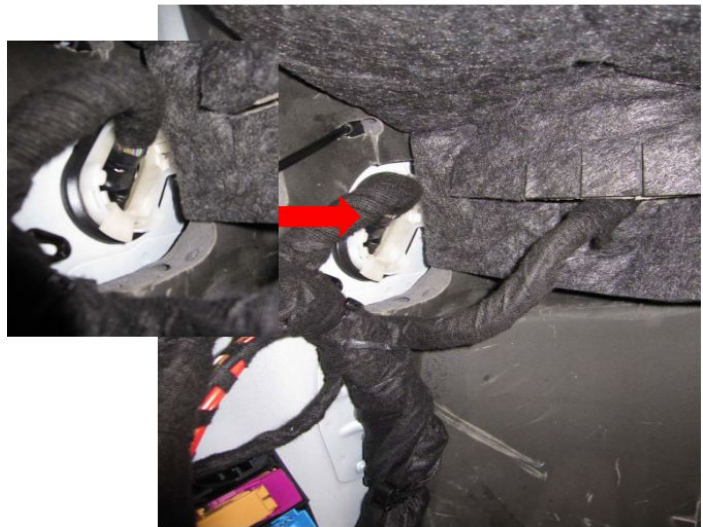
- Note the grommet and original harness position from inside the passenger compartment (Figure 4).

Figure 4. Grommet position photo, taken from inside the passenger compartment.
