Technical Service Bulletin

45 ABS warning light on with additional warning lights on (EPB/TPMS/EPC/MIL) - Wire harness damage

45 13 07 2033412/2 September 25, 2013. Supersedes Technical Service Bulletin Group 97 number 13-35 dated March 27, 2013 for reasons listed below.

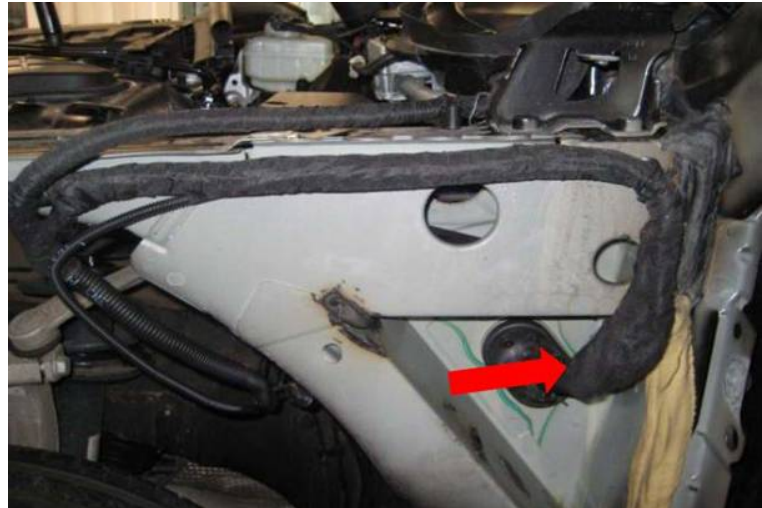
The insulation for the ABS wheel speed sensor is damaged in production. Over time, this can lead to corrosion on the wires and restricted functions with the ABS control module. Only the wires in the left bulkhead grommet (Figure 1) are affected.

Figure 1. Left front fender is removed to show the left bulkhead grommet

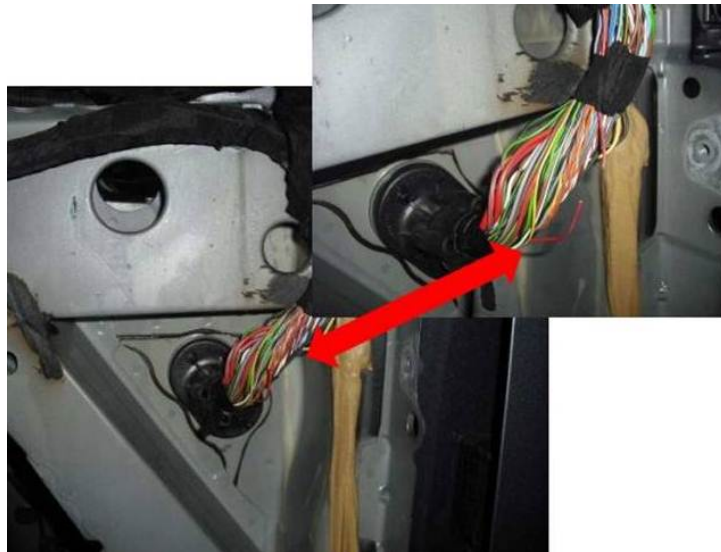
- If the voltage drops (over 0.3 V), the wiring loom around the grommet must be checked (Figure 2)

Figure 2. Affected area of the left front wiring loom behind the fender

Tip: For better access to all sections of the wiring loom, the wheel arch liner and the windscreen washing reservoir must be removed.

3. Repair the damaged cable in the wiring loom using the VAS1978B wiring harness repair kit.
4. Remove the sections of the individual cable where the copper wires are black or corroded.
5. Pull back the insulation for the complete wiring loom, for a distance of about 40 cm from the grommet towards the front of the vehicle, and inspect for additional damage or corrosion.

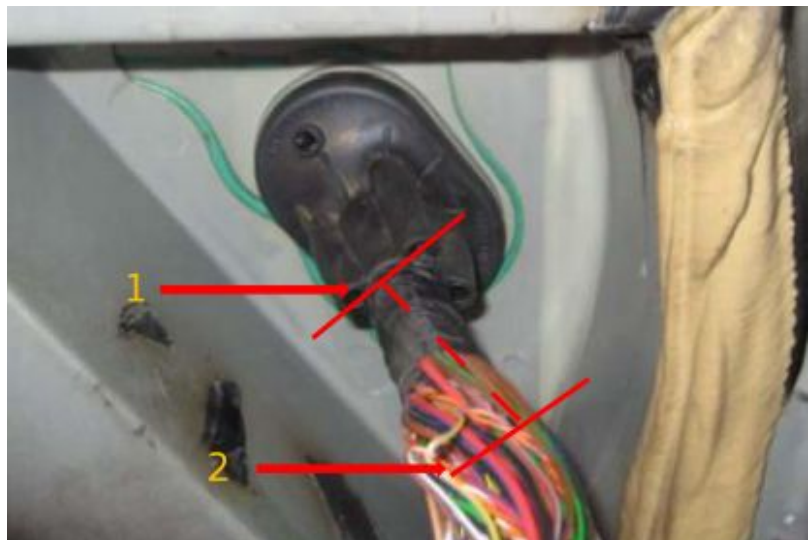
Figure 3. Measuring point of damage in relation to the end of the grommet

2. If damage is found, please contact the Technical Assistance Center (TAC) and take a photo of the damage:
 - Measure the distance from the **grommet front side** (Figure 3, point 1) to the **point of damage point** (Figure 3, point 2). Include this measured distance in the TACS contact.

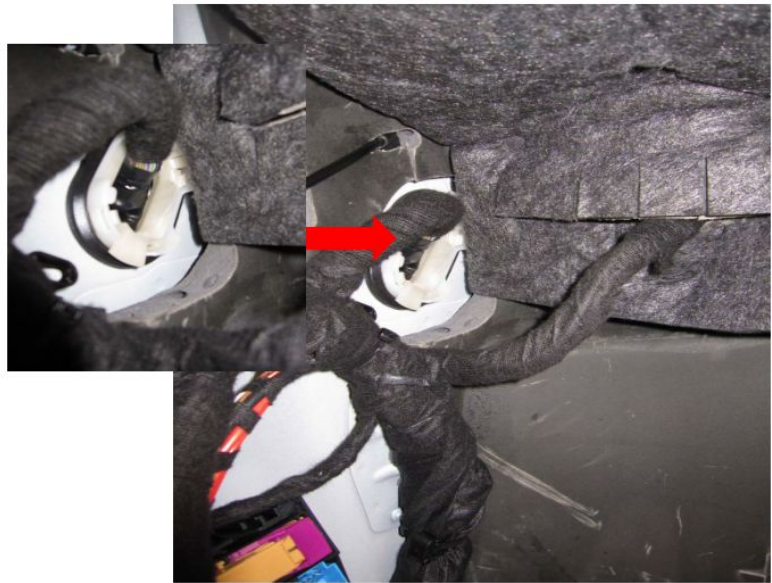
Figure 4. Grommet position photo, taken from inside the passenger compartment.

- Take a photo, using camera flash, of the grommet and original harness position from the passenger compartment (Figure 4). Please attach the photo to the TACS contact.
