SB-10054910-9378**FORD:**

2013-2014 Escape

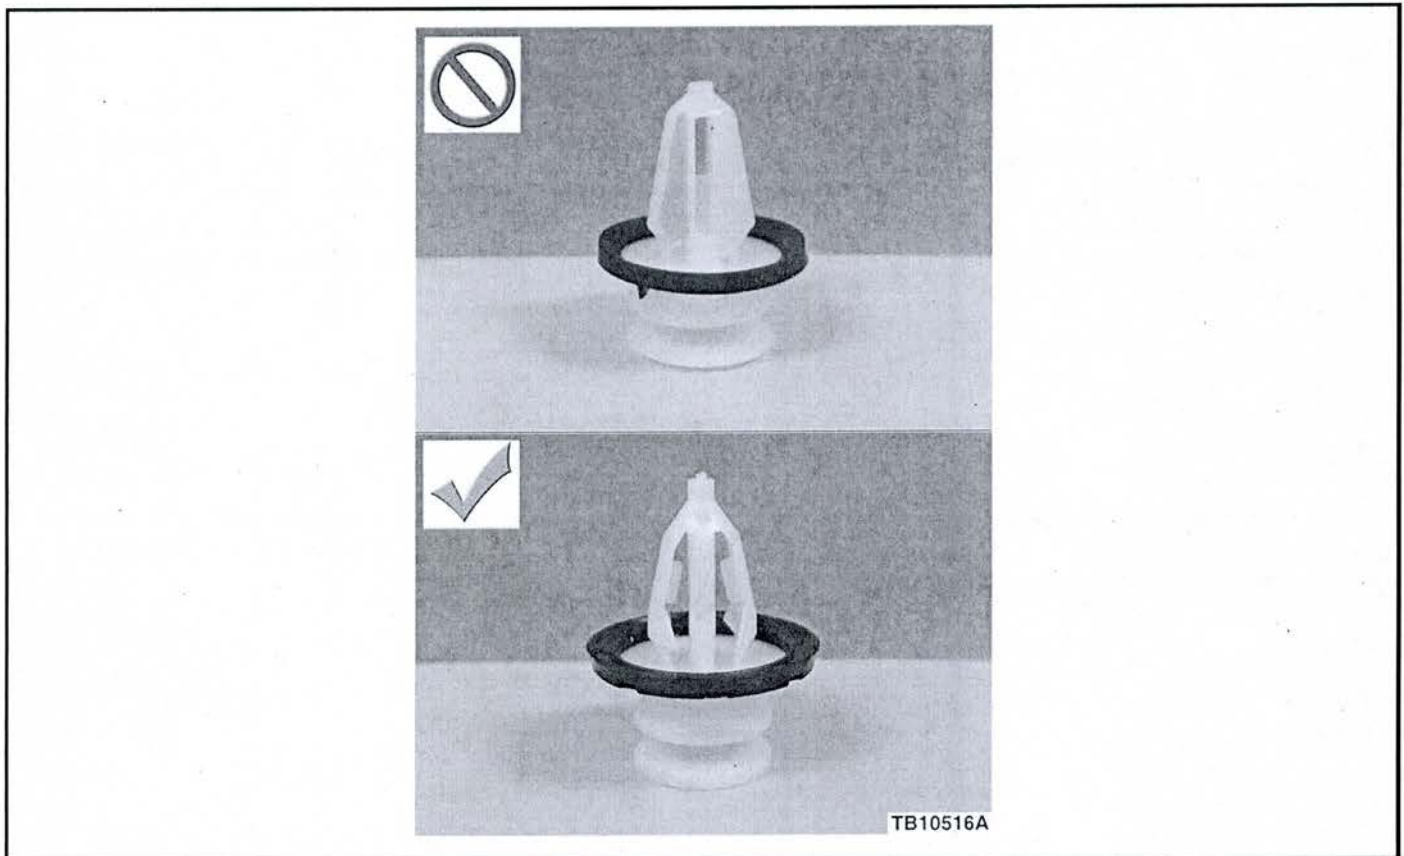
Figure 1 - Article 14-0004

Some 2013-2014 Escape vehicles built on or before 9/13/2013 may exhibit loose attachment of the left or right rear door trim panel, typically near the bottom of the door. A new retaining clip is now available for service.

1. Is the affected rear door trim panel damaged as a result of the loose attachment?
 - a. Yes - replace the rear door trim panel. Refer to Workshop Manual (WSM), Section 501-05. Use new style retaining clips on new door panel. (Figure 1) Repair is complete.

- b. No - proceed to Step 2.
2. Remove the affected rear door trim panel. Refer to WSM, Section 501-05.
3. Remove the seven retaining clips from the rear door trim panel and discard.

4. Install the new retaining clips into the holes in the door trim panel.
 - a. When retaining clip is inserted in the correct position a clicking noise can be heard.
5. Install the rear door trim panel. Refer to WSM, Section 501-05.
