SERVICE BULLETIN

EC14-002

February 14, 2014

2014 VERSA NOTE; MIL ON WITH DTC P059F STORED

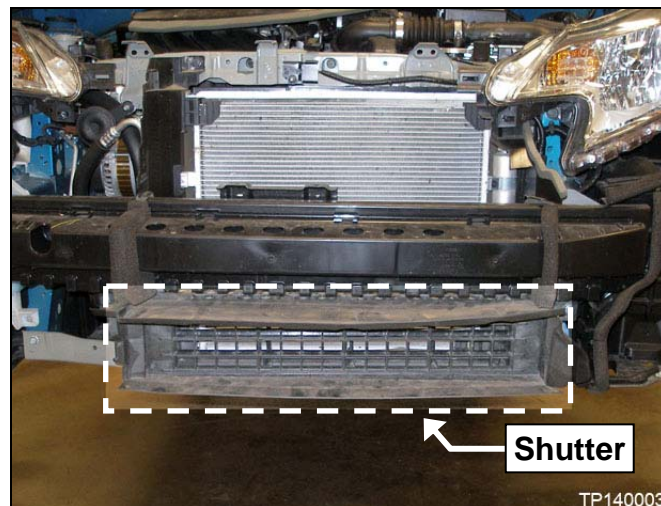
Figure GS3

3. Inspect the active grille shutter (shutter), remove any debris found (snow, trash, leaves, etc.).

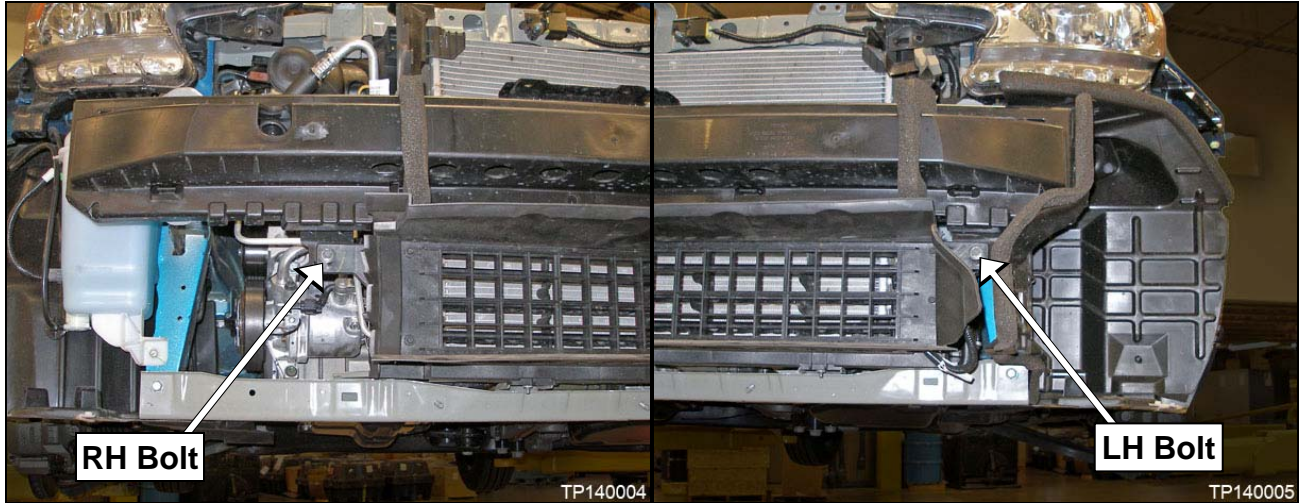
4. Inspect the shutter's installation for binding as follows:

a. Remove the two (2) bolts, one at each side (see Figure GS4 and GS5).

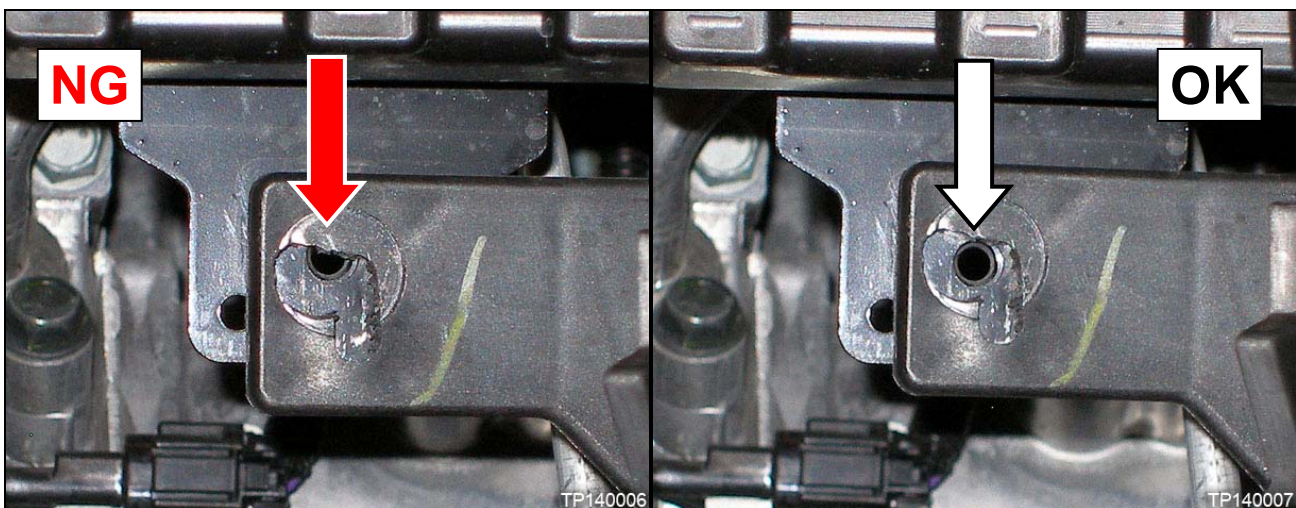
- c. If the bolts cannot be reinstalled easily (the bolt holes interfere - see Figure GS6 below), **go to Active Grille Shutter Adjustment on the next page.**

1. When interference is found at the shutter's bolt holes: Loosen the two (2) lower radiator core support bolts (see Figure GS8).
 - Loosen the bolts – do not remove.
2. To adjust the shutter bolt holes from interfering, raise the lower radiator core support (core support) as needed.
 - Raise at the center of the core support.
 - Use a "pole" jack or other suitable support tool.

CAUTION: Do not use excessive force. Damage may occur to the lower radiator core support.
3. Once the shutter bolt holes are properly adjusted, tighten the core support bolts.
 - Core support bolts torque: 24.0 N•m (2.45 kg-m, 17.7 ft lbs)
