SERVICE BULLETIN

EC14-002a

March 6, 2014

2014 VERSA NOTE; MIL ON WITH DTC P059F STORED

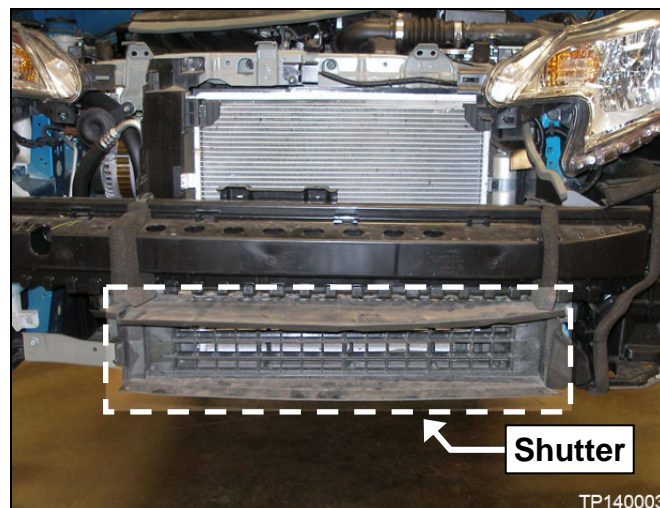
Figure GS3

3. Inspect the active grille shutter (shutter), remove any debris found (snow, trash, leaves, etc.).

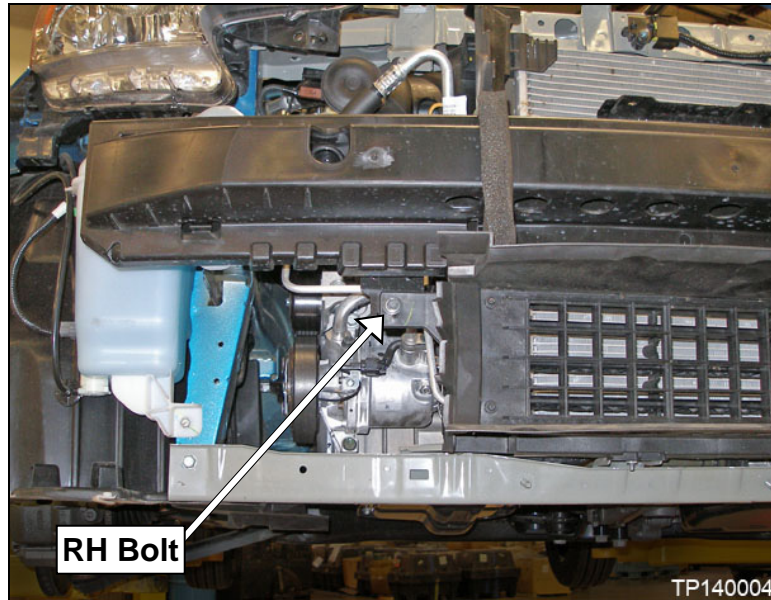
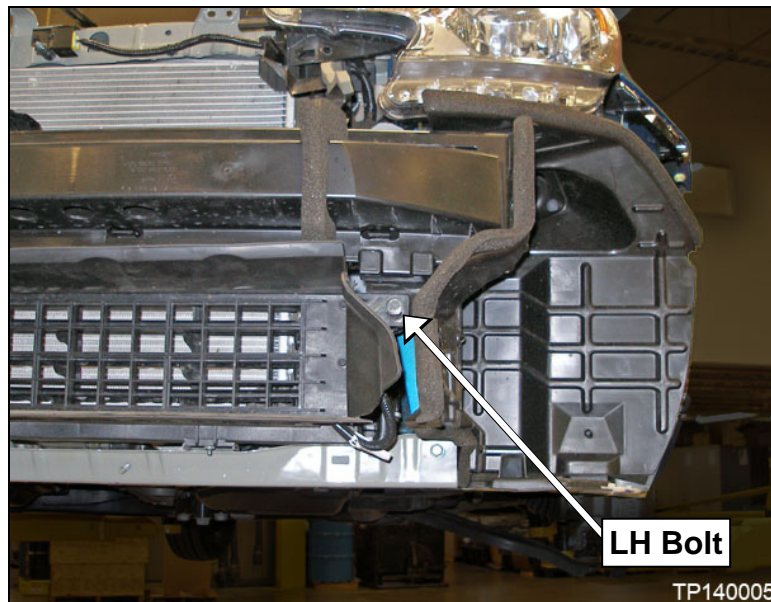
Figure GS5

4. Inspect the shutter's installation for binding as follows:

a. Remove the two (2) bolts, one at each side (see Figure GS4 and GS5).

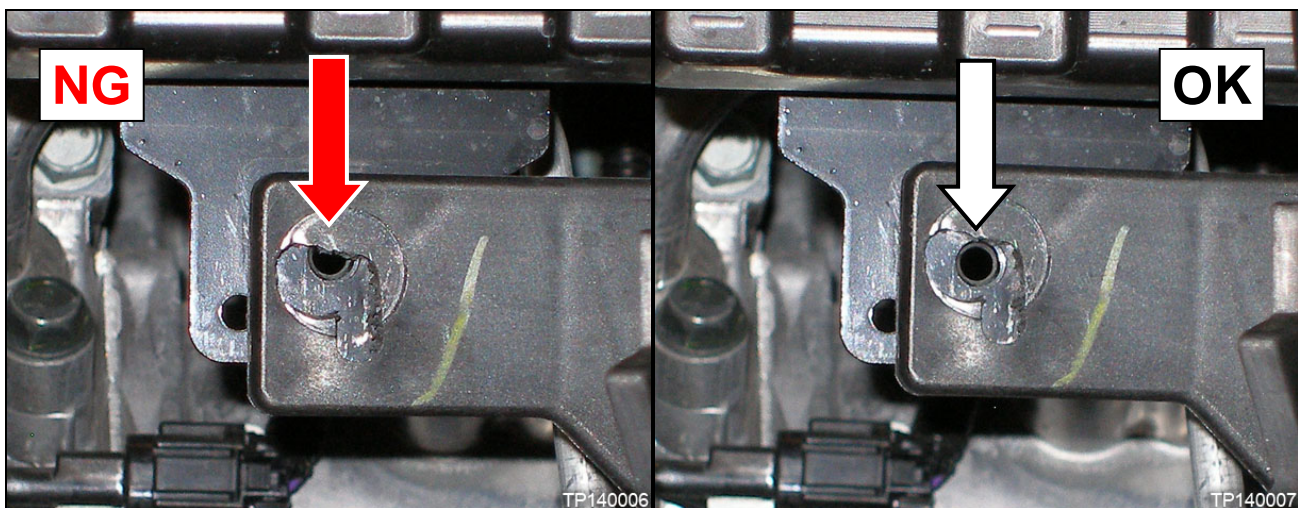
- c. If the bolts cannot be reinstalled easily (the bolt holes interfere - see Figure GS6 below), **go to Active Grille Shutter Adjustment on the next page.**

1. When interference is found at the shutter's bolt holes: Loosen the two (2) lower radiator core support bolts (see Figure GS8).
 - Loosen the bolts – do not remove.
2. To adjust the shutter bolt holes from interfering, raise the lower radiator core support (core support) as needed.
 - Raise at the center of the core support.
 - Use a "pole" jack or other suitable support tool.

CAUTION: Do not use excessive force. Damage may occur to the lower radiator core support.
3. Once the shutter bolt holes are properly adjusted, tighten the core support bolts.
 - Core support bolts torque: 24.0 N•m (2.45 kg-m, **17.7 ft lbs**)
