Bulletin No.: 14-06-04-002

**Subject:** Information for No Start Due to Inoperative LPG Fuel Pump Resulting From Upfitter Revisions

**Models:** 2012-2014 Chevrolet Express  
2012-2014 GMC Savana  
Equipped with Liquefied Petroleum Gas (LPG) — RPO KO7

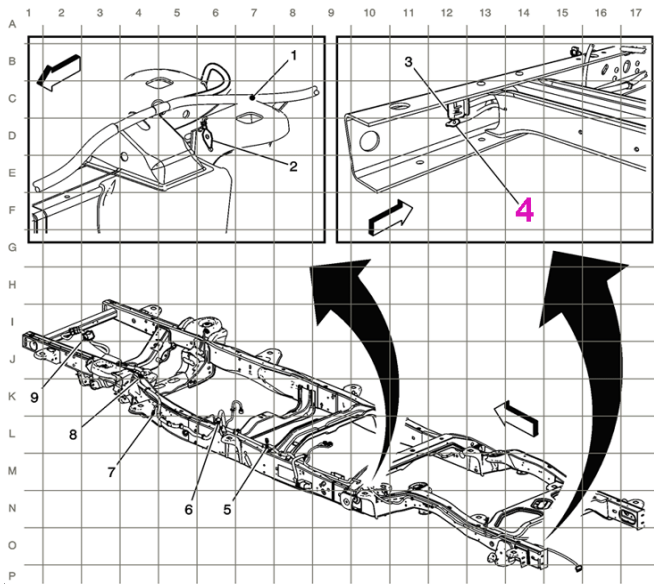
3679777

1. Review the original OEM location of G400 (4) in the graphic. The new G400 location selected by the upfitter will be in this general area of the chassis frame.

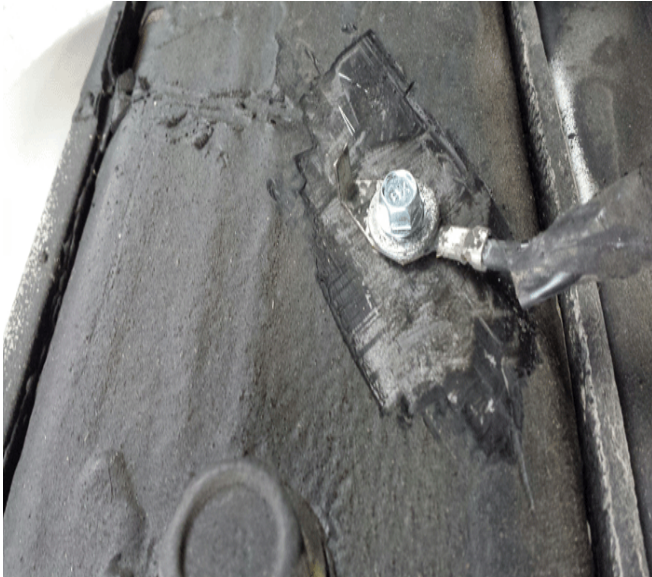
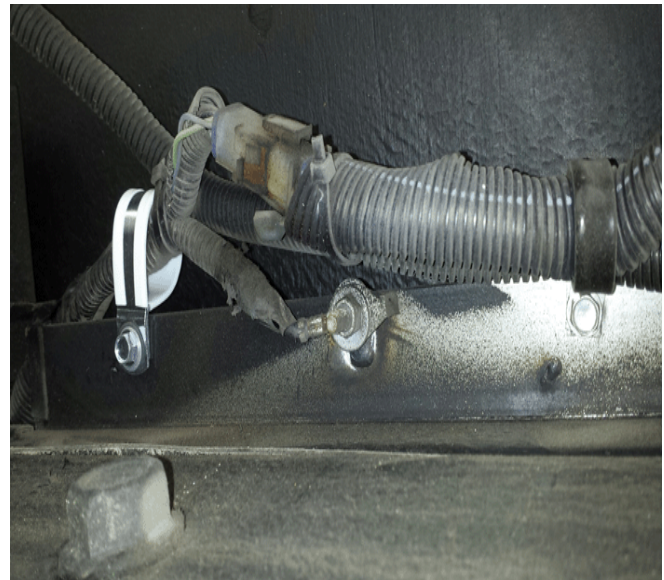
2. Review the graphics of the several new G400 locations that were possibly selected for use by the upfitter on the chassis frame in order to become familiar with the various locations.
