#### 94 Xenon headlight flickers or is inoperative on one side (DTC 00978 or 00979)

94 14 31 2021751/4 January 16, 2014. Supersedes Technical Service Bulletin Group 94 number 10-19 dated June 7, 2010 for reasons listed below.

## Technical Service Bulletin

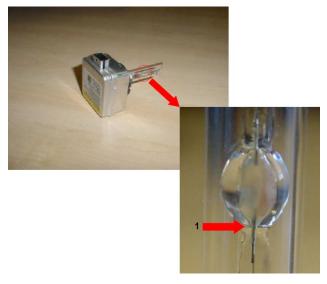
The xenon bulb may have an internal leak at the crimp of the electrodes, and xenon gas can be released (Figure 1).

Without an adequate amount of xenon gas, the bulb cannot establish a stable light arc. The xenon igniter control unit (ballast) repeatedly tries to establish an arc, which may cause a flickering of the headlight.

Figure 1. The location of the xenon bulb leak.
