Bulletin No.: PIC5955

Service Bulletin

Subject: 4ET50 Electric Drive Unit Service – Rotor B Replacement

Models: 2011-2014 Chevrolet Volt
2014 Cadillac ELR

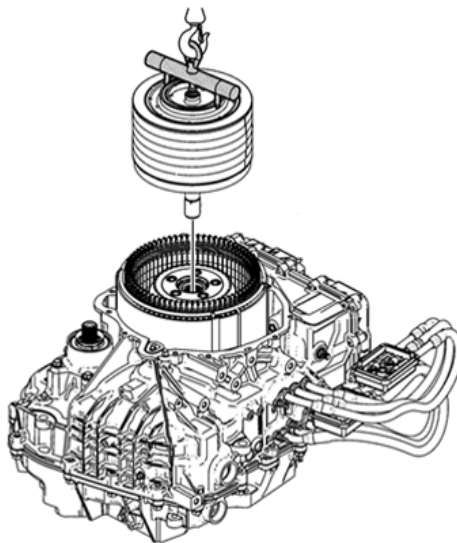
3696546

The proper way to address a Rotor B bearing noise is to perform a bearing only replacement per P/I #PIP5081. This can be done on-car.

If this is a repeat repair, and TAC recommends a Rotor B replacement, this must be done off car per S/I.

When replacing the Rotor B Assembly, it is imperative that the technician follows SI (Document ID: 3641026) exactly step by step. The transmission must be removed from the vehicle. Attempts to try this as an on-car procedure will result in subsequent failures and possible transmission damage. Damage or repeat repairs due to not following publish procedures will not be covered by warranty.
