SB-10055001-4261

Countries:	CANADA, UNITED STATES, PUERTO RICO	Document ID:	IK1201004
Availability:	ISIS, Bus ISIS, FleetISIS	Revision:	6
Major System:	ENGINES	Created:	10/28/2013
Current Language:	English	Last Modified:	1/27/2014
Other Languages:	NONE	Author:	Mark Ehlers
Viewed:	2312

Title: MaxxFORCE DT, 9 & 10 electric fuel pump and fuel system diagnostic information**Applies To: EPA 2010 and later MaxxFORCE DT, 9 & 10**

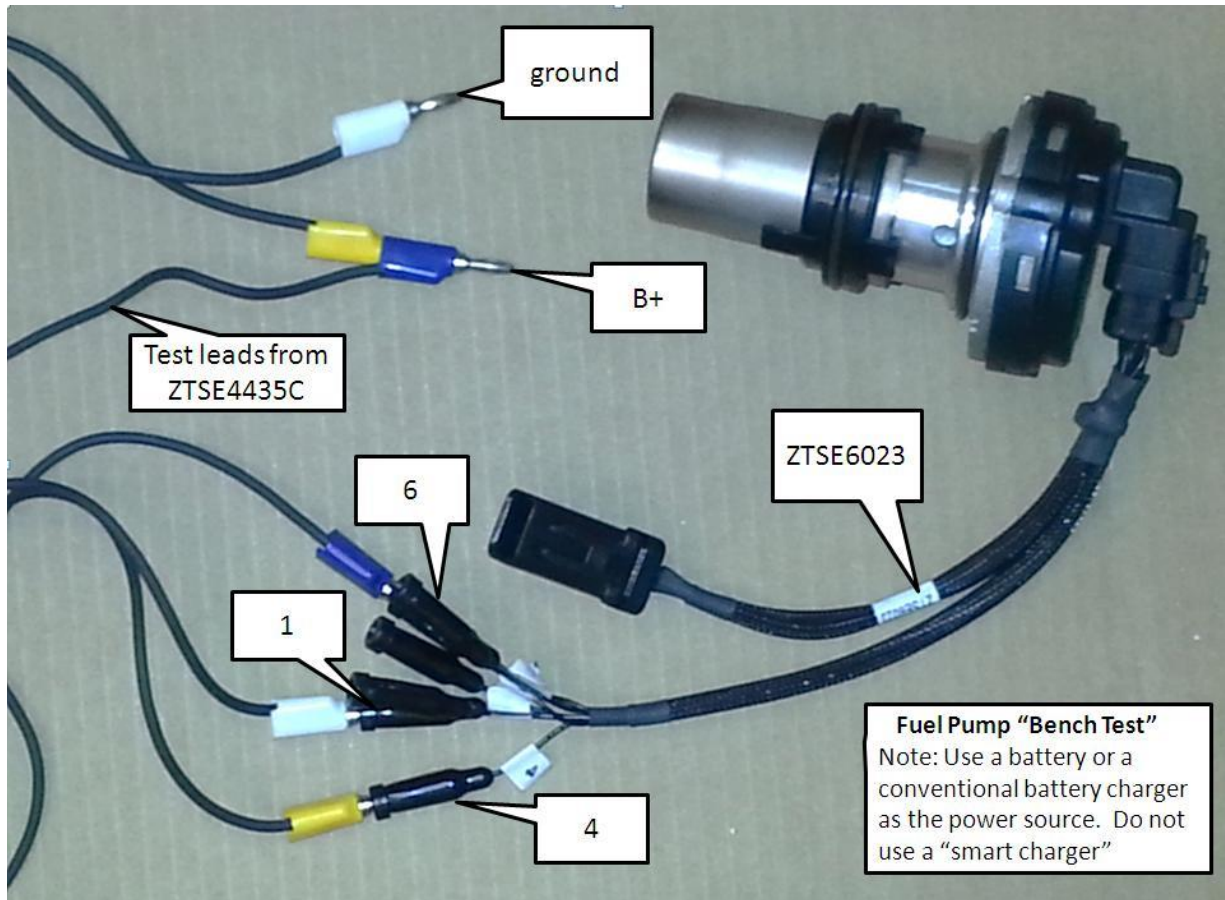
- Use and ZTSE6023 fuel pump breakout tee and male banana test leads from ZTSE4435C to bench test the fuel pump
 - **Bench test a suspect pump before replacing it**

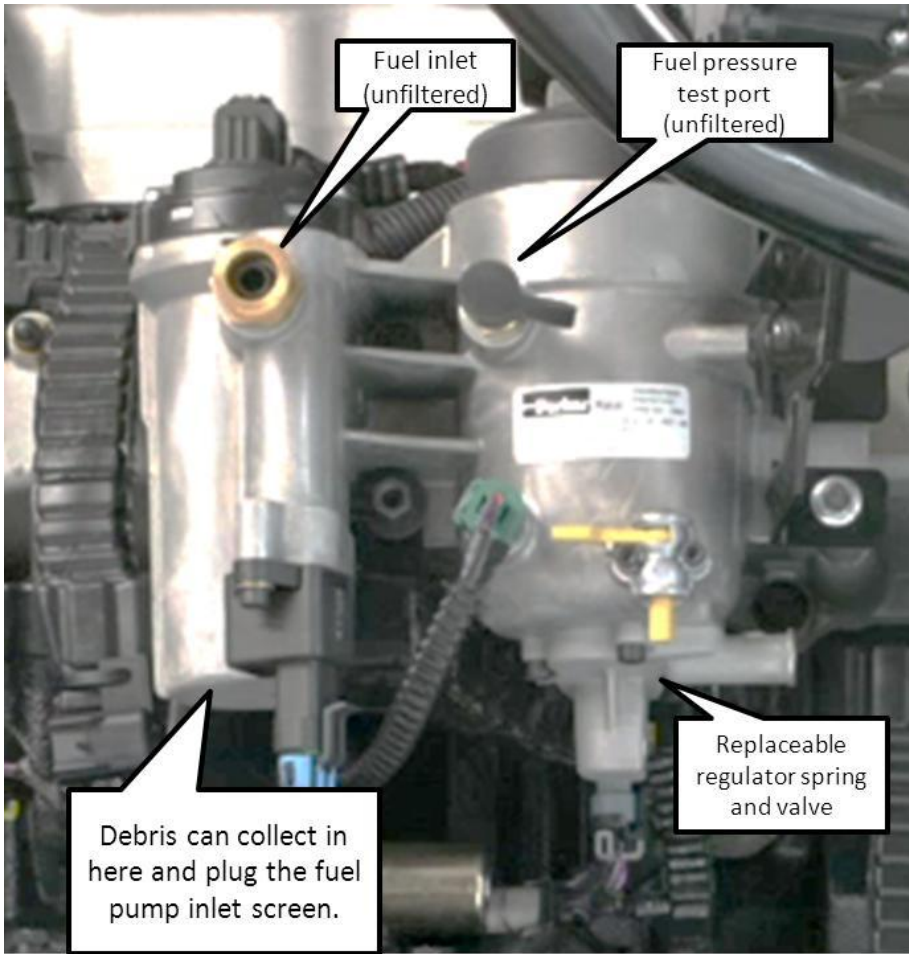
- Clogged fuel pump strainer (see image below)
- Worn fuel pressure regulator valve (serviceable)
- Plugged fuel filter element
- High fuel inlet restriction caused by plugged strainer, kinked fuel line, fuel pickup tube interference with fuel tank bottom, or tank debris
- Low voltage to fuel pump

Common DTCs associated with an issue with the fuel pump are SPN 94-1 and 94-17. These codes can be caused by a variety of issues and should be investigated before servicing the pump.

The fuel strainer can be seen when the pump is removed from the filter module. The strainer should be serviced at the filter replacement interval (30K miles / 43K Km / or 12 months). The strainer P/N is 1899335C91

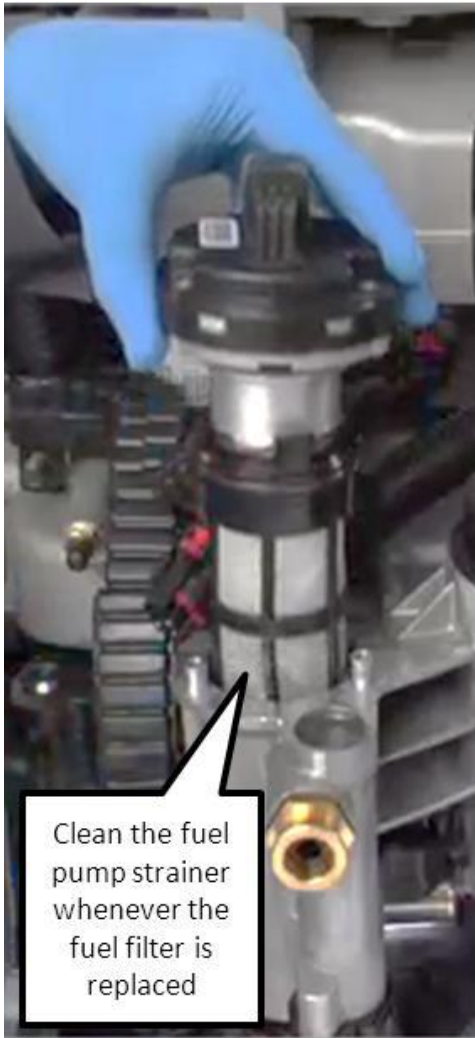
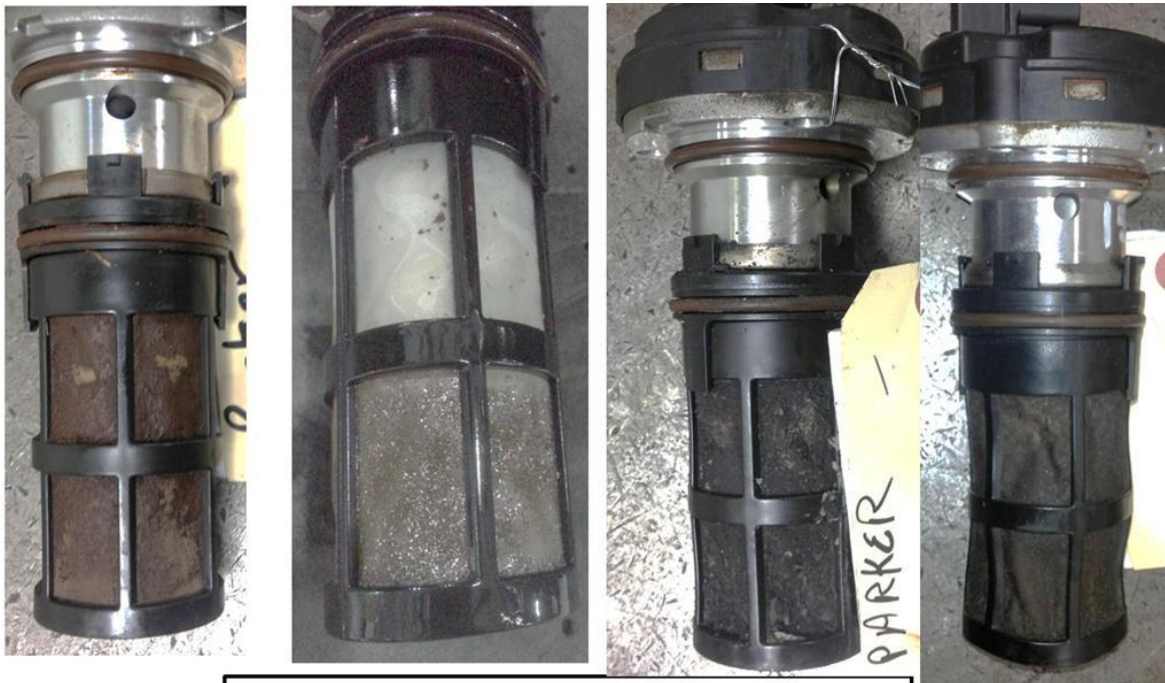
These vehicles need the strainers replaced
