SB-10055003-1400

This article supersedes TSB 13-12-21 to update the vehicle application.

ISSUE

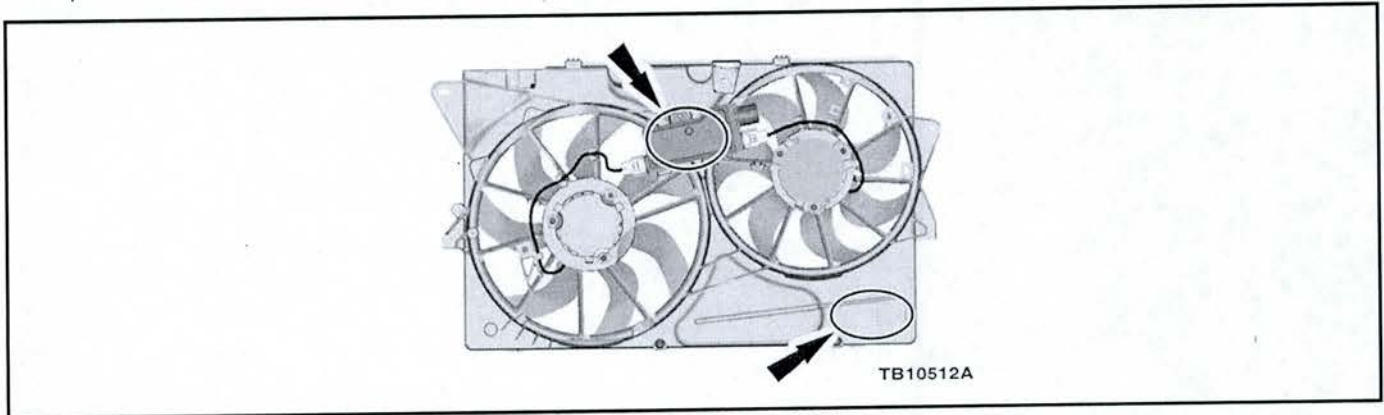
Figure 1 - Article 14-0019

Some 2011 and 2012 Explorer, Taurus, Flex, MKS and MKT vehicles built on or after 9/1/2010 and equipped with dual engine cooling fans may exhibit a lack of air conditioning (AC) performance while the vehicle is stationary or moving at slow speeds, and/or an overheat condition. Diagnostic trouble codes (DTCs) P0217, P1299 and P1285 may be present.

- a. No – please be sure to check the fan assembly for being original equipment manufacturer (OEM). (Figure 1)

- (1) For Taurus and MKS vehicles, replace the cooling fan motor and control module assembly. Refer to Workshop Manual (WSM), Section 303-03 and then proceed to Step 5.
- (2) For Explorer, Flex and MKT vehicles, proceed to Step 3.

3. Remove the cooling fan motor and control module assembly. Refer to WSM, Section 303-03.
4. Remove the cooling fan control module from the original cooling fan motor assembly and transfer onto the new cooling fan motor assembly. Tighten screw to 7 Nm (60 lb-in).
5. Install the new cooling fan motor assembly. Refer to WSM, Section 303-03.
6. Check coolant level and top off as necessary using the correct coolant type. Refer to WSM, Section 303-03.
