SB-10055044-6134

SERVICE BULLETIN

2009 ALTIMA AND MAXIMA; STEERING COLUMN LOCK REPLACEMENT

APPLIED VEHICLES: 2009 Altima Sedan (L32)
2009 Altima Coupe (L32)
2009 Altima Hybrid (L32)
2009 Maxima (A35)

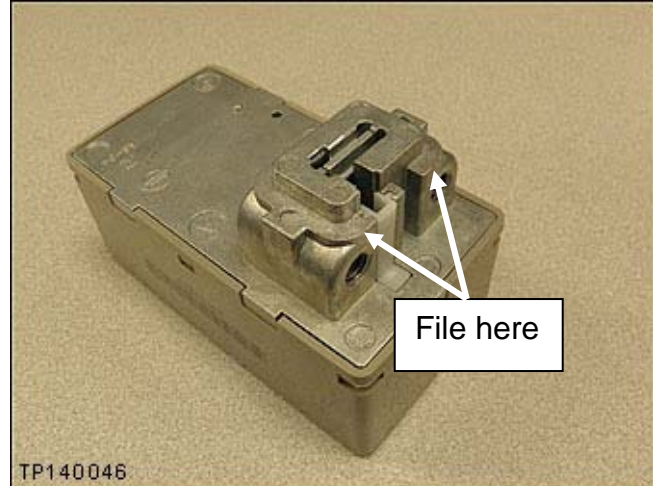
Figure 1

48700-1NC0A is shown in Figure 1. Its shape (physical appearance) is different than the original.

If you receive Electronic Steering Column Lock P/N **48700-1NC0A**, the bolts that hold it in place may not line up. You may not be able to start the bolt threads.

If you encounter the above condition, use a **hand file** to remove a **small** amount of metal from the edges shown in Figure 1.

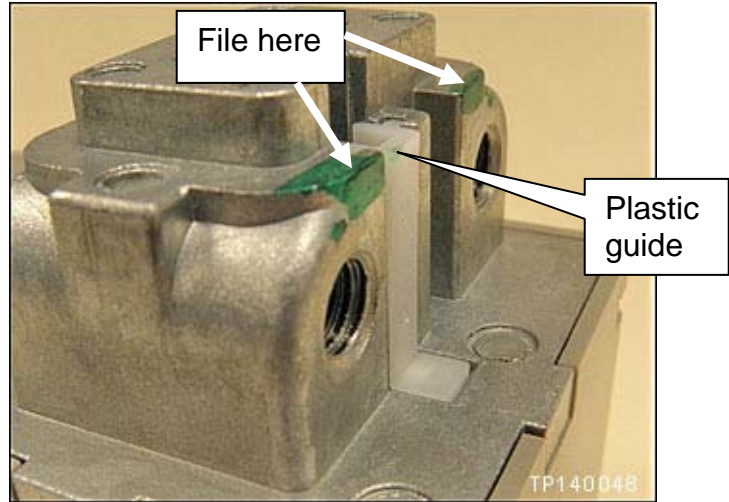
Figure 2

Close up before metal is removed:

- A green marker was used to mark the area that is to be filed.
- Be careful not to damage the plastic guide.
- Use tape to cover openings and prevent metal shavings from entering the assembly (see Figure 3).

- Do not use any power tools (grinders, sanders, etc.) to remove the small amount of metal.
- Only a **very small amount** of metal removal, **with a hand file**, is needed.

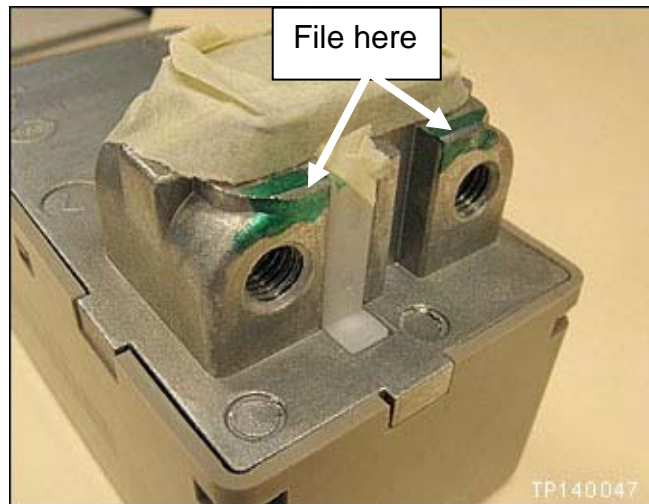
Figure 3

Close up after metal is removed:

- Use tape to cover openings and prevent metal shavings from entering the assembly.
- Remove only a **small amount** of metal as shown.
- After filing, if the assemble still will not fit, file a little more and retry.
