Service Bulletin

SUBJECT: Service Update for Inventory Vehicles Only
Fuse Block Retention
Expires February 28, 2016

MODELS: 2015 Chevrolet Silverado HD
2015 GMC Sierra HD
Equipped With 220 Amp Generator (KW5)

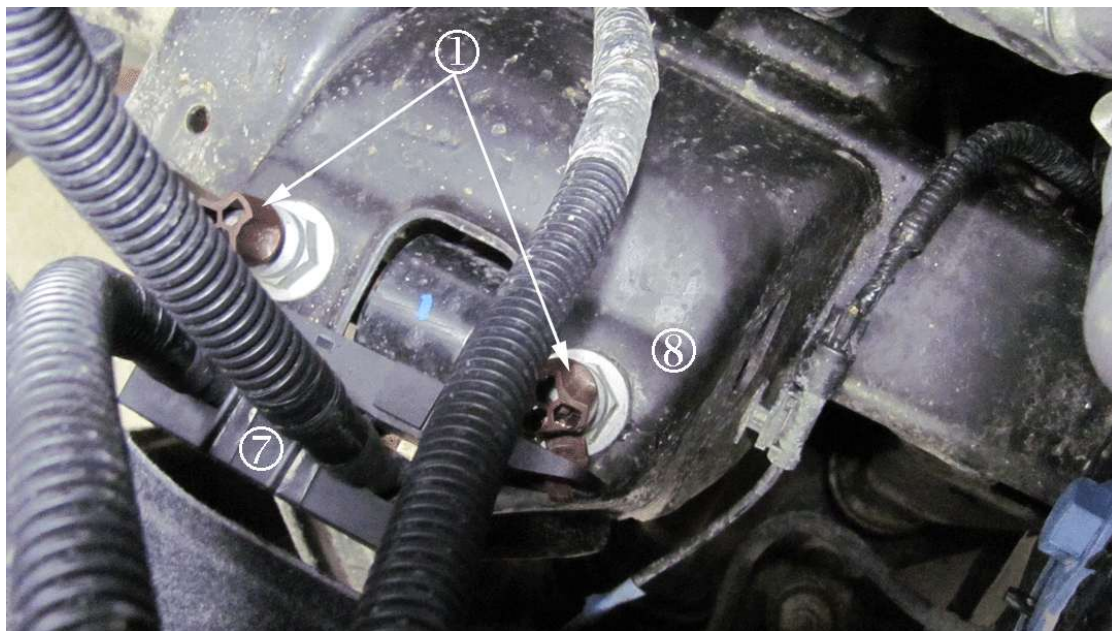
3709055

1. Open the hood and locate the fuse block housing assembly. The fuse block housing assembly (7) is located on the right (passenger) side shock tower (8) in the engine compartment.
2. Determine if the fuse block housing assembly rework has been performed.

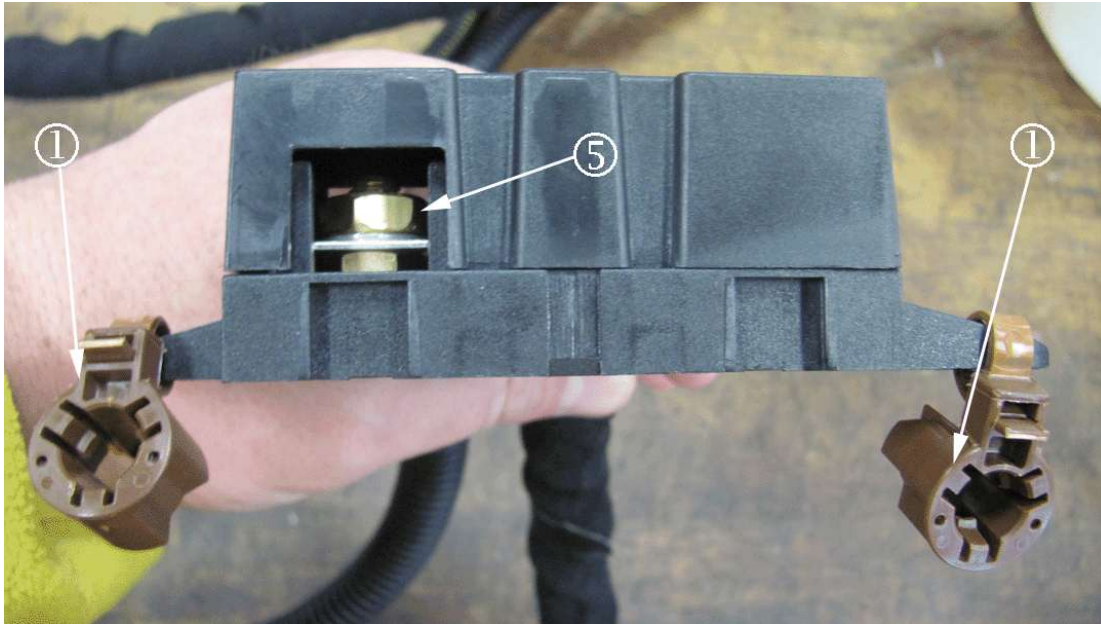
3709060

- A fuse block housing assembly that has NOT been reworked will have two brown clips (1) that secure the fuse block housing assembly to the shock tower studs. The fuse block housing cover will also NOT have a black polyolefin side window shield (5) or a black polyolefin bottom shield that is secured to the fuse block housing assembly with two black tie straps. **If the fuse block housing assembly rework has NOT been performed, perform the rework procedure in this bulletin. Proceed to step 3.**

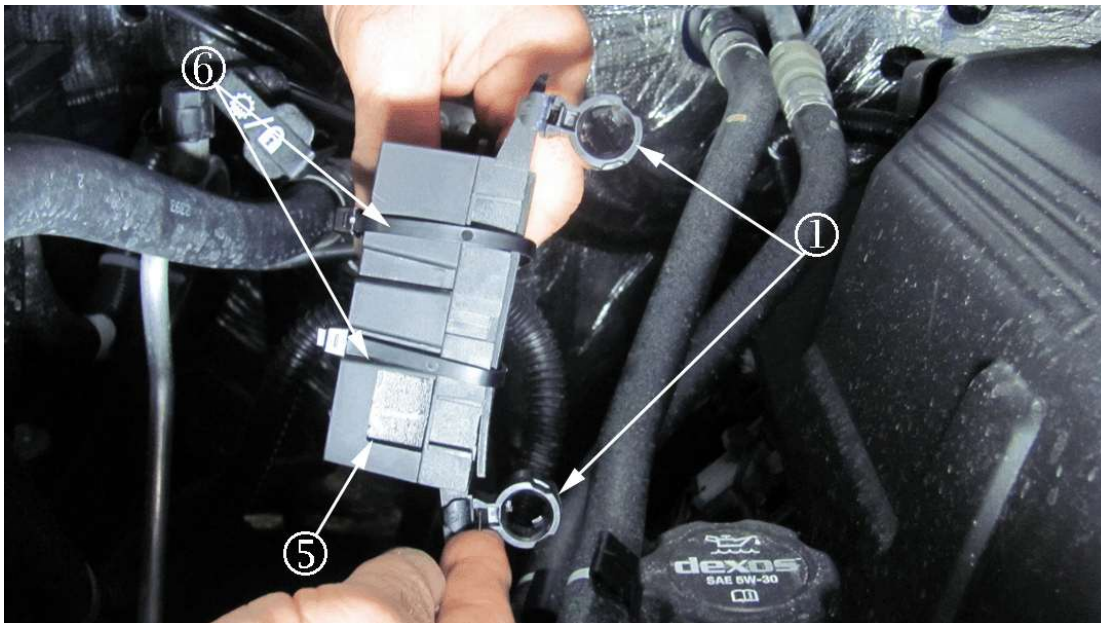
3709065

- A reworked fuse block housing assembly will have two black clips (1) that secure the fuse block housing assembly to the shock tower studs. The fuse block housing cover will also have a black polyolefin side window shield (5) and the bottom of the fuse block housing will have black polyolefin bottom shield that is secured to the housing assembly with two black tie straps (6). **If the rework has been completed, no further action is required.**
3. Disconnect the negative battery cable. Refer to Battery Negative Cable Disconnection and Connection in SI.

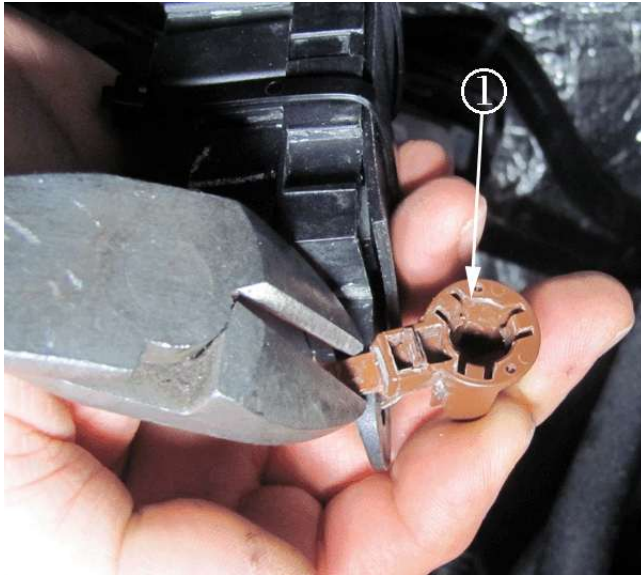
3709042

Note: Review the current orientation of the brown clips (1) on the fuse block. Ensure the black clips are installed in the same orientation as the brown clips were installed.

4. Remove the brown clips (1) from the fuse block using wire cutters or similar tool.
5. Discard the brown clips.
6. Install the black clips onto the fuse block.

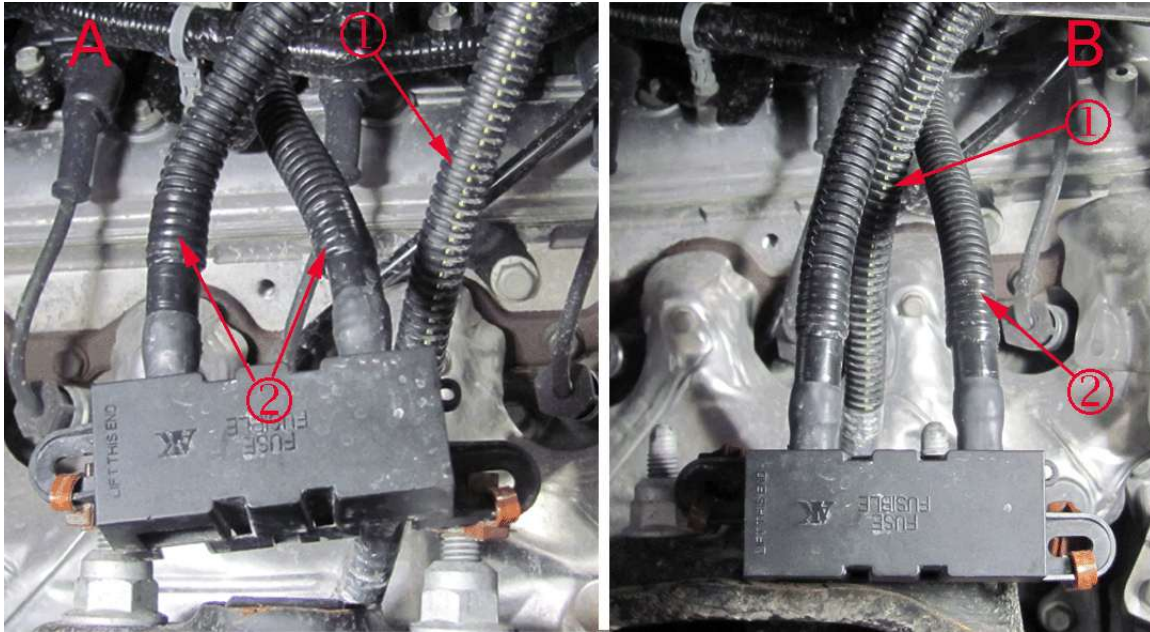
3709073

8. Determine if the cable routing is correct. The starter cable (1) routes forward of the other two fuse-center cables (2).
- If the cable routing is correct, proceed to step 9. Refer to the 'A' portion of the photograph for the correct routing of the cables. The starter cable (1) is forward of the two fuse center cables.
 - If the cable routing is NOT correct, unfasten the fuse center cable (2) that is to the right of starter cable (1). Refer to the 'B' portion of the photograph to view the incorrect routing of the cables. The starter cable (1) is routed in between the two fuse center cables. Reroute the right fuse center cable (2) to ensure the starter cable (1) is routed forward of the two center fuse cables. Next, re-install the fuse center cable (2) to the fuse block. Proceed to step 9 after correcting the cable routing.
