Bulletin No.: PI1178

Subject: Engine Rough Run with Check Engine Light (CEL) On/Low Compression on Cylinder with Misfire, DTC P0300 Set

Models: 2013 Cadillac ATS
2013 Chevrolet Malibu
Equipped with 2.0L Turbo Engine (RPO LTG)

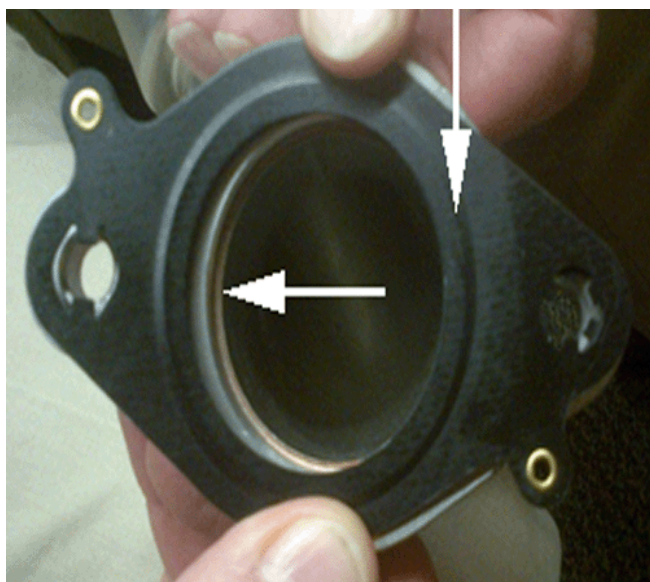
3657523

Note: If the gasket is flipped, as shown in the illustration above, it will reduce the outlet flow.
