# WARRANTY BULLETIN

CAN-AM® ROADSTER

### SB-10055104-7966

Subject: **Spyder™**

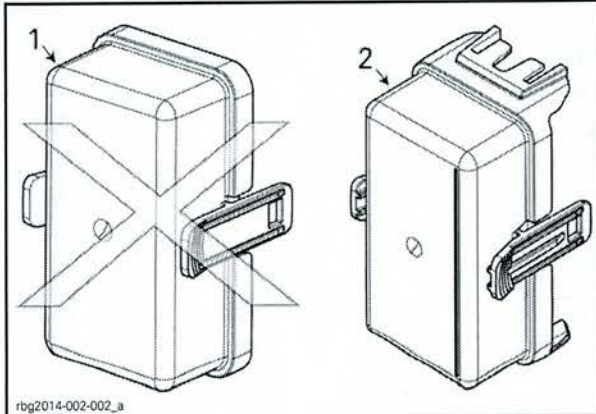
Water may infiltrate either of the front fuse boxes. The source of the infiltration may be:

1. Old fuse box cover
2. New fuse box cover

1. Replace the fuse box covers.
2. Apply liquid tape around base of bus-bar.
3. Apply liquid tape into and around all splices behind fuse boxes.

1. Remove old covers.

2. Transfer fuses to new covers.

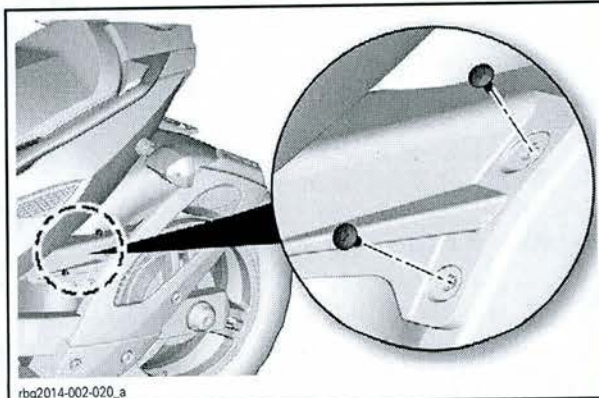
Retaining screws may not secure the belt guard properly.

Remove and discard screws on vehicle and replace with new screws.

TIGHTENING TORQUE	
Upper belt guard retaining screws	5 N•m ± 7 N•m (44 lbf•in ± 62 lbf•in)
