SB-10055104-8435

Roadster 2013 ST Upper Belt Guard Falling Off

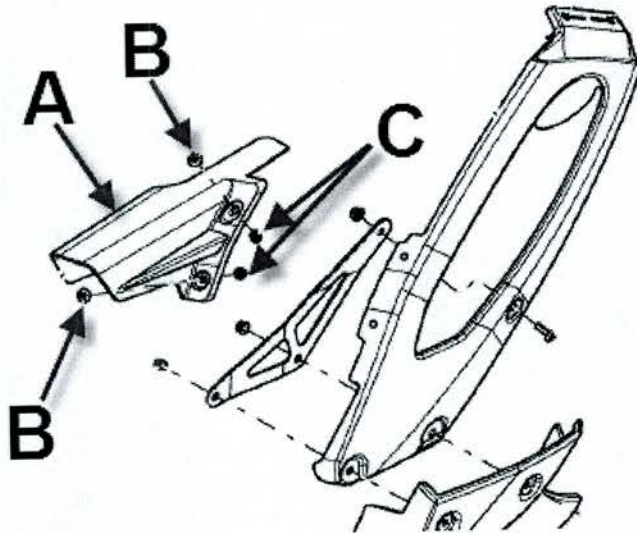
The problem has been identified as being the Torx screws being too short and not reaching the nylon of the nut. At the present time the MY13 parts catalog does not show the correct Torx screw, this will be corrected. Here is a breakdown of the parts needed:

- A. 705007213 upper belt guard
- B. 250000349 Torx Screw M6x10 --> 250000454 Torx Screw M6x12 (X2)
- C. 232361600 Nut M6 (X2)

If the belt guard has fallen off and needs to be replaced, order all parts above. If you want to be proactive and replace the screws, order the correct screws since the nut's nylon has not been touched.
