SB-10055106-2536

Roadster Spyder RS and ST Series Subject 1 - Front Fuse Box Covers Replacement Subject 2 - Update ECM Software P1614 Hi-Temp Lamps Limp Home Mode

Campaign no.: 2014-0001

Subject: **Roadster Spyder™ RS and ST Series**  
**Subject 1 - Front Fuse Box Covers Replacement**  
**Subject 2 - Update ECM Software (P1614, Hi-Temp Lamps, Limp Home Mode)**

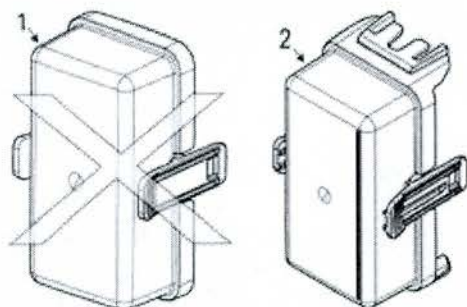
An improved fuse box cover is now used in production. Since this was a running change, a very limited quantity of vehicle were produced having a version of the fuse box cover which no longer meets BRP standards.

1. Old fuse box cover
2. New fuse box cover

1. Remove the cover from both fuse boxes.
2. Transfer fuses to new covers.

3. Install new covers on fuse boxes. Make sure they are properly clipped.
