WARRANTY
CAMPAIGN

ROADSTER
WARRANTY
Bulletin

Subject: **Spyder™**

No. **2013-9**

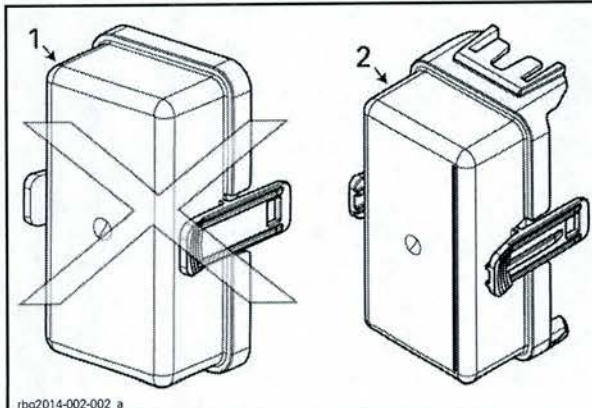
rbg2014-002-002_a

1. Old fuse box cover
2. New fuse box cover

IMPORTANT In the event you discover signs of corrosion or presence of water in the fuse box, **STOP** and communicate with the BRP technical support department by submitting a **BOSSWeb case with pictures**. A service representative will communicate with you providing detailed information based on the situation.

1. Remove old covers.

2. Transfer fuses to new covers.

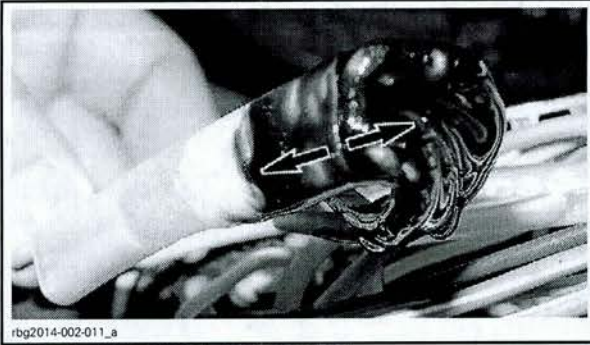
TYPICAL LIQUID TAPE APPLICATION

Water may infiltrate either of the front fuse boxes. The source of the infiltration may be:

1. The fuse box cover.
2. The bus-bar connection behind fuse box
3. Any of the wire splices behind fuse box.

4. Remove electrical tape as needed to expose all wire splices behind the fuse box.
5. Seal both ends of all the wire splices with liquid tape.

NOTE: Extend liquid tape onto wires and push the liquid tape into both ends of the splice for a good seal.

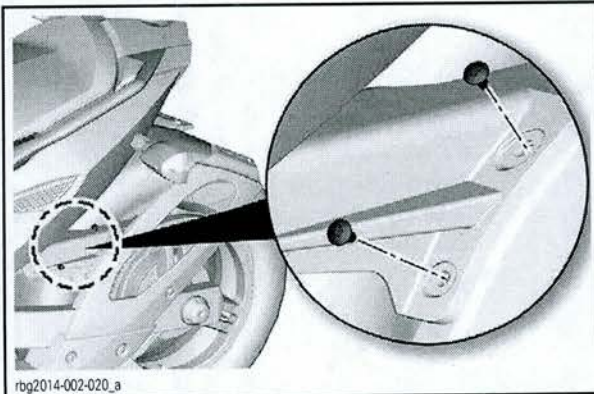
rbg2014-002-020_a

Retaining screws may not secure the belt guard properly.

Remove and discard screws on vehicle and replace with new screws.

5 N•m ± 7 N•m
(44 lbf•in ± 62 lbf•in)
