# Service Bulletin

Bulletin No.: 14-08-42-001

**Subject:** Additional Diagnostic Tips for Headlamp Inoperative or Intermittent Conditions

**Models:** 2014 Chevrolet Corvette

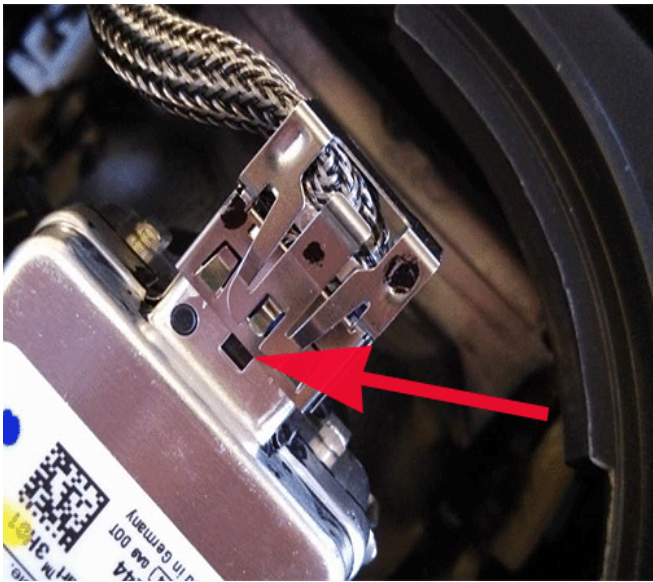
3687120

**Connector not fully seated**

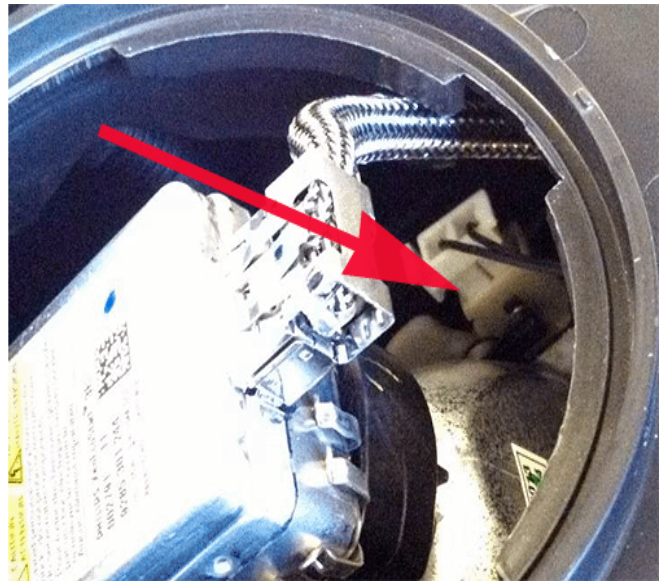
3687122

**Connector not fully seated**

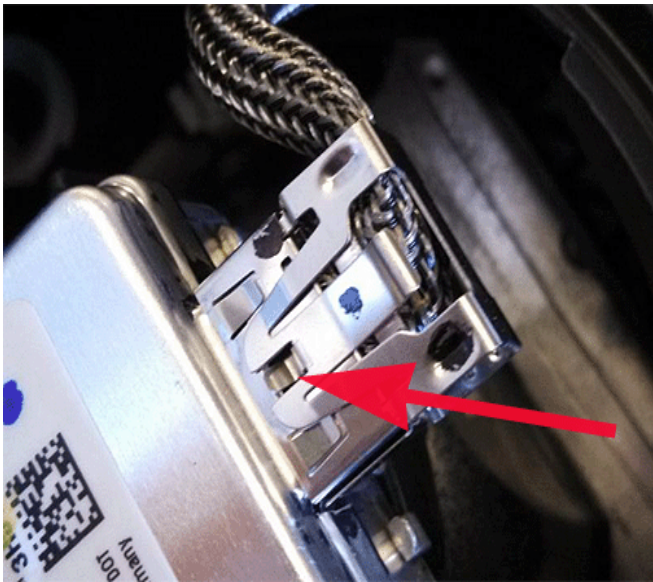
3687119

**Connector fully seated**

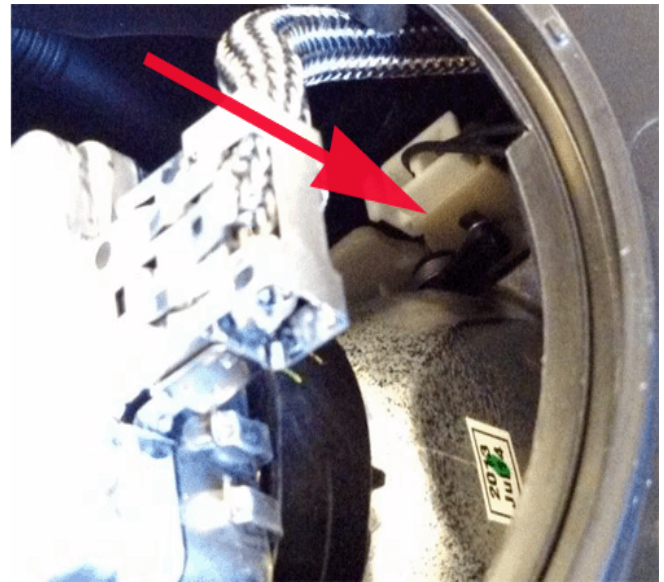
3687126

**Connector fully seated**

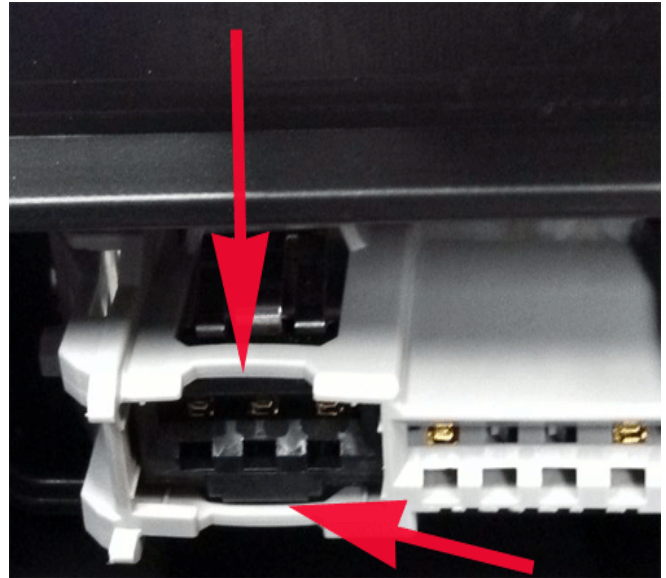
3687135

**Incorrect position, HV Cable tabs not fully seated in grey housing (reposition as necessary)**

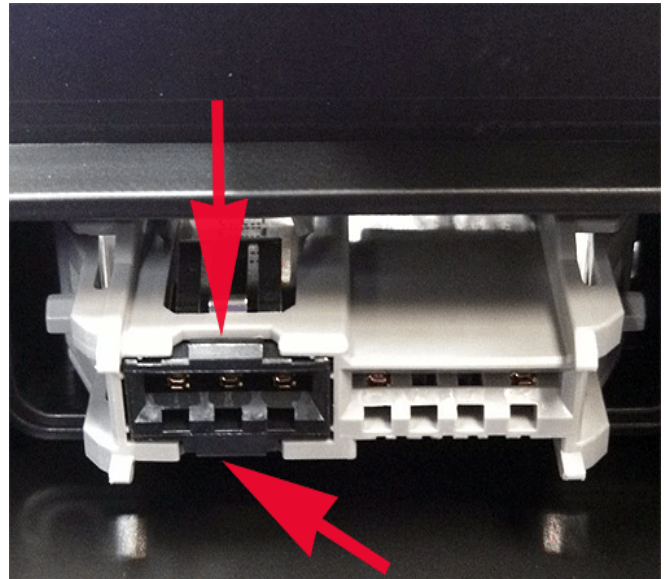
3687132

**Correct position, HV Cable tabs seated in grey housing**

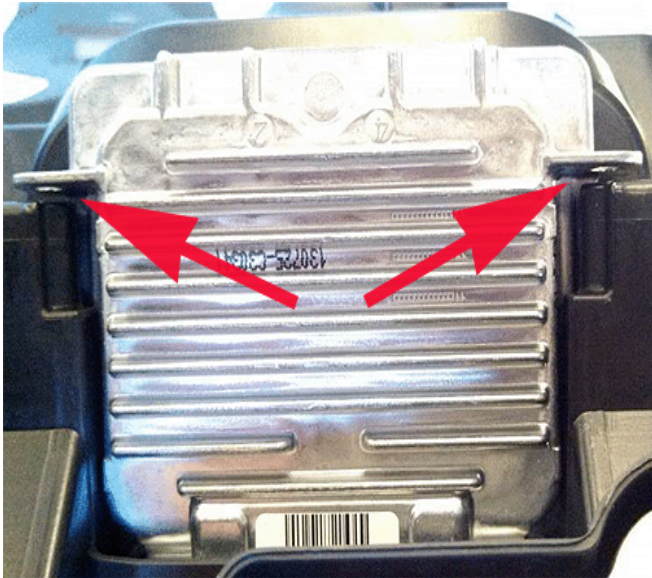
3687139

A slight gap can be seen between ballast and housing.

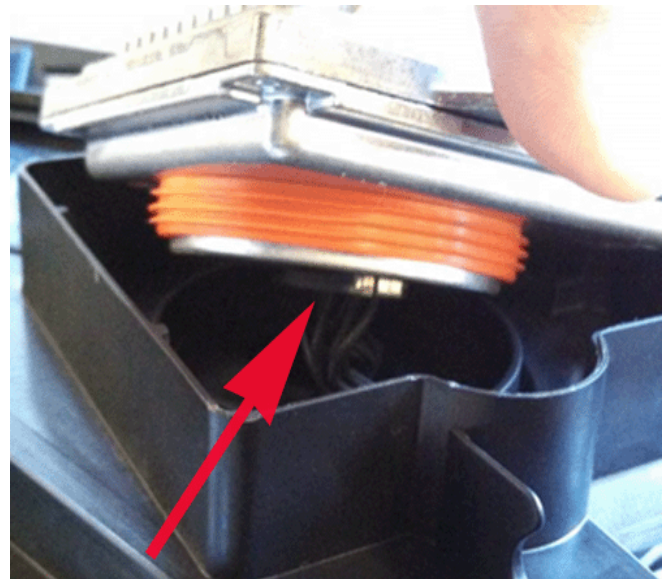
3687151

Visually check if the harness is connected. Slide your fingers between the module and housing to feel if the connection is secured.
