SB-10055203-4147

Compressor Discharge Line
LEU, MRU

FSB 561-024, Compressor Discharge Line

(February 2014)

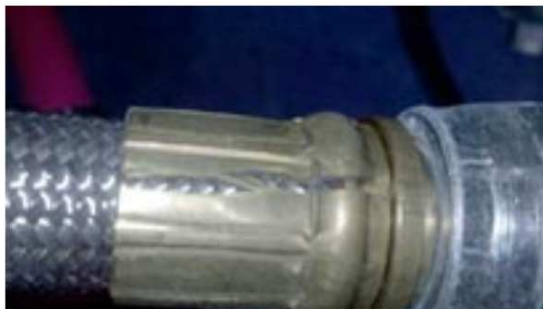
W5085642

On LEU633 and MRU633 models built between March 2012 and August 2013 the brass collar that is crimped onto the stainless steel compressor discharge line may split, resulting in the inability of the unit to build air pressure. The original part numbers of the Stainless Steel line assembly that are affected are: 25195537, 25192424, and 21628882. Should a failure occur the discharge line should be replaced with the new compressor discharge lines that have a steel collar.

- 1 Raise the cab.
- 2 Remove clamps securing main air line.
- 3 Disconnect braided line.
- 4 Install the replacement braided line. Tighten securely.
- 5 Install clamps securing main air line.
- 6 Start engine. Build air to maximum pressure and check for leaks.
- 7 Lower cab.
