Technical Information Bulletin

CT660 Engine Injector Doser Nozzle Plugging {7000}

Media Number -TIBU7394-00 Publication Date -21/02/2014 Date Updated -21/02/2014

CT660 (S/N: TGA1-UP; TGD1-UP; TRK1-UP; TKL1-UP; TGS1-UP; TJS1-UP; TGT1-UP; TSW1-UP; TSY1-UP; TGZ1-UP)

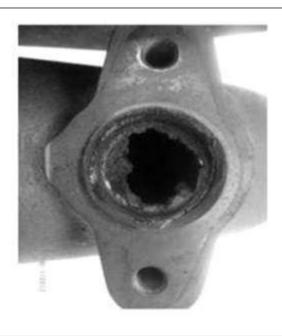
Illustration 2 g03554458

Doser nozzle plugging due to carbon bridging over the nozzle.

Below are photos of a partially plugged port Illustration 2, a completely plugged doser Illustration 3 and a clear port Illustration 4.

Partially plugged AFI port

New style **452-8519** Gasket (1) replaces **376-2628** Gasket (2). The new style has a raised center portion of the gasket removed (refer to Illustration 1. This design reduces carbon bridging. The old style gasket can be modified if the new style gasket is not available.

- 5. Remove the carbon plugging with a chisel or other appropriate tool.
- 6. Remove the carbon debris from the exhaust brake housing (A shop vac can be used).

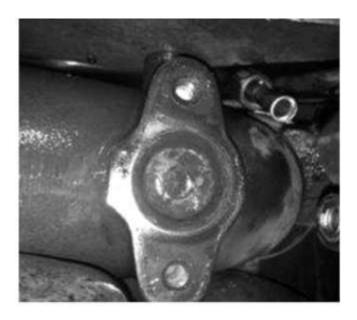
Illustration 3

A plugged HC injector port will result in improper or frequent after-treatment regenerations (regens). If the AFI port is plugged use this procedure and the CT11 and CT13 Engine Diagnostic Manual, UENR1846, for additional reference.

Fully plugged AFI port

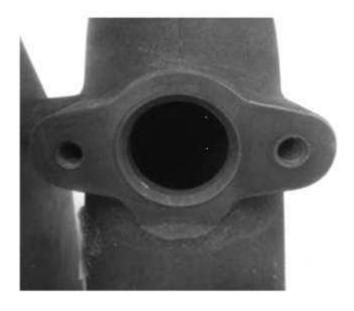
Illustration 4

Clear AFI port
