SB-10055240-4338

Title: Prostar upper radiator pipe cracking or breaking at support bracket or at flange area

Applies To: Prostars built before 8/28/07

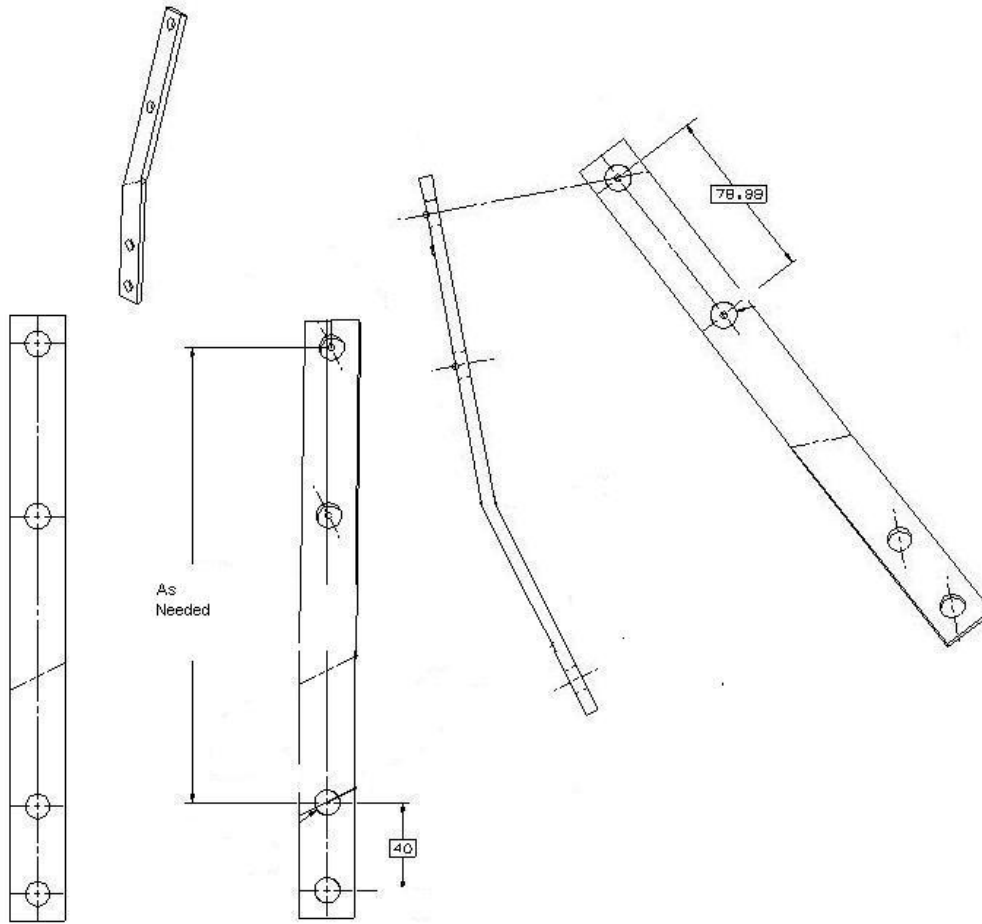
Drawing 1

On some ProStar tucks built before 8/28/07 we have seen the upper radiator pipe break either at the support bracket that is welded to the pipe, or at the flange that mates to the engine. The fix is to cut off the support bracket that is welded to the pipe and make a simple bracket out of flat stock similar to drawing 1 below. Bolt the new bracket to the engine and secure the pipe to the bracket with an exhaust u-bolt (471200C1). Make sure to loosen the flange bolts and retighten them after all parts and hoses are loose-fit together and the pipe is secured to the bracket to prevent stress on the support bracket or flange.

Note1: In the near future you will be able to order Kit number 8000893R91 along with New pipe number 3625914C2. This kit will contain the new support bracket, U-bolt, nuts, and washers necesseccary to install the new pipe. Keep in mind that the new support bracket will not look like the bracket pictured below.
