BULLETIN NUMBER:  
**IB14-J-002**

## **OIL IN THE INTAKE – TURBOCHARGER INSPECTION**

- 2011-2015MY Isuzu N-Series  
Equipped with 5.2L (4HK1), 3.0L (4JJ1) Diesel Engine and Diesel Particulate Filter (DPF)

***This bulletin supersedes IB09-J-002C. Please discard previous bulletin IB09-J-002C.***

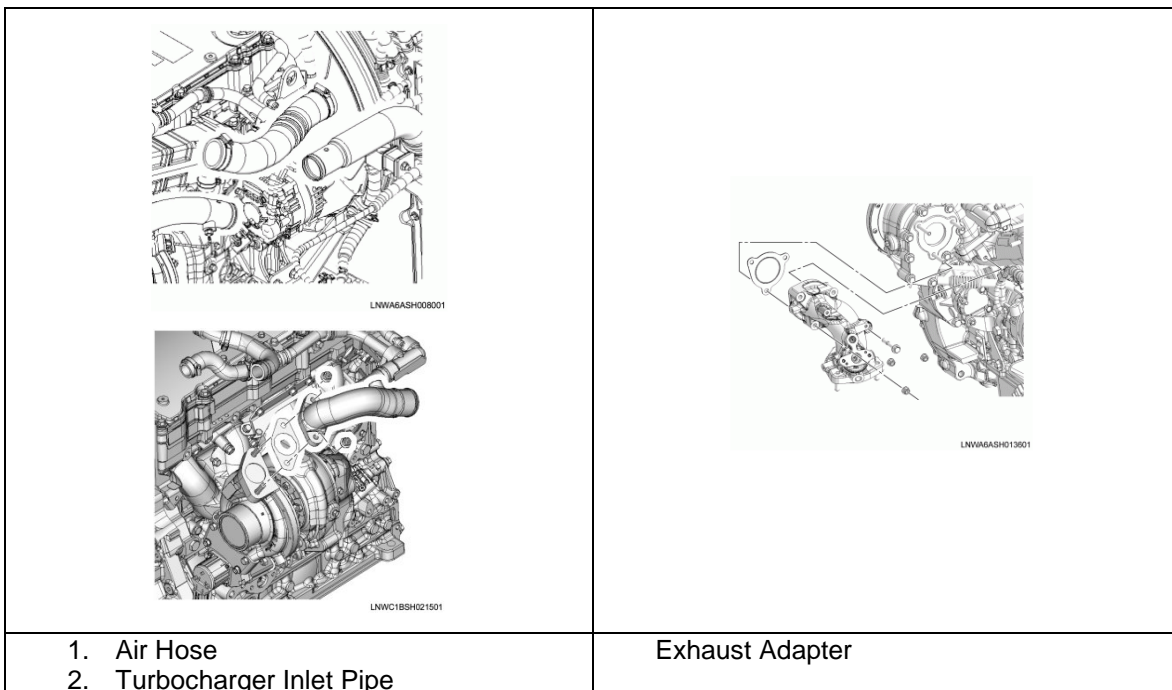
Remove the air hose, the turbocharger inlet pipe and the exhaust adapter from the compressor. Using an inspection light, inspect the compressor and turbine wheels for evidence of foreign object damage. If one or both of the wheels are damaged, a foreign object(s) has probably entered through the intake or exhaust system. Be sure to identify the origin of the foreign object, as foreign objects tend to occur from human error or deteriorated engine/intake systems. Repair the source for the foreign object and replace the turbocharger assembly. If **NO** damage is found, inspect the radial and axial shaft play.
