WARRANTY
CAMPAIGN

ROADSTER
WARRANTY
Bulletin

Campaign no.: 2013-0015
2013-0016

Subject: **Spyder™**

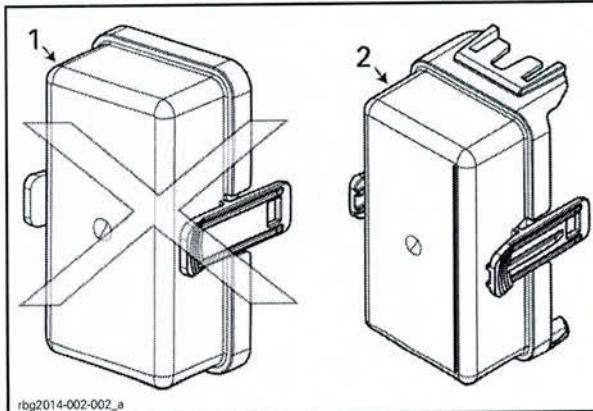
Water may infiltrate either of the front fuse boxes. The source of the infiltration may be:

1. Old fuse box cover
2. New fuse box cover

1. Remove old covers.

2. Transfer fuses to new covers.

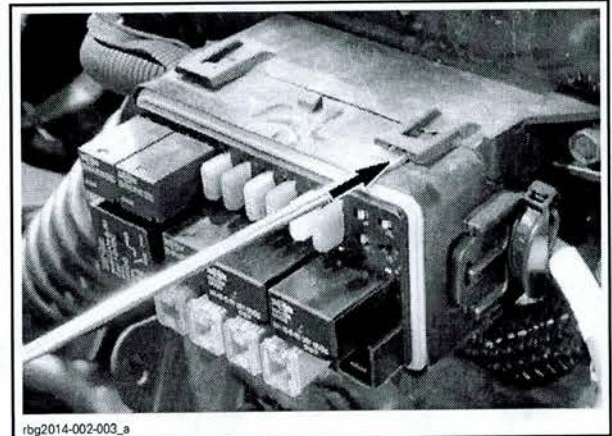
RH FUSE BOX SHOWN

1. Carefully unclip a fuse box.

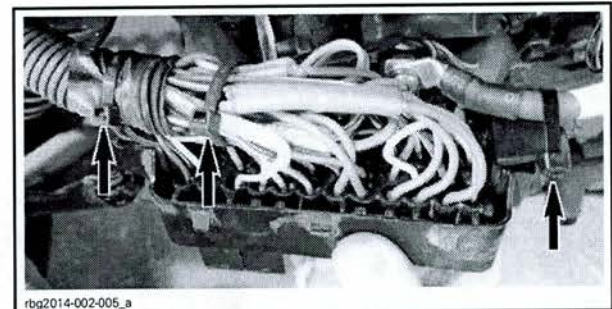
RH FUSE BOX SHOWN

2. Note position and cut locking ties.

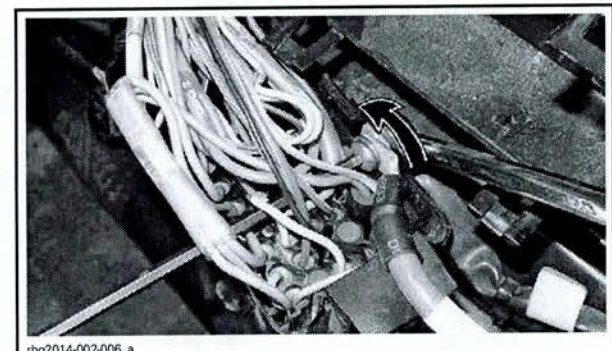
RH FUSE BOX SHOWN

3. Remove the power cable to the bus bar.

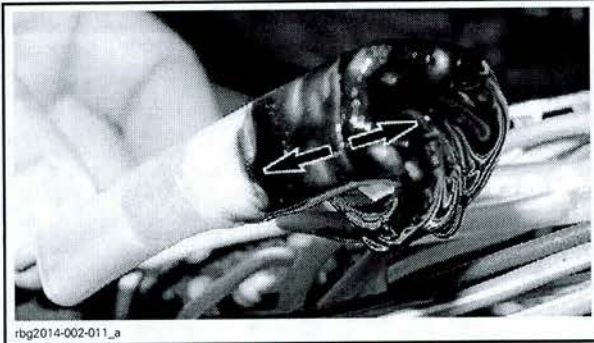
TYPICAL LIQUID TAPE APPLICATION

5. Seal both ends of all the wire splices with liquid tape.

NOTE: Extend liquid tape onto wires and push the liquid tape into both ends of the splice for a good seal.

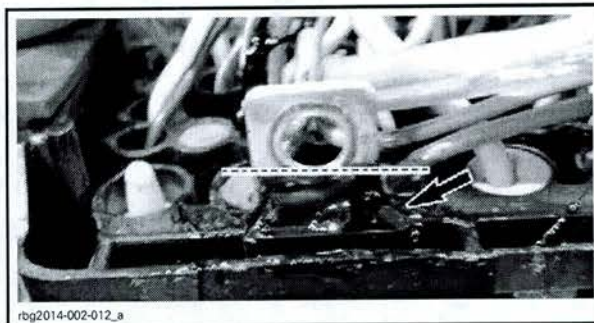
TYPICAL LIQUID TAPE APPLICATION

1. Apply liquid tape around the base of the bus-bar. Do not exceed the dotted line area.

TIGHTENING TORQUE	
Power cable to bus-bar nut	5 N•m ± 1 N•m (44 lbf•in ± 9 lbf•in)

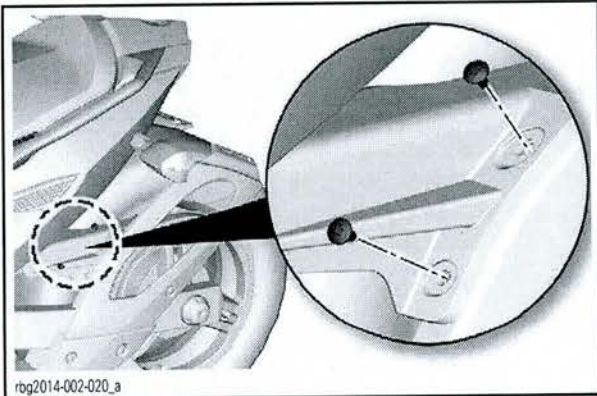
Retaining screws may not secure the belt guard properly.

Remove and discard screws on vehicle and replace with new screws.

TIGHTENING TORQUE	
Upper belt guard retaining screws	5 N•m ± 7 N•m (44 lbf•in ± 62 lbf•in)
