Bulletin No.: PI1188

Subject: Duramax® Fuel Temperature Sensor Contacts Fuel Return Pipe After Pump Replacement

Models: 2012-2014 Chevrolet Silverado 2500/3500
2012-2014 GMC Sierra 2500/3500
Equipped with 6.6L Diesel Engine (RPO LML)

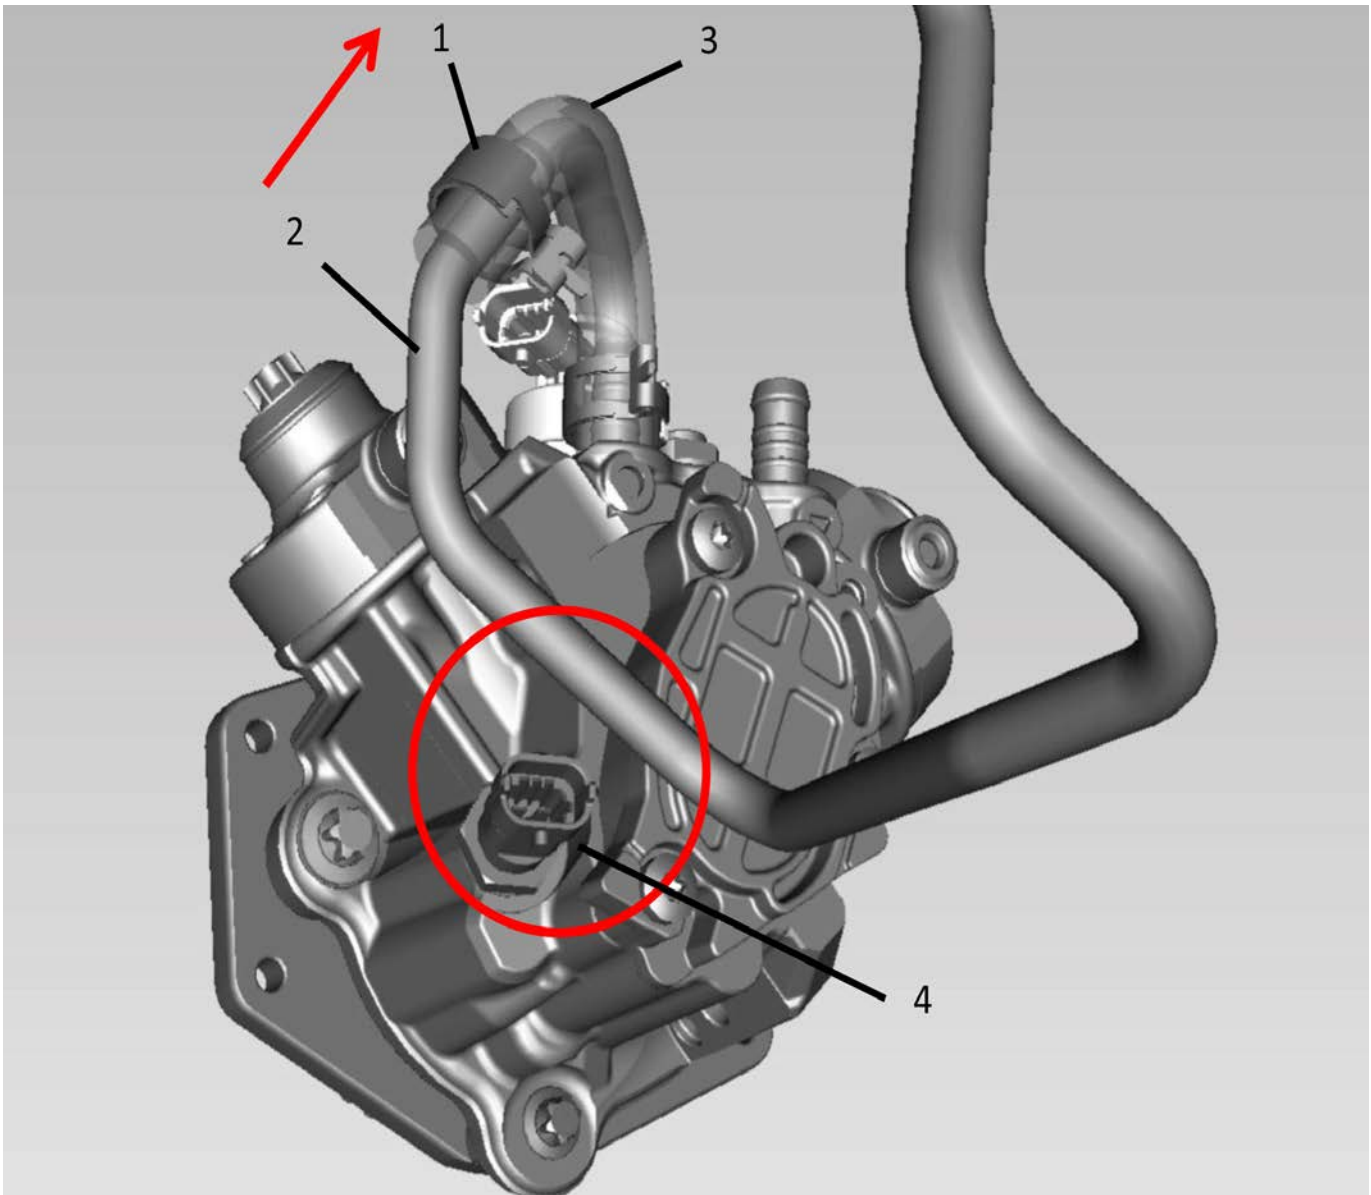
3629232

The following information may be helpful for a technician when replacing a fuel pump. If there is contact between the fuel temperature sensor connector and the fuel return line or clearance is very tight, please follow this service recommendation.

Follow the procedure below for inspecting the fuel return pipe to see if adjustment is needed. If sufficient clearance of 5 mm cannot be obtained through adjustment, replace the fuel return pipe with the newer design.

1. Remove the fuel return pipe to fuel return hose clamp (1).
2. Adjust the fuel return pipe (2) deeper into the fuel return hose (3).
3. Rotate the pipe assembly away from the fuel temperature sensor (4).
4. Install the fuel return hose clamp (1).
