# Service Bulletin

Bulletin No.: PI1126B

**Subject:** Blank Screen After Startup and Reverse, Rearview Camera Message On, Touch Screen Inoperable, Bluetooth® and Navigation Concerns

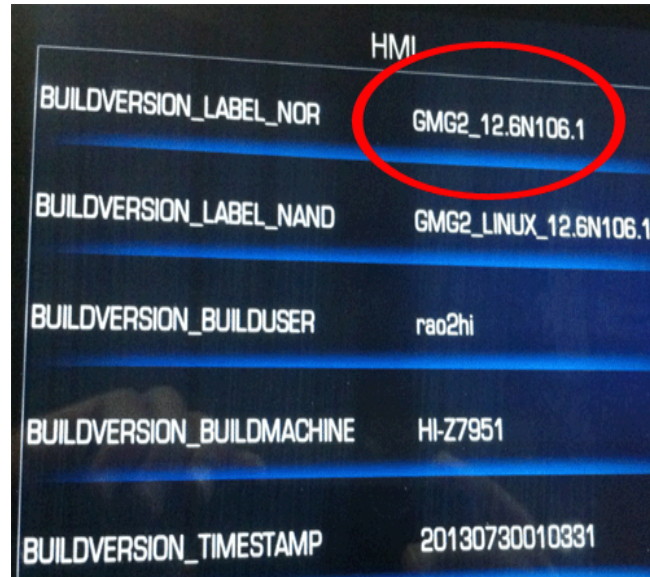
3749596

Before updating software, check the HMI build version. The HMI build version label should be GMG2.12.6N106.1 or earlier.

**Caution:** If the software version is later than GMG2.12.6N106.1, damage to the HMI module may occur. DO NOT PROCEED WITH THIS PI.

To verify the HMI build version, on the radio push the following button combination together (refer to chart below), then select HMI from the onboard development screen.
