Technical Bulletin

Model(s)	Year	Eng. Code	Trans. Code	VIN Range From	VIN Range To
Passat	2012 - 2014	All	All	All	All

69 14 01 February 14, 2014 2032959 Supersedes V691302 dated March 15, 2013 to update warranty table damage code and add additional model year applicability.

Airbag Warning Lamp – Front Side Airbag Pressure Sensor Interruption/ Short to B+

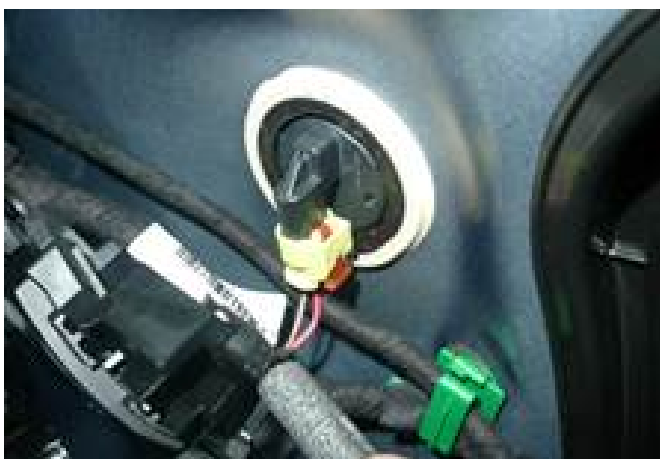
Figure 1

If Vehicle only has pressure Sensor Faults B101715 OR B103615 showing in GFF:

- Disconnect battery negative cable.
- Remove door panel and ensure secondary lock is fully seated on the pressure sensor.
- Verify pressure Sensor (5K0.959.354) is properly installed in the front door.

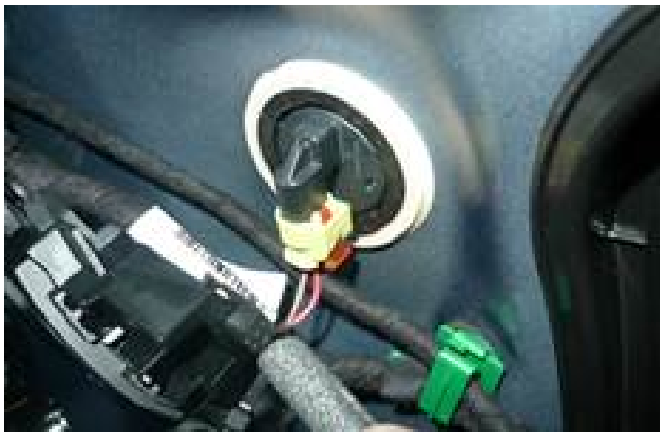
Figure 4

If Vehicle has pressure Sensor Faults B101715 OR B103615 AND Door Faults in the Electronic Control Module:

- Disconnect battery negative cable.
- Remove door panel and ensure secondary lock is fully seated on the pressure sensor.
- Verify pressure Sensor (5K0.959.354) is properly installed in the front door.
