## Transmission Connector (Multiple Open Circuits) LEU, MRU

### FSB 373-018, Transmission Connector (Multiple Open Circuits)

(November 2013)

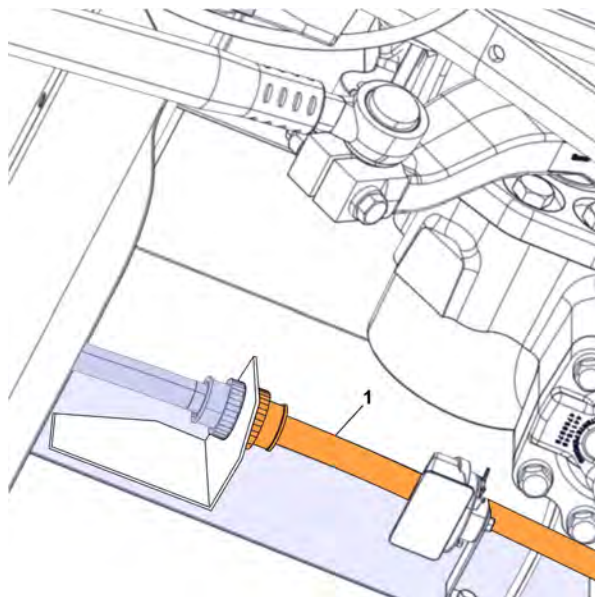
W3085373

1. Approximate location of "Yellow" marking

4. Look for yellow marking on harness (1).
  - a. If marking is present then no further action required. (Lower the cab).
  - b. If **NO** marking present, see repair below.

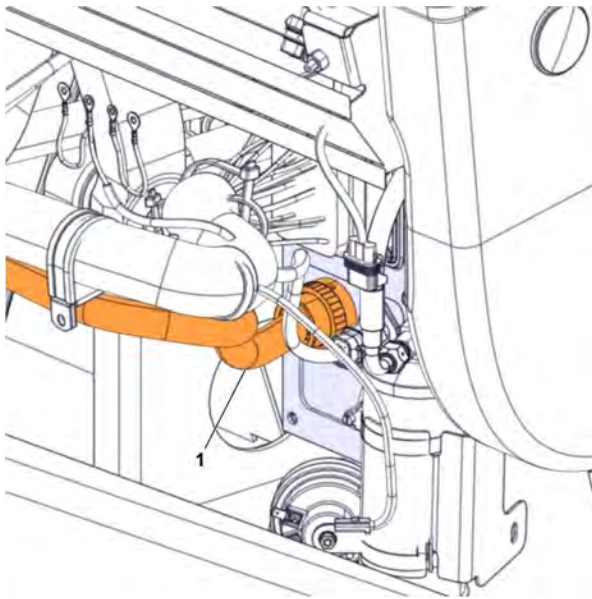
W3085374

1. Approximate location of "Yellow" marking
3. Inspect harness for "Yellow" marking on harness (1).
  - a. If marking is present then no further action required.
  - b. If **NO** marking is present, see repair below.

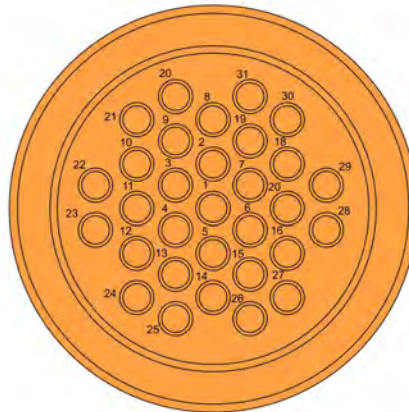
W3084149

Male Pin

- 5 Remove the transmission connector.
- 6 Untape and remove back shell and discard.
- 7 Remove the tape from the harness approximately 152 mm (6 in.) back from the connector.
- 8 Extract the terminals from the Delphi connector one terminal at a time and insert it into the same cavity of the Deutsch connector.

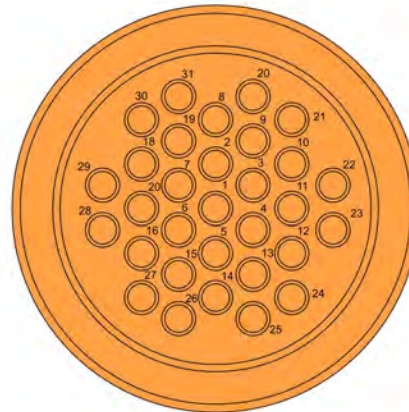
W3084150

Female Socket
