SB-10055488-7379

MBTA: Sidewall Panel Inspection

Issue: Corrosion inspection to assess the sidewall structure (underneath the windows).

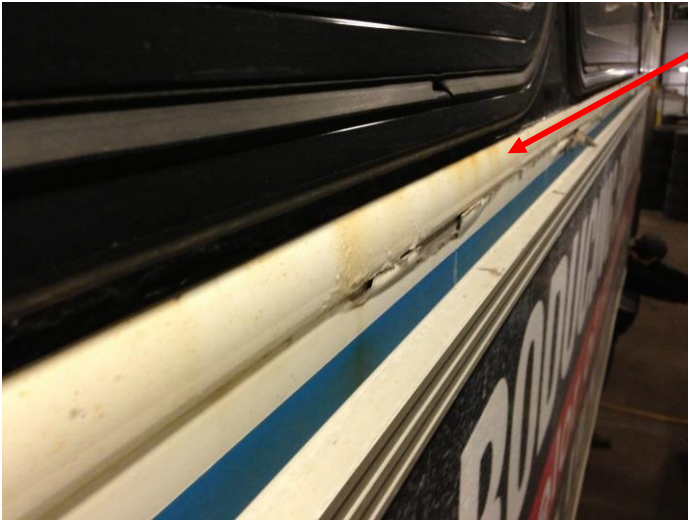
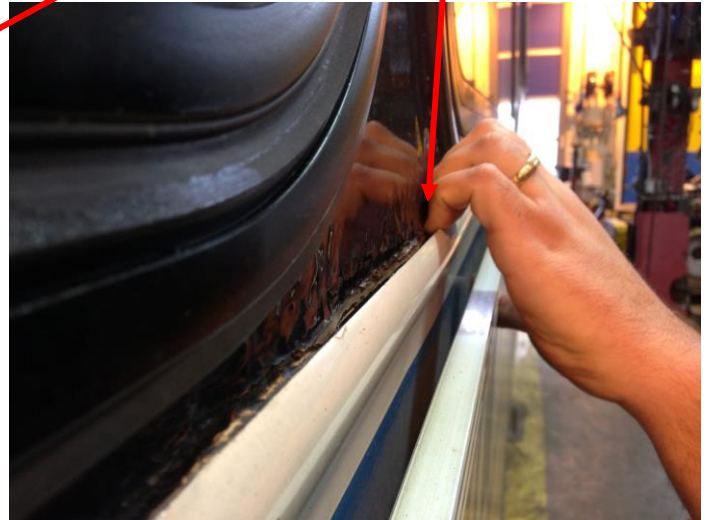
1. Park the bus on a flat surface and apply the parking brake.
2. Inspect side panels according to the following method:
 - Start from the front of the bus and attempt to pull the top trim piece away. Do not use tools – apply hand force only.

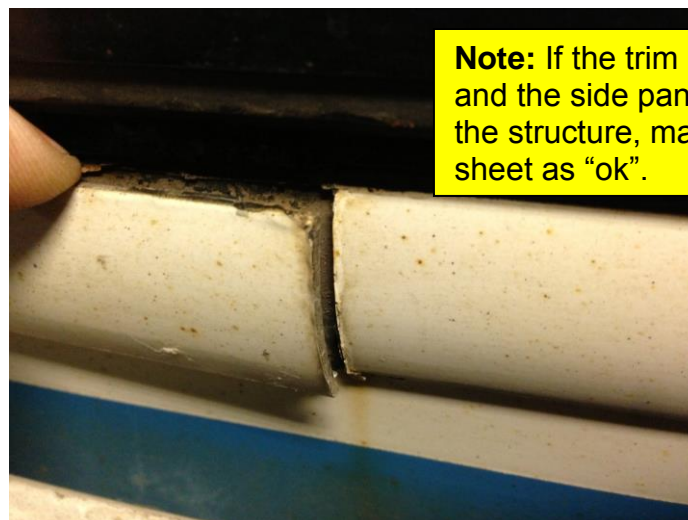
- Check the top trim piece from the front to the rear of the bus and record whether the side panel can be displaced.

Note: If the trim piece is displaced and the side panel remains secured to the structure, mark the inspection sheet as "ok".

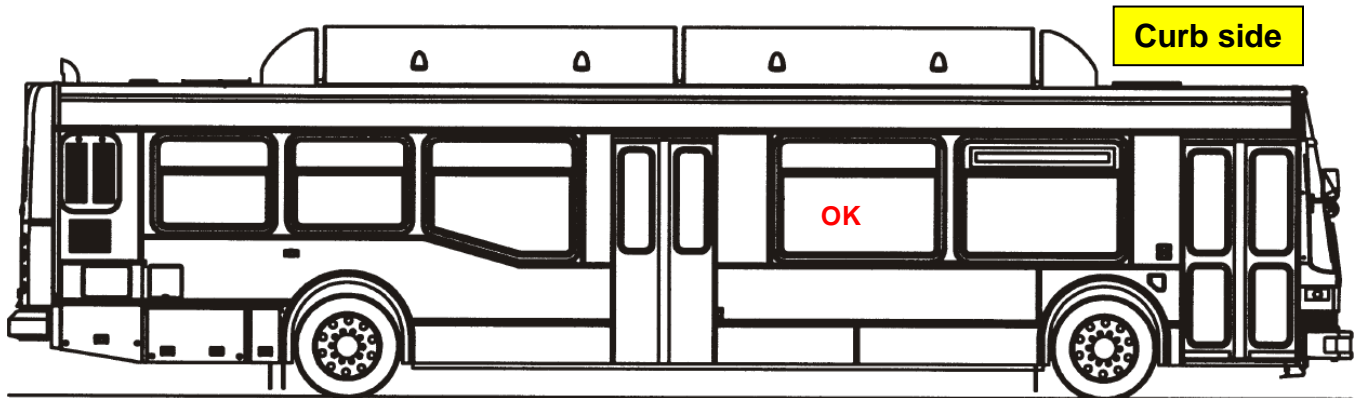
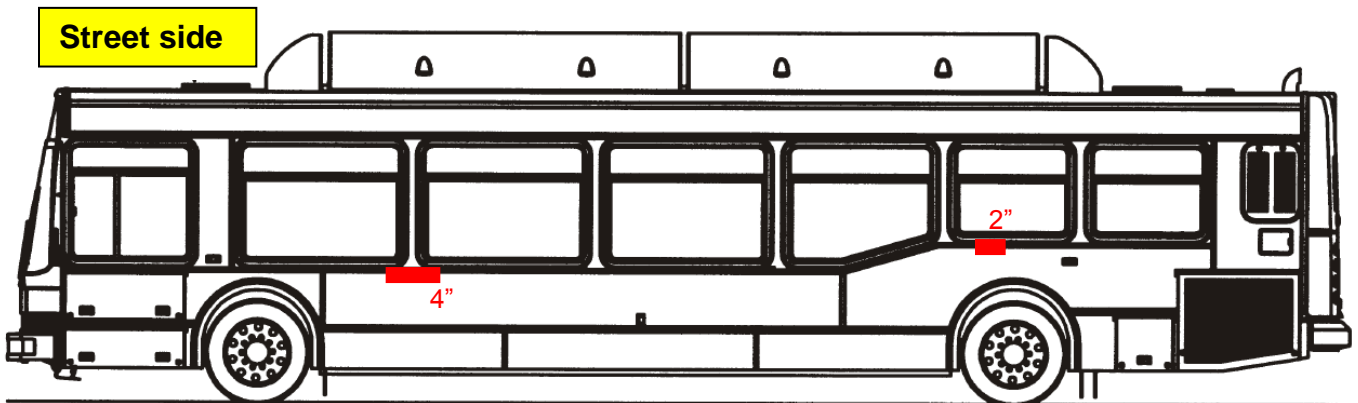
Result of Inspection (OK or number and length of separation): **Curb side is OK. Street side has two separated sections.**
