# Program Bulletin

**SB-10055497-8593**

## CUSTOMER SATISFACTION PROGRAM

**SUBJECT:** Incorrect Transmission Thrust Bearing

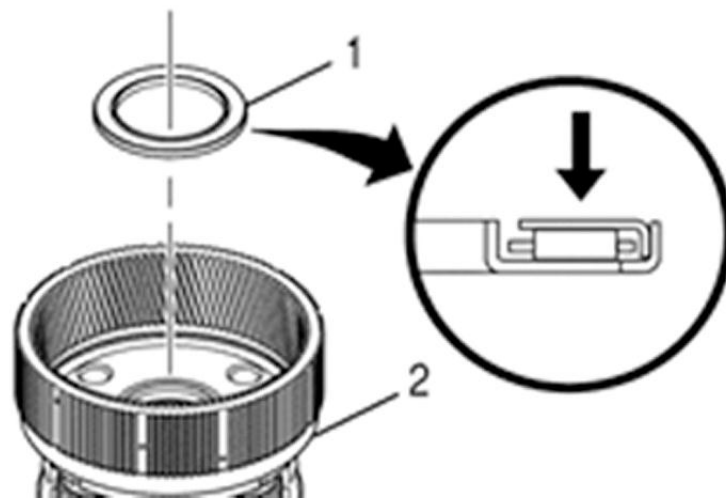
3723744

**Caution:** Installing the thrust bearing incorrectly may cause permanent damage to the transmission.

1. Align the thrust bearing (1) so that the black oxide surface on the thrust bearing is facing up, away from the input carrier module (2).
2. Install the thrust bearing (1) onto the input carrier module (2).
