## Harness Relay, CNG VN

### **SB-10055556-2387**

### **SP 373-020, Harness Relay, CNG**

(April 2014)

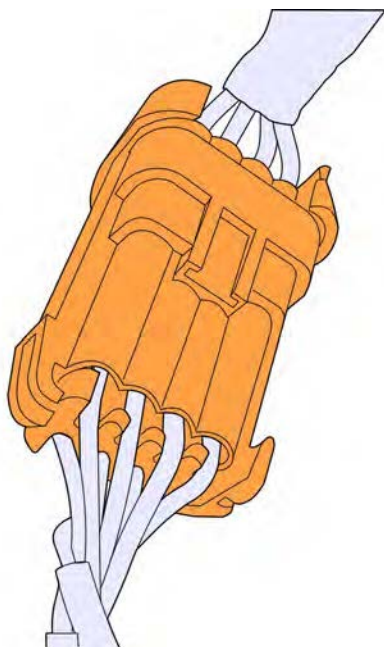
W3089792

CNG tank side connector

- 7 Look for seals on the wires on the CNG tank side connector.  
A. If seals present continue to step 8.  
B. If **NO** seals present to go to repair procedure on page 6.
